## **CS Energy (Callide Power Station)**

**Cooling Towers CT3 and CT4**

**Investigation into Failures and Root Cause Analysis**

**Report No 2210001-RCA1 - Rev 0**

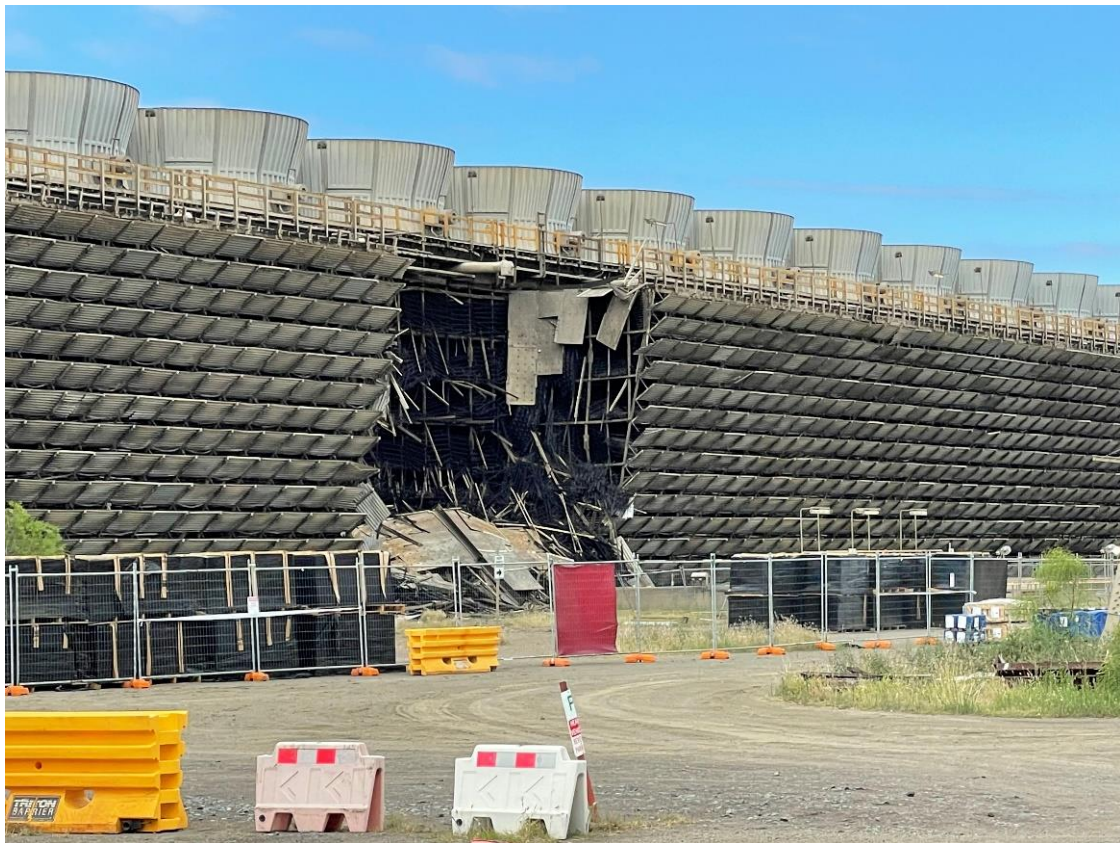
*Figure 1.2 Cooling Tower CT3 viewed from the north-east showing collapsed cells 8 and 9*

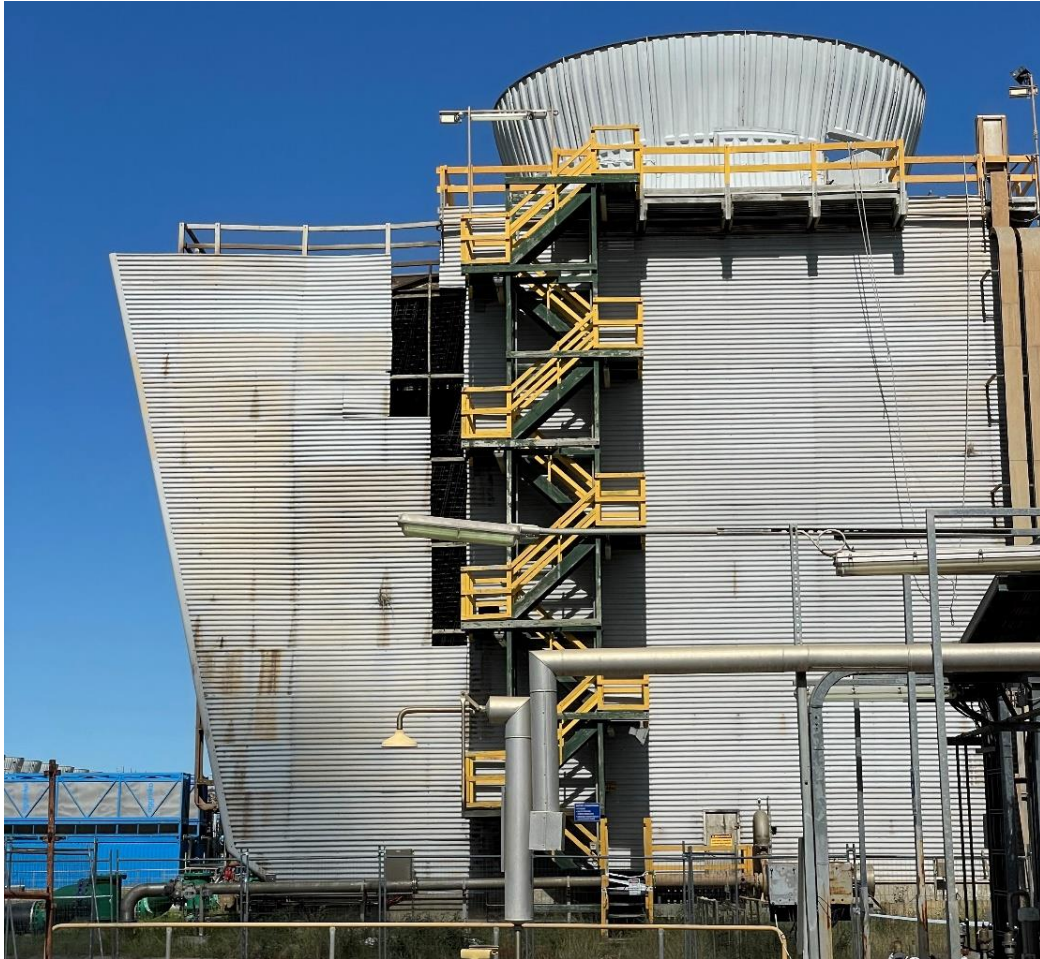
*Figure 1.4 Cooling tower CT3 - Cell 1 internal collapse (2022 Photo)*

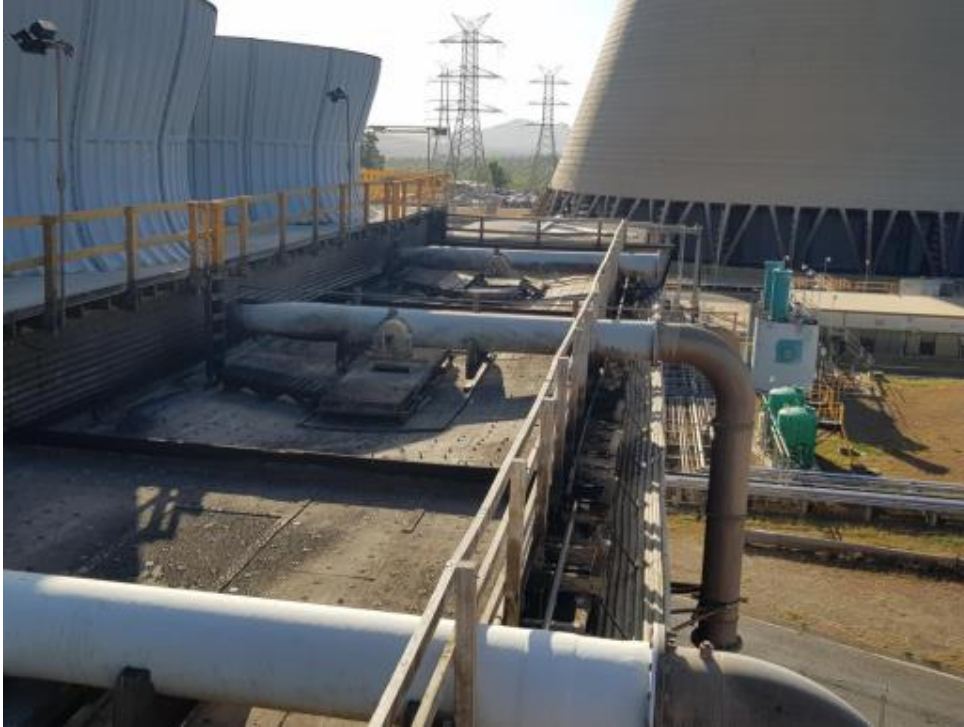
*Figure 1.5 Cooling tower CT3 - Cells 1 and 2 hot water basin subsidence (2022 Photo)*

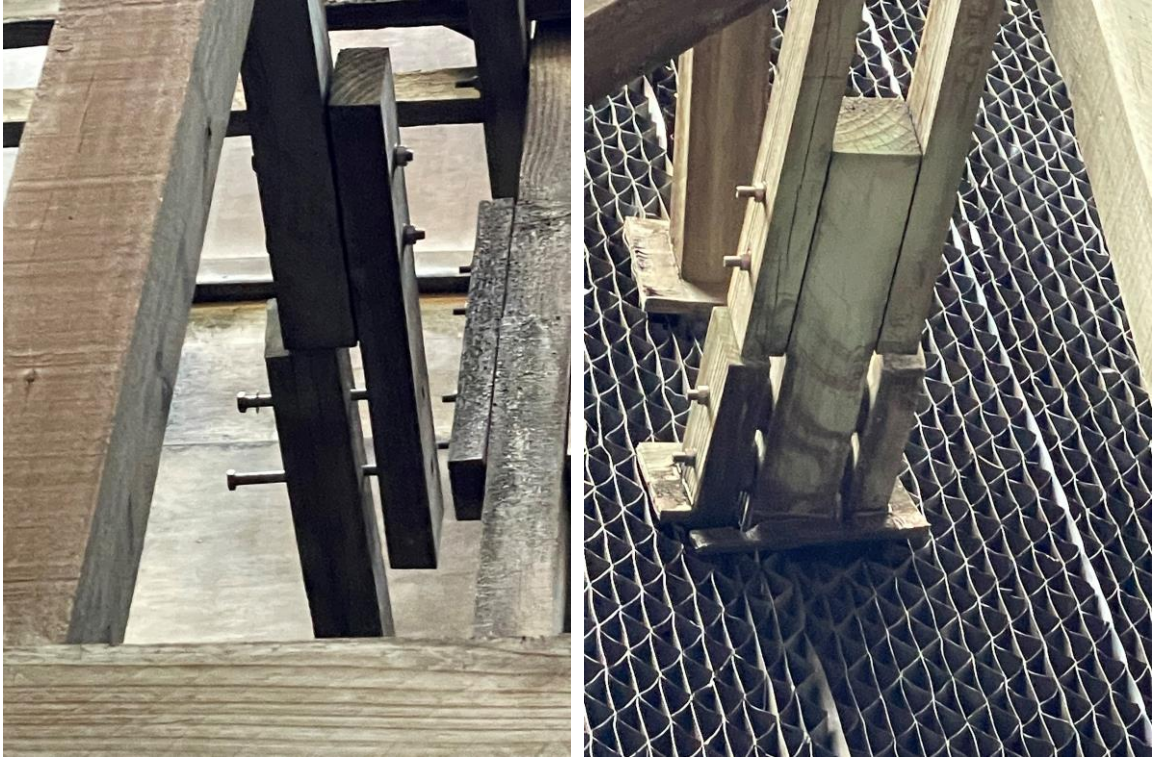
**Figure 5.1** Left – Nuts missing, danger of bolts falling out. Right – Loose connection with shear plates disengaged, alternatively these are spacer blocks

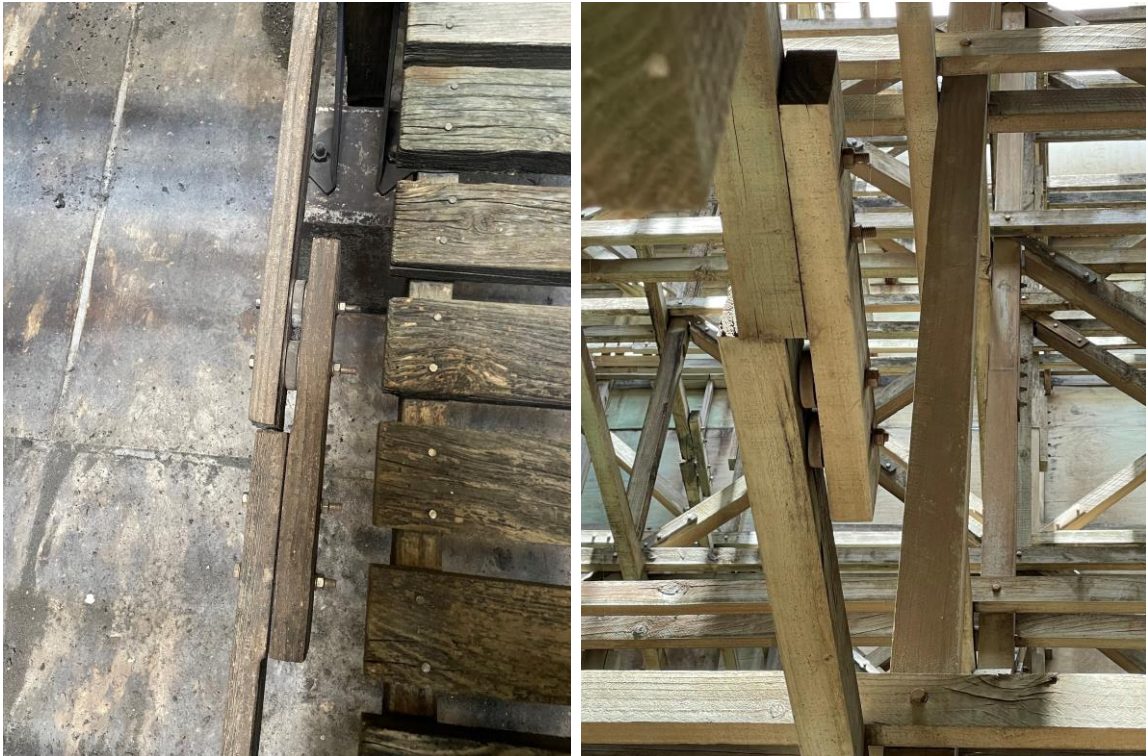
**Figure 5.2** Left and Right – Loose connections, misaligned girts with shear plates disengaged, alternatively these are spacer blocks

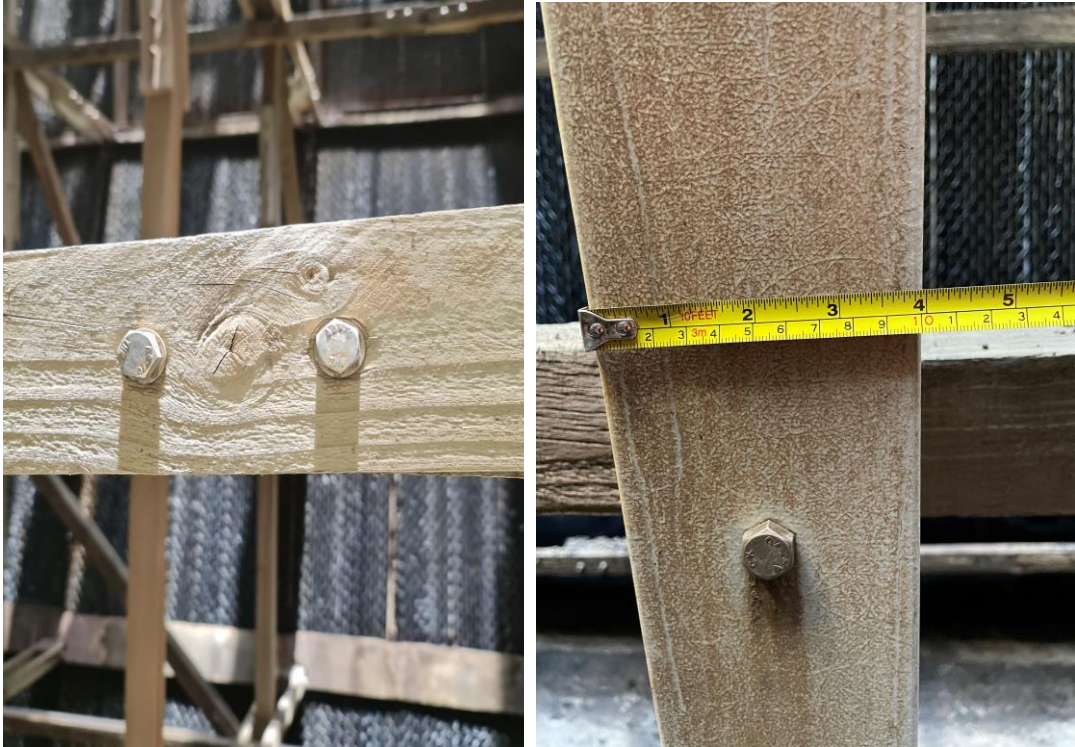
*Figure 5.3 Left - Undersized washers. Right: No washer in FRP column*

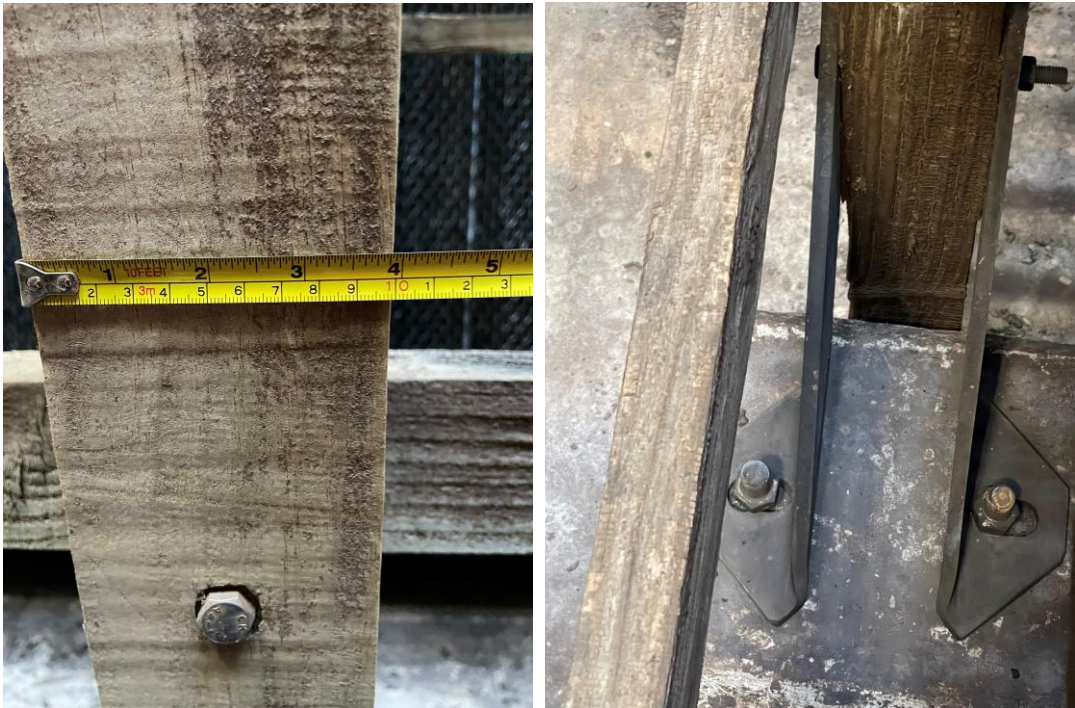
*Figure 5.4 Left - No washer or undersized washer penetration. Right Anchor plate with no washers*

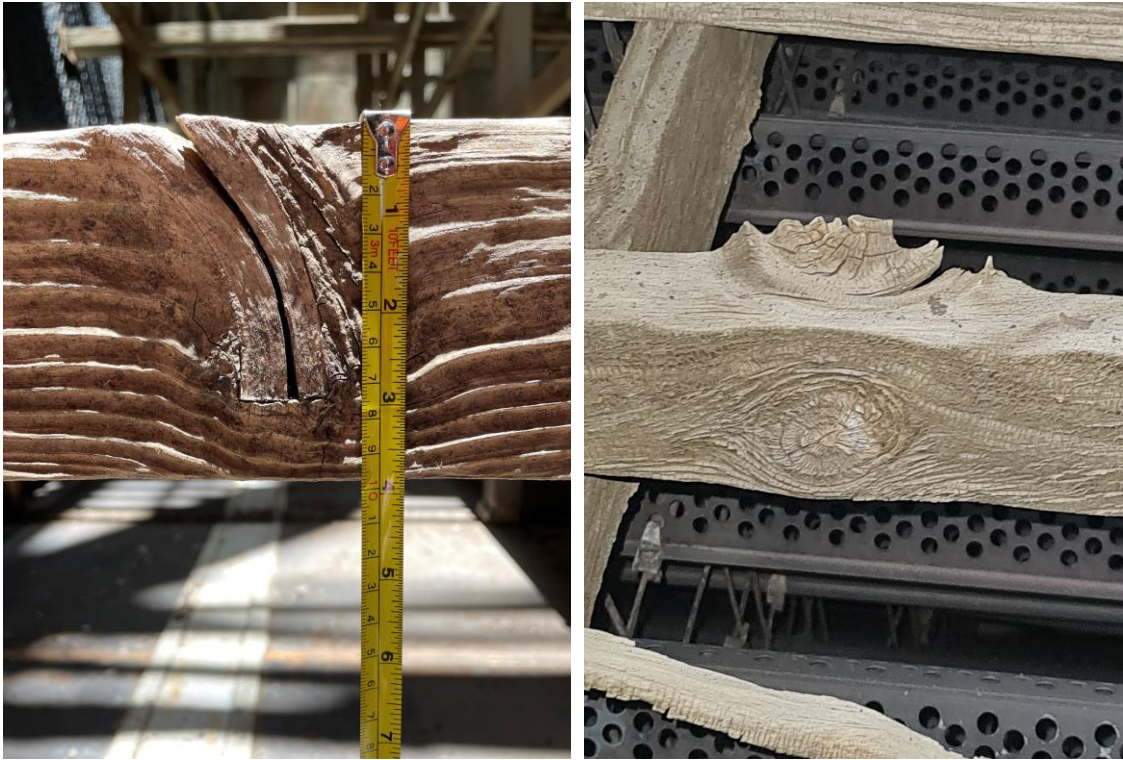
*Figure 5.5 Left and Right - Knots in horizontal girts - chemical erosion*

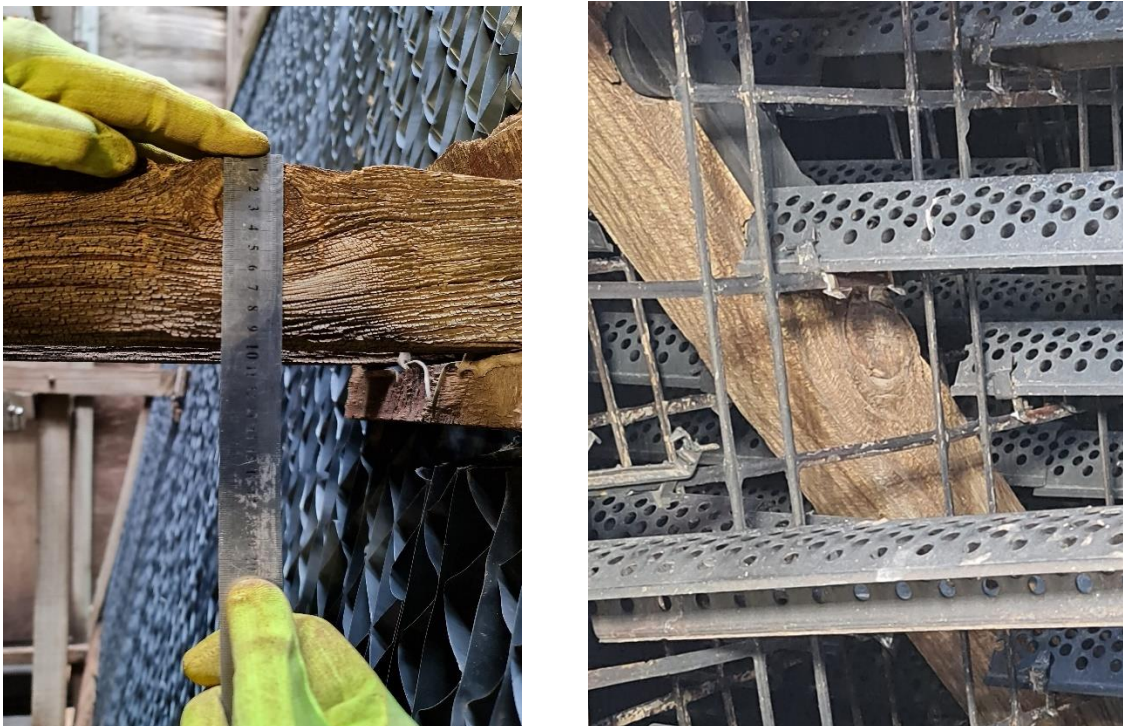
*Figure 5.6 Left - Knot in horizontal girt with chemical erosion. Right - Knot in diagonal brace, chemical erosion*

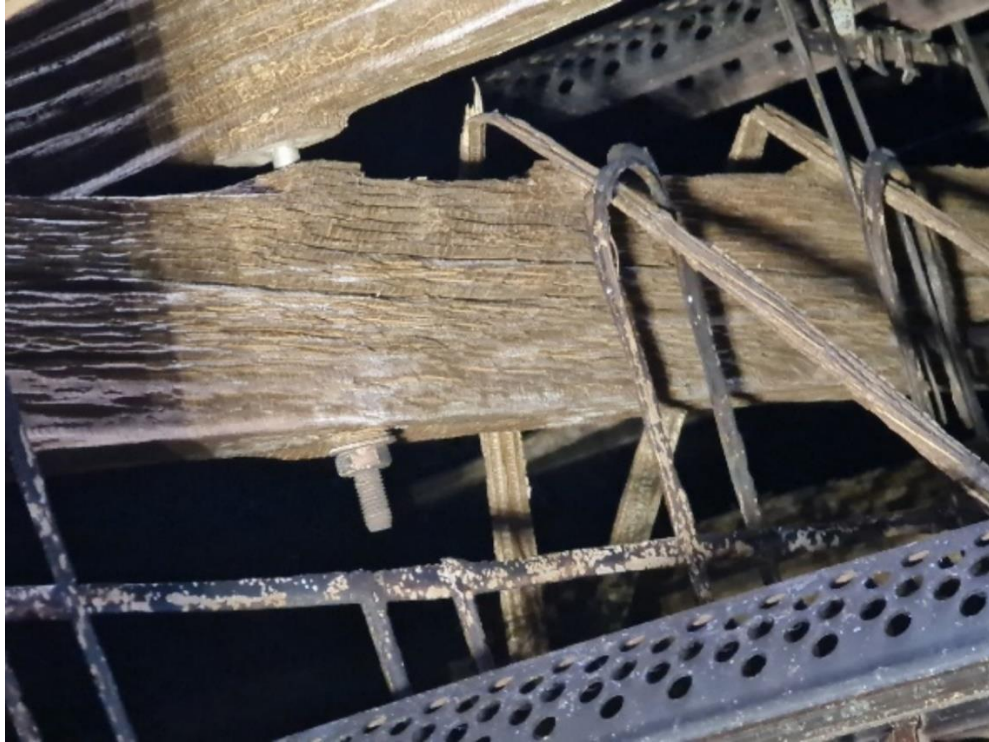
*Figure 5.7 Transverse girt with chemical corrosion. Timber D-Moulds completely eroded*

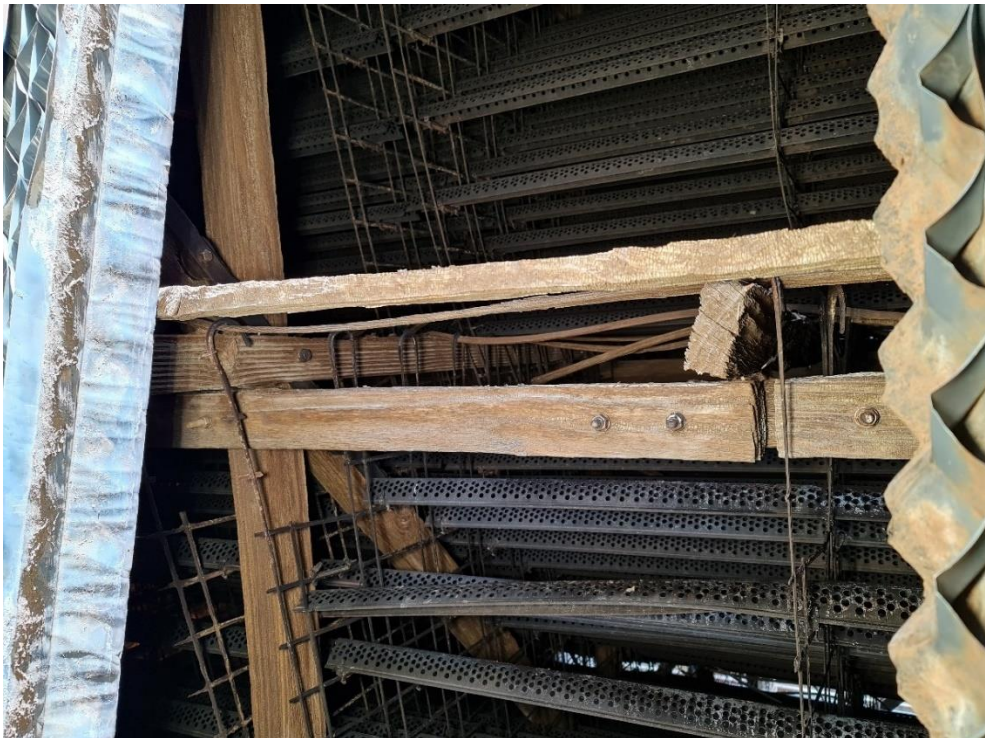
*Figure 5.8 Longitudinal girt with chemical erosion. Twisted end of intermediate girt due to bottom fixing only*

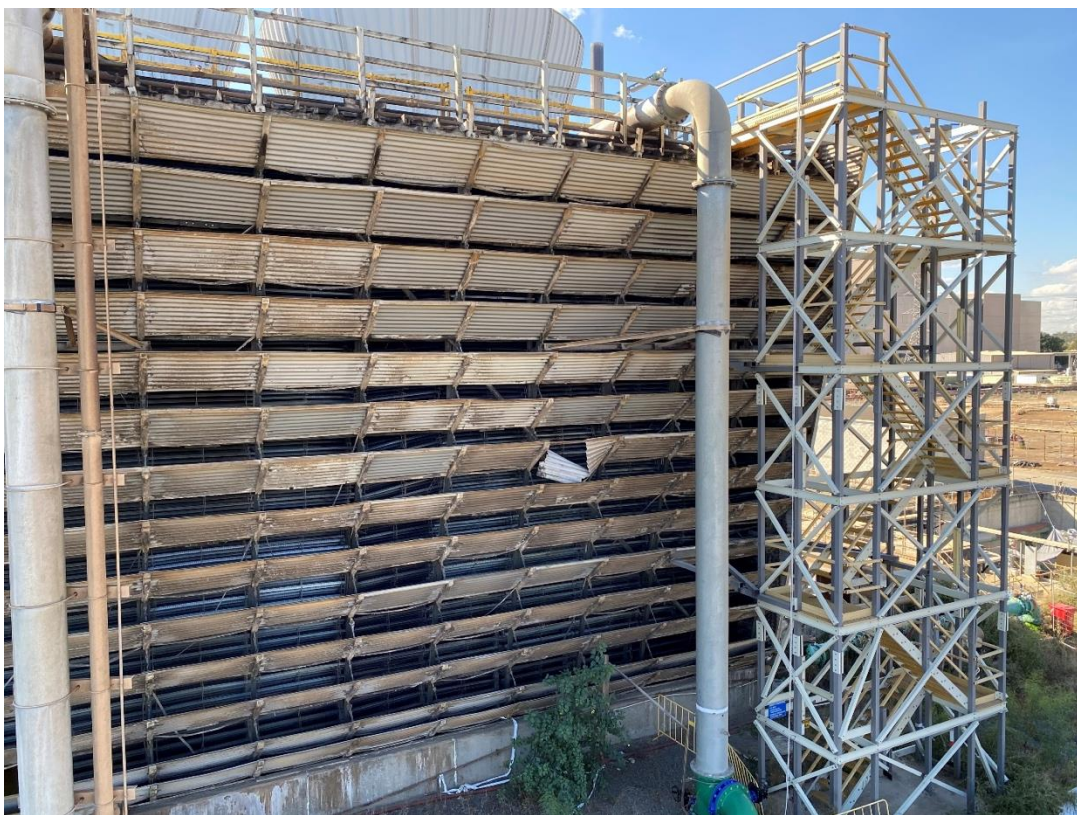
*Figure 5.12 Typical damage to louvre sheet*

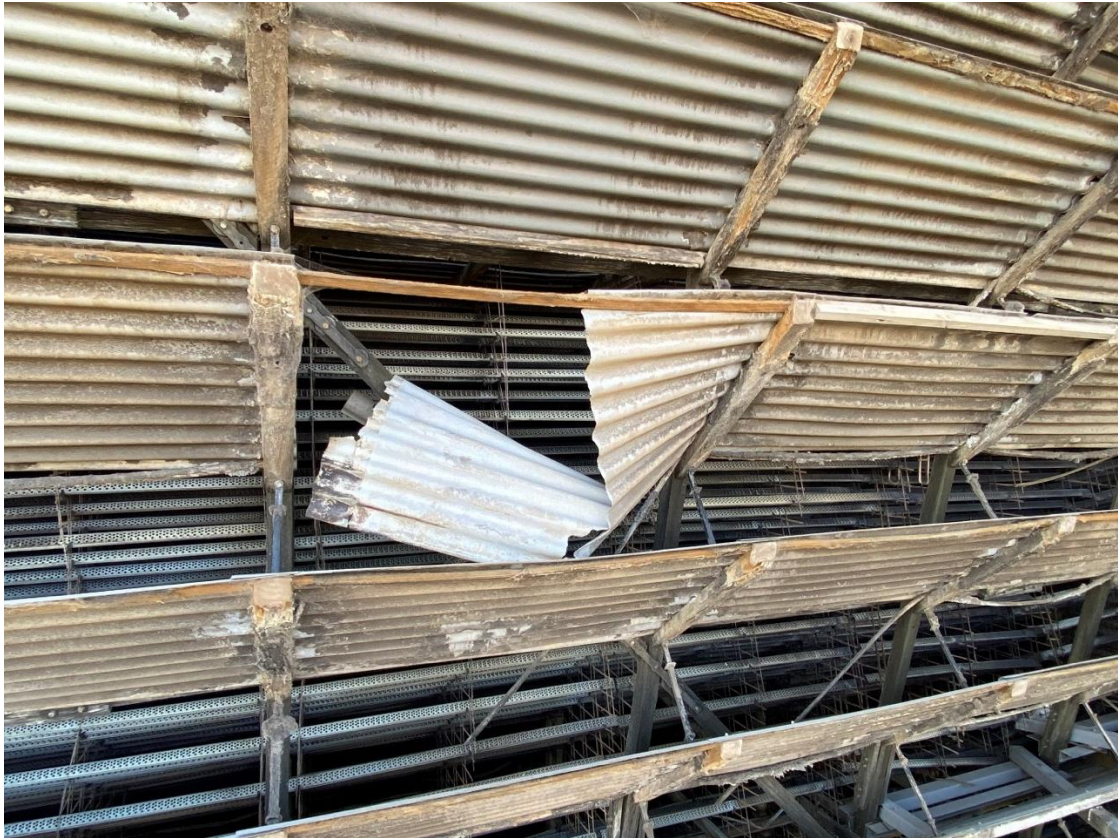
*Figure 5.13 Close up of broken louvre sheet - typically damaged sheets were cut and removed*

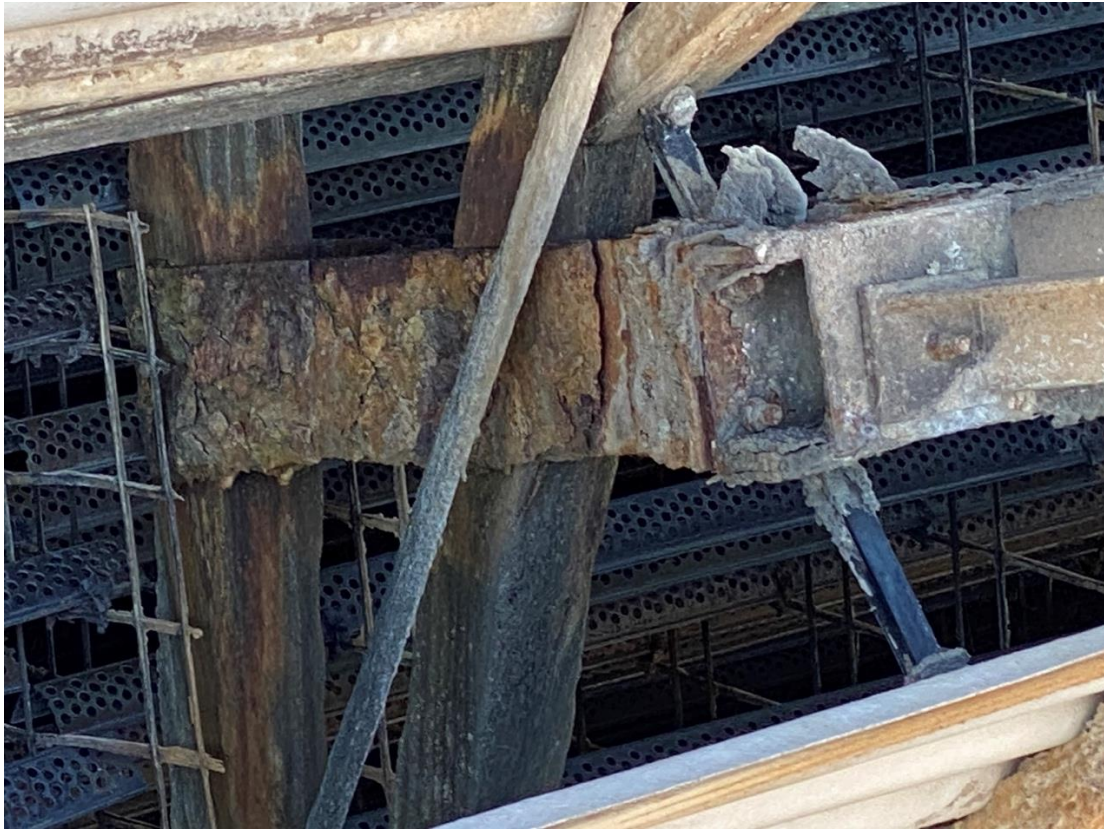
*Figure 5.15 corrosion in the riser pipe braces*

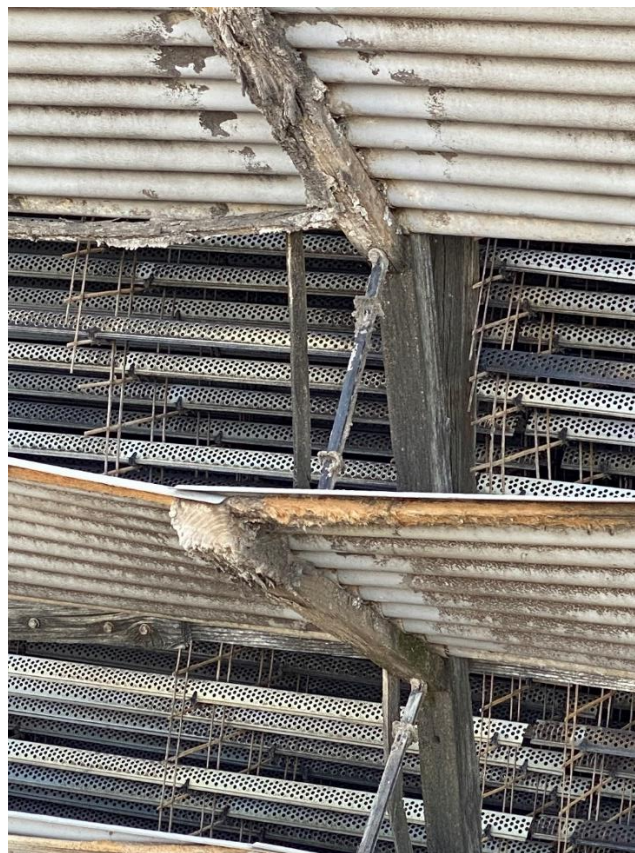
*Figure 5.16 Louvre support timber sagging where the FRP plastic tie has come undone*

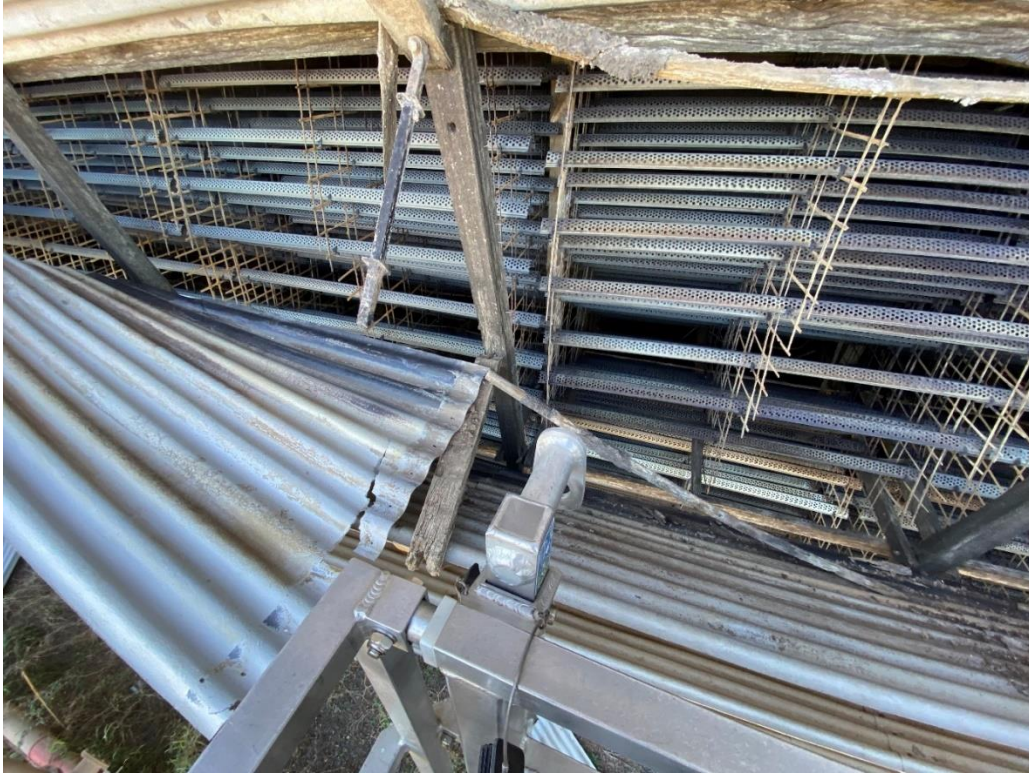
*Figure 5.17 Louvre support member that has dropped and FRP tie is hanging free*

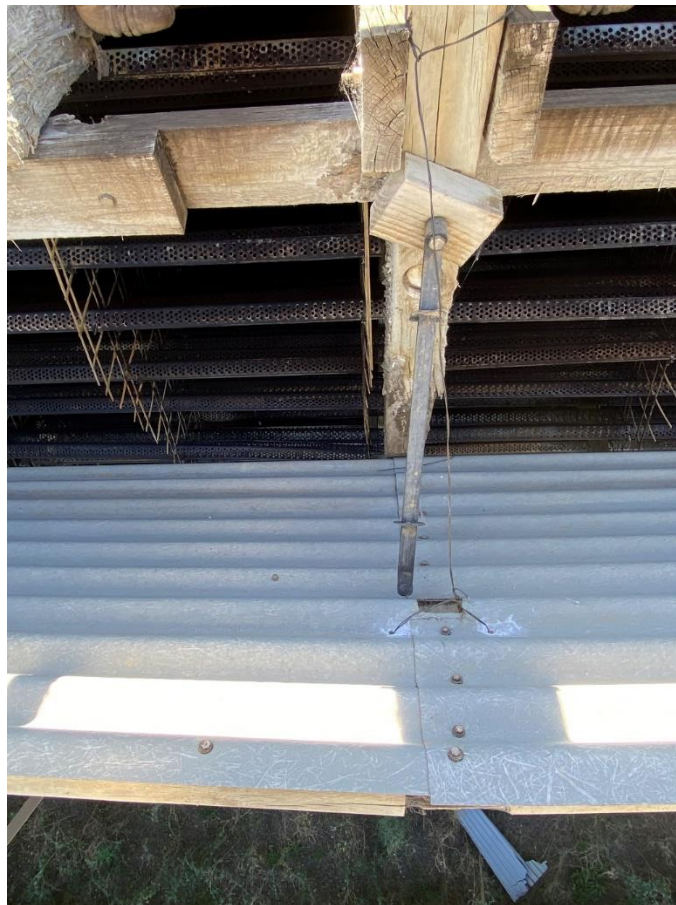
*Figure 5.18 Typical temporary repair to re-support louvre supports using wire ties*

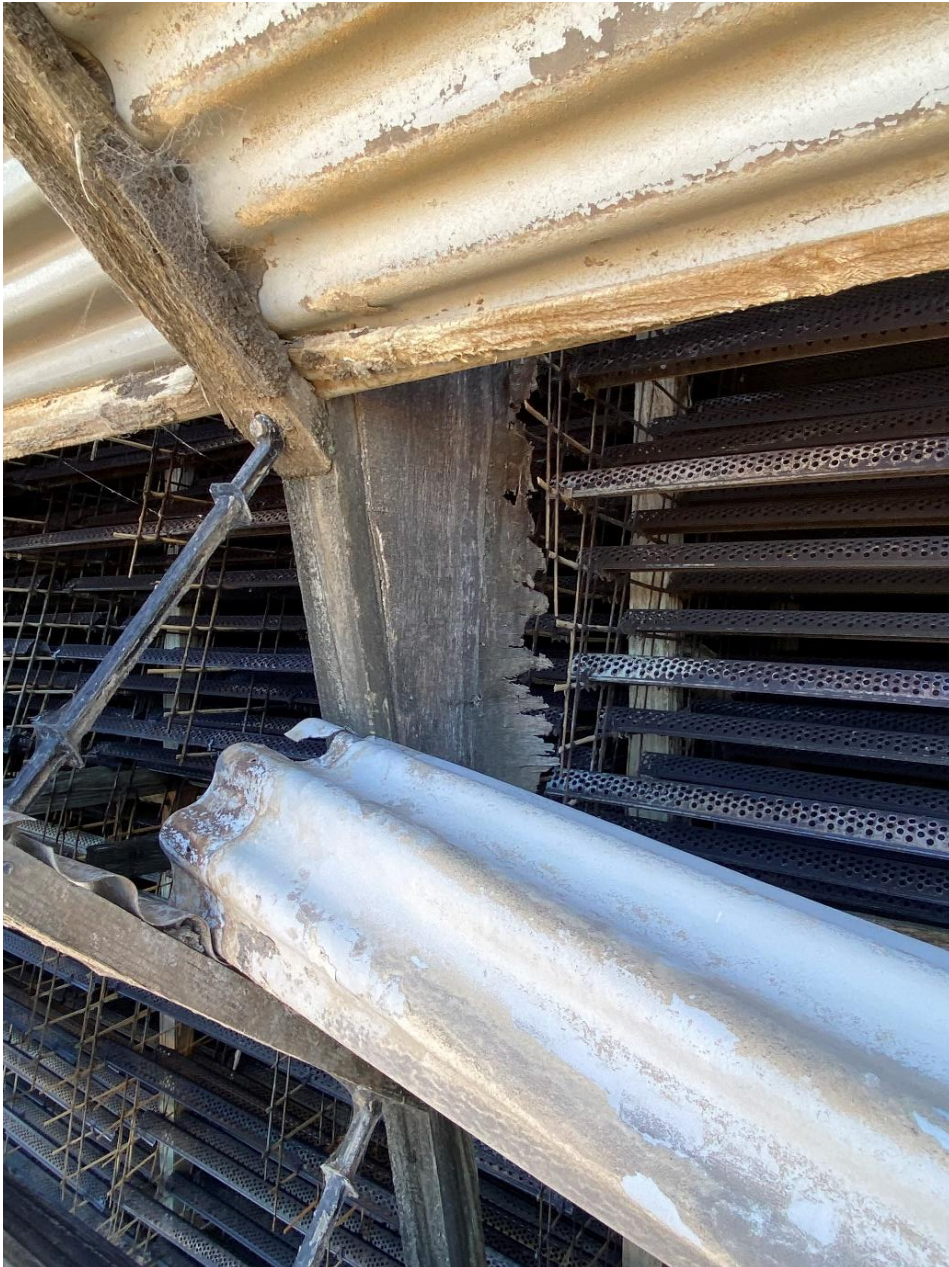
*Figure 5.19 Remnant of the cell divide plywood potentially. Loose louvre sheet in the foreground*

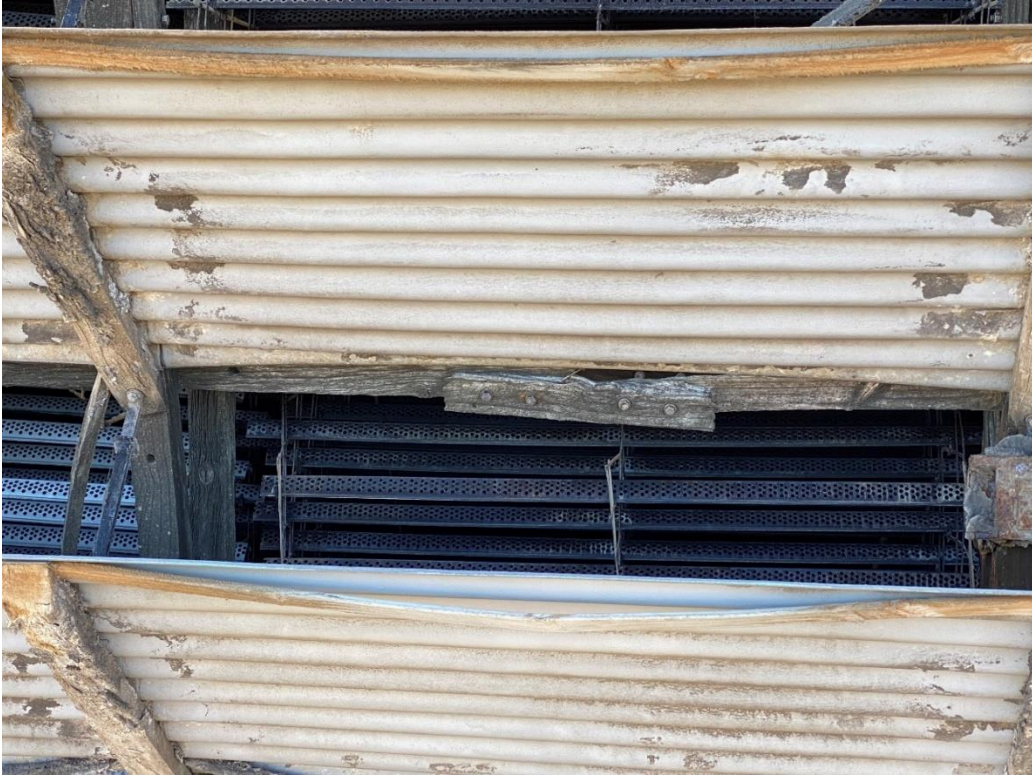
*Figure 5.20 Louvre sheet D-mould timber eroded and absent in many locations. Also eroded longitudinal girt and splice*

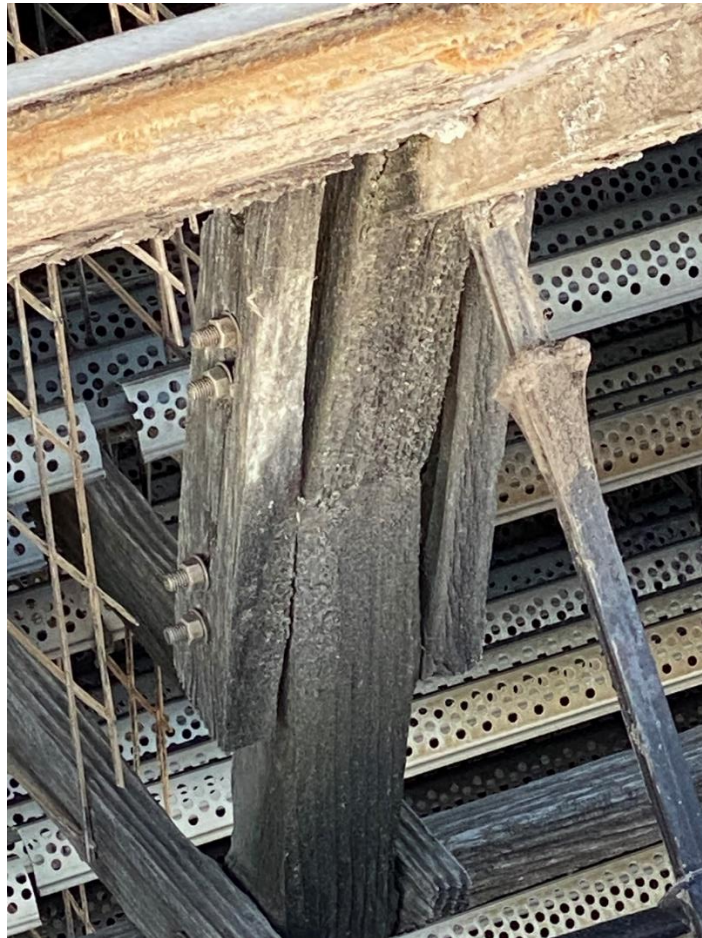
*Figure 5.21 Column bent at splice*

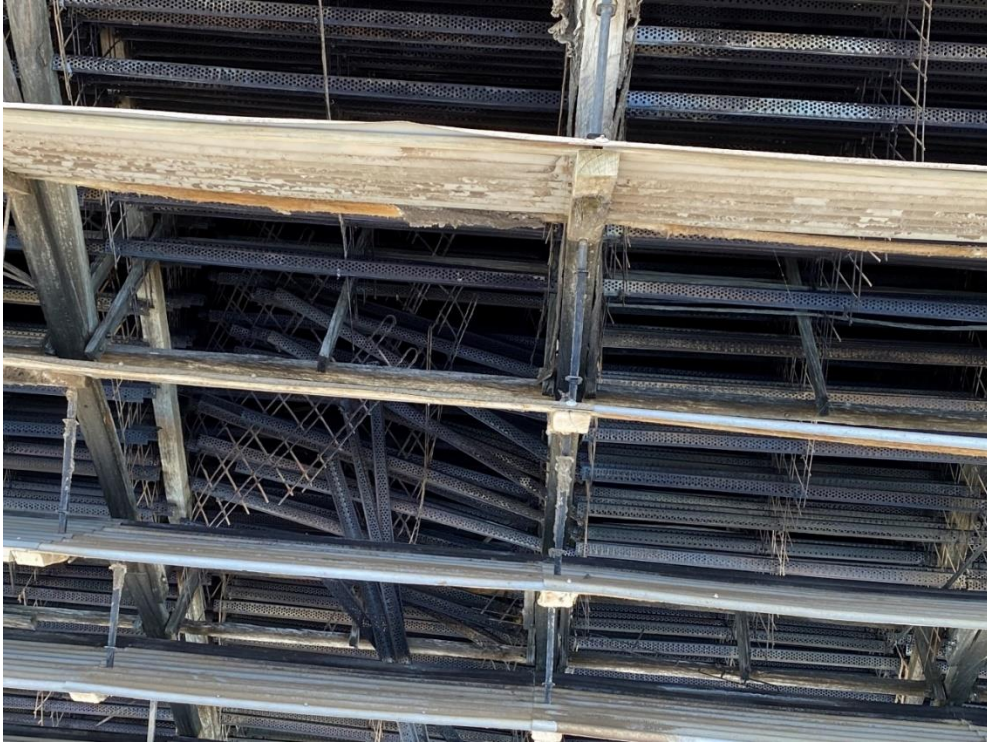
*Figure 5.22 Some sections of fill collapsed though not widespread on this side of CT4*

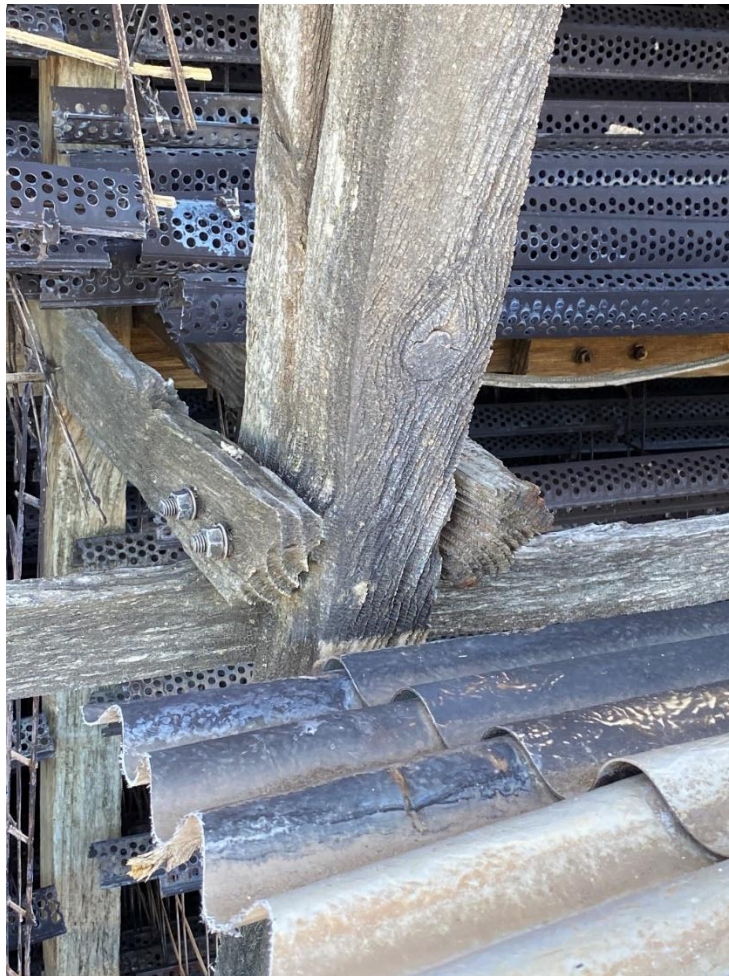
*Figure 5.23 Erosion of transverse girts and column. Cut louvre sheet in the foreground*

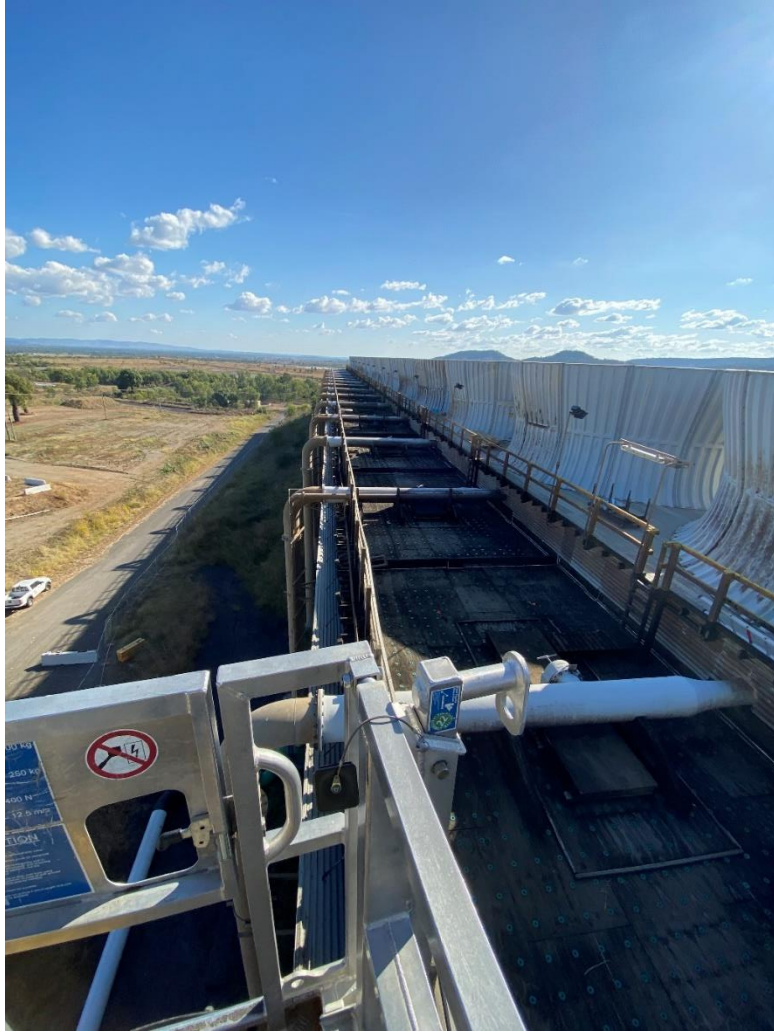
*Figure 5.24 View of hot water basin. No evidence of sagging*

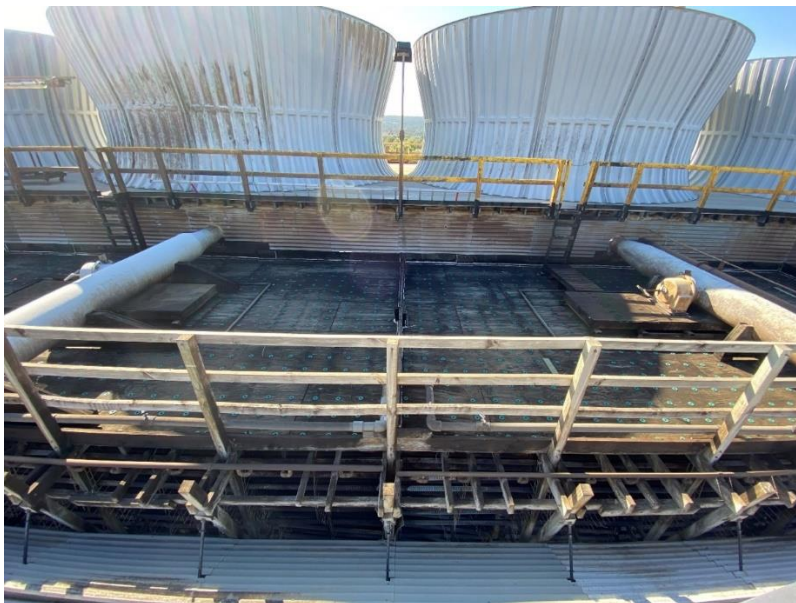
*Figure 5.25 Hot water basin appeared to be in reasonable condition*

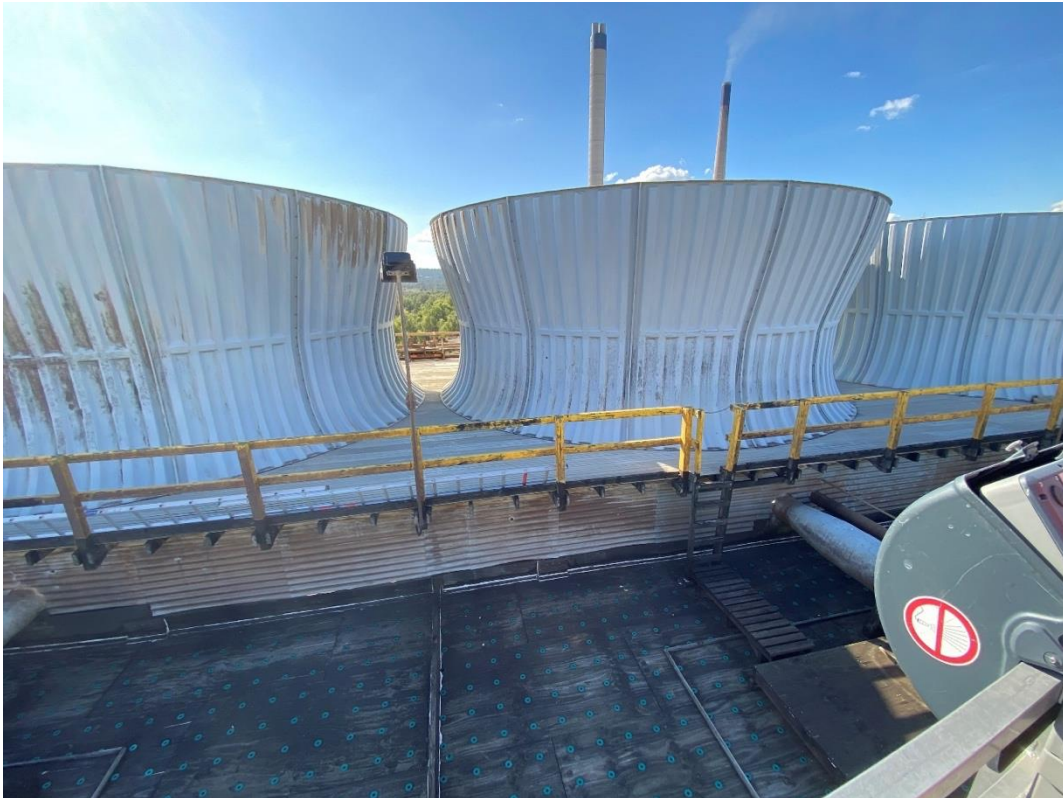
*Figure 5.26 Fan deck appeared to be in good condition*

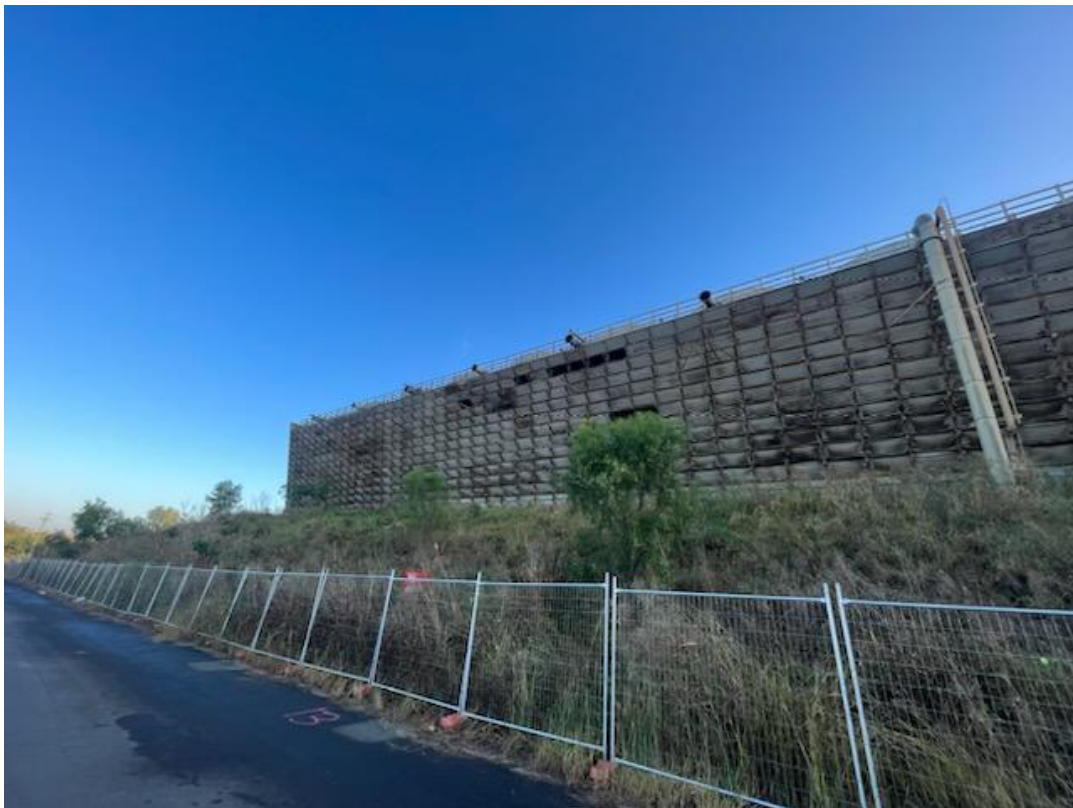
*Figure 5.27 Several sections where louvre sheets were removed. Access was granted and riser pipes removed*

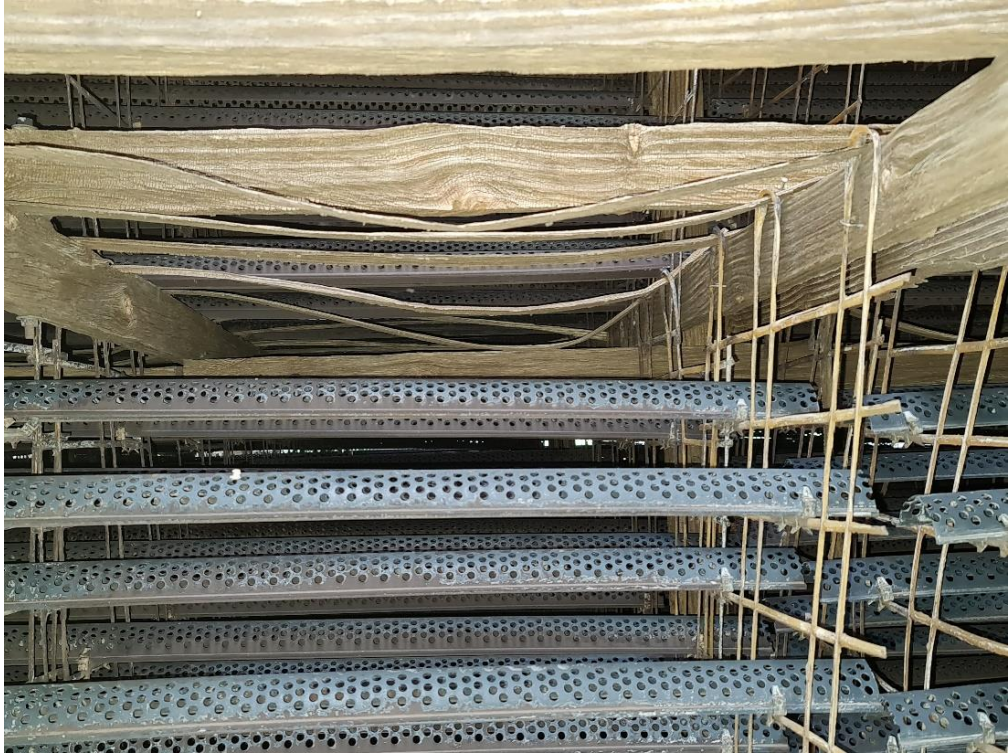
In general, the splash bars are supported on vertically hung FRP grids. The FRP grids then appear to be supported on thin timber D-moulds with the grids hanging off the D-moulds, and in addition to this, the grids are also side stapled to the timber girts. Many of the D-moulds have deteriorated to the extent they are now largely ineffective or have fallen out completely. The photo below shows the condition of the D-moulds as well as the seemingly irregular staple fixings.

**Figure 5.29** Remnants of the D-mould support strips and the staples supporting the FRP grids

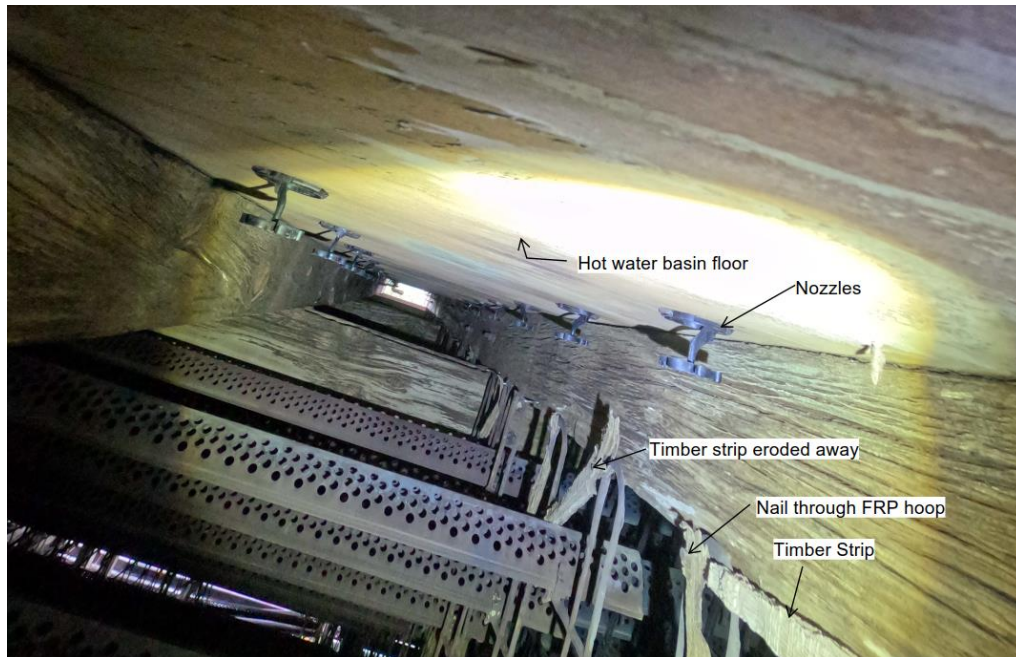
At the uppermost section under the hot water, the FRP is supported by nails driven through a thin strip of plywood. This strip of plywood is in poor condition and loose and largely eroded away. While the FRP grids are supported by the nails, and not the timber strip, with the timber strip eroded away, the FRP grids can now fall off the nails and drop a whole tier of fill. See Figures 5.30 and 5.31.

**Figure 5.30** Support at top section of FRP grids showing eroded timber
