## **CS Energy (Callide Power Station)**

**Cooling Towers CT3 and CT4**

**Investigation into Failures and Root Cause Analysis**

**Report No 2210001-RCA1 - Rev 0**

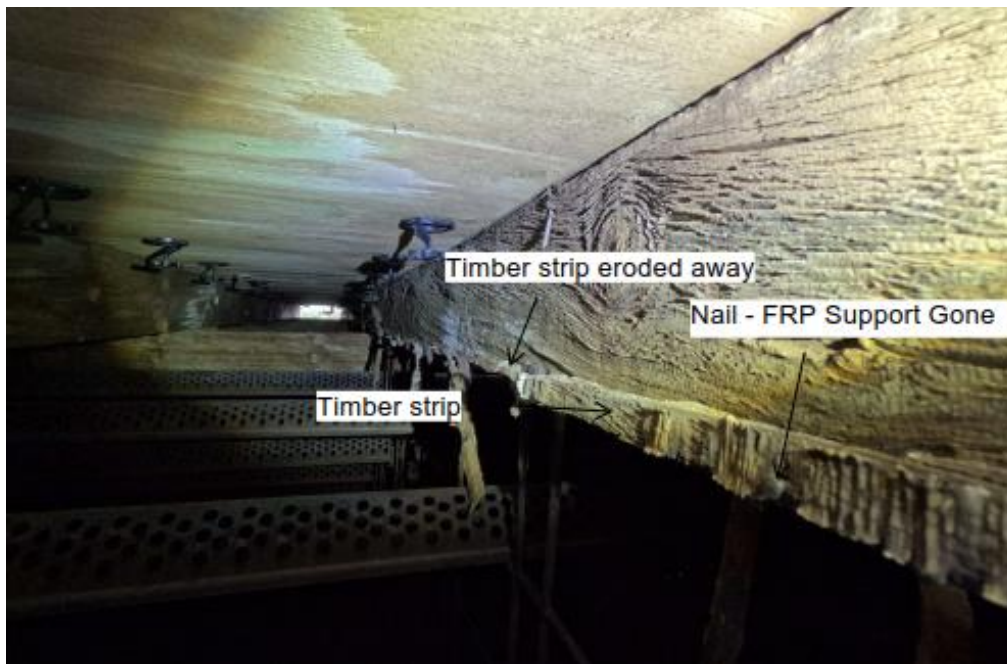
At the uppermost section under the hot water, the FRP is supported by nails driven through a thin strip of plywood. This strip of plywood is in poor condition and loose and largely eroded away. While the FRP grids are supported by the nails, and not the timber strip, with the timber strip eroded away, the FRP grids can now fall off the nails and drop a whole tier of fill. See Figures 5.30 and 5.31.

*Figure 5.31 Section where the upper fill supports have fallen*

As can be seen the condition of the splash bar supports is poor. As such there could be collapse of the fill independently of the tower primary structure. Therefore, when large sections of splash bars collapse it is not necessarily an indication of problems with the primary structure. However, the weight of collapsing tiers accumulating on supports lower down, could overstress those lower supports.

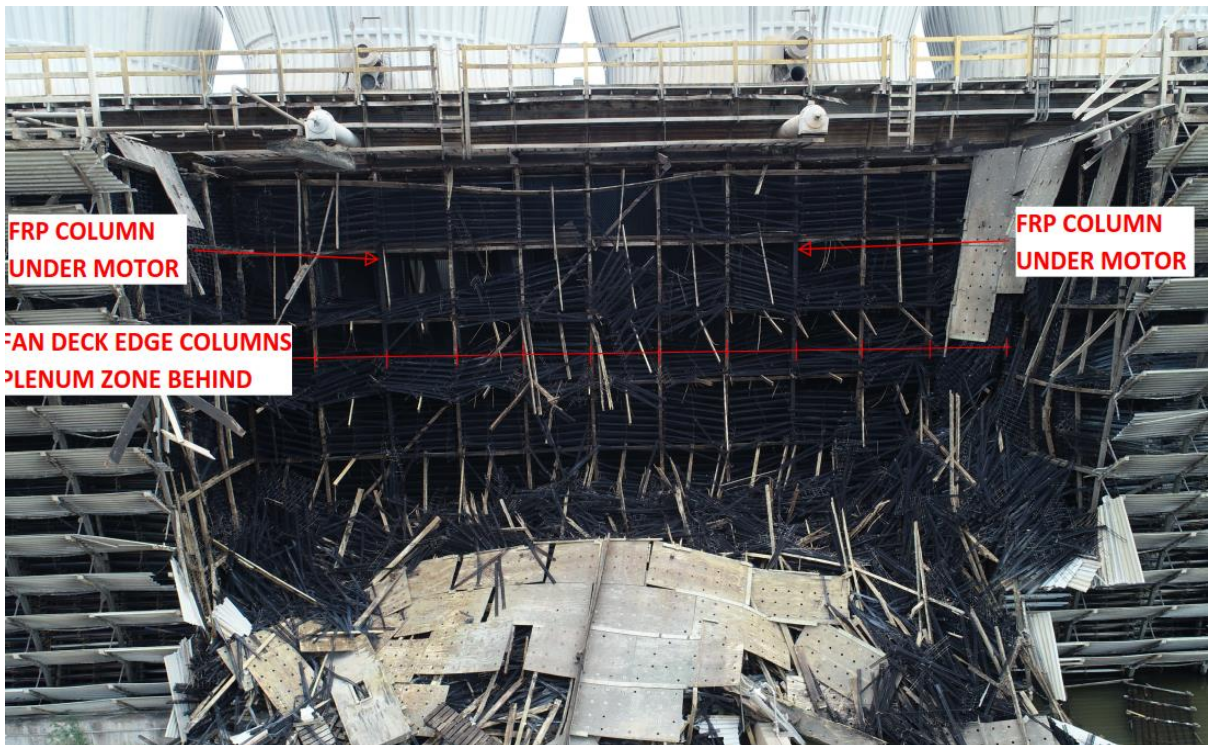
Figure 7.4 Photograph of failure zone

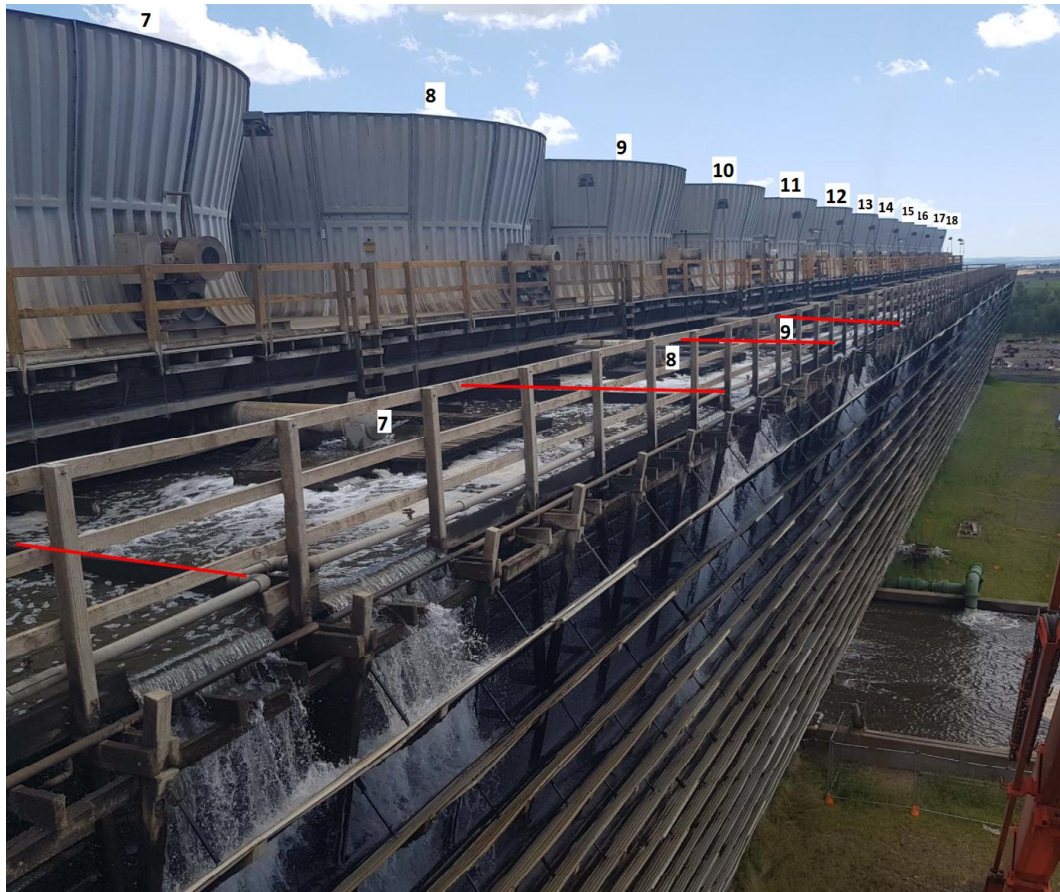
*Figure 7.6 Overflow through cut outs in hot water basin*

It is highly unlikely therefore that the overflow from the hot water basin was in any way a trigger that could trigger the collapse of cells 8 and 9.

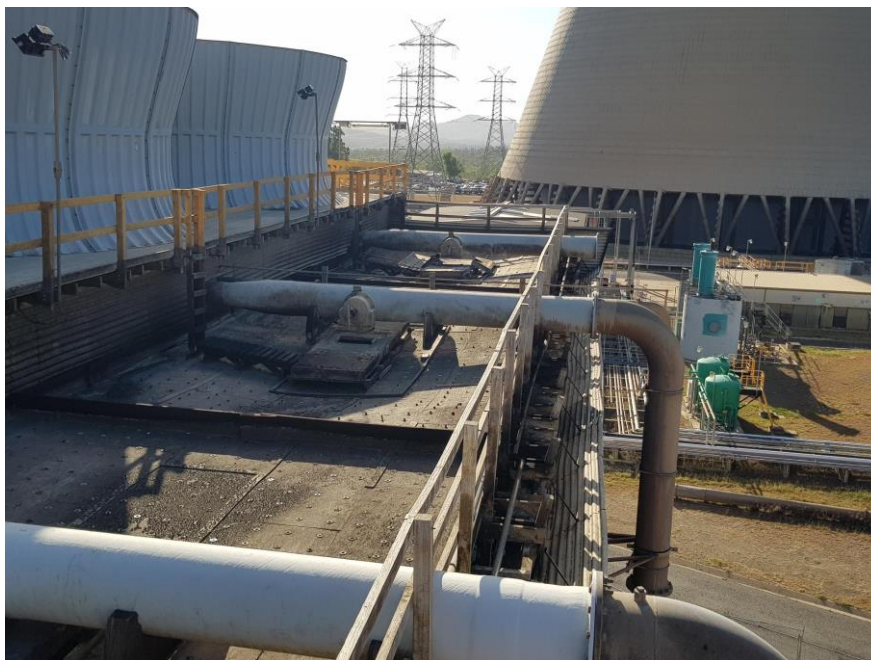
*Figure 7.8 Subsidence in hot water basin CT 3 cells 1 and 2 - CS Energy*

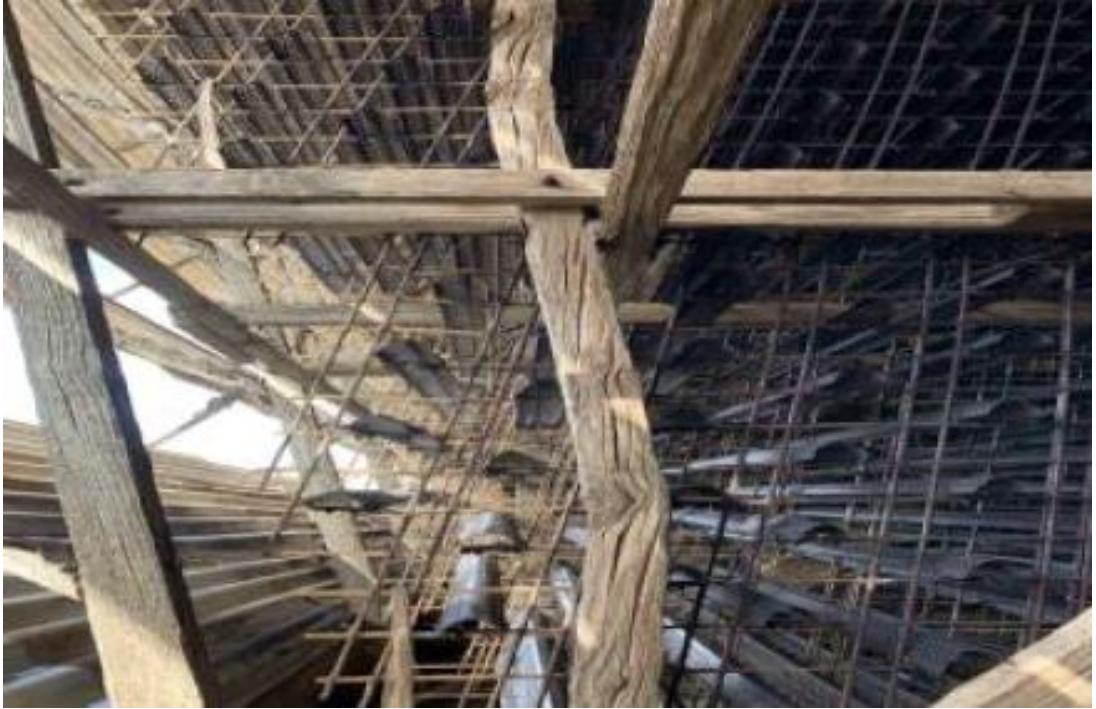
*Figure 7.9 Example of column distortion reported throughout wet areas. Note first vertical column adjacent louvre columns - Marley April 2022*

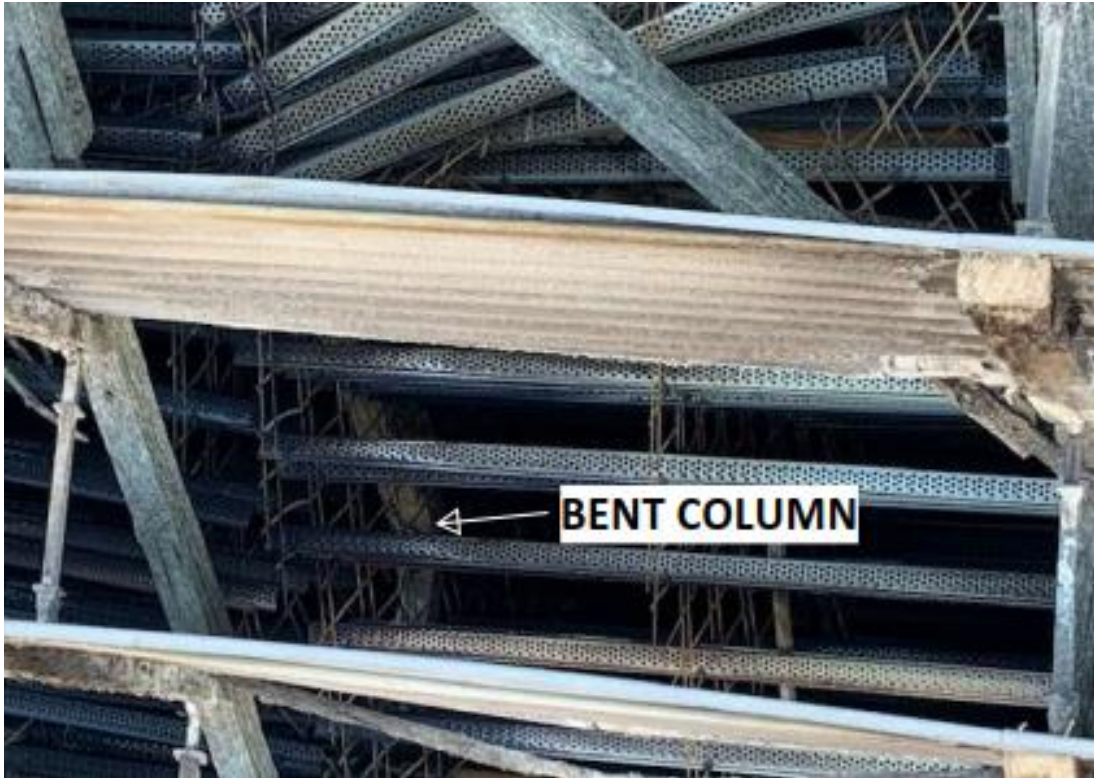
*Figure 7.11 Bent Column CT3 unknown location - Marley April 2022*

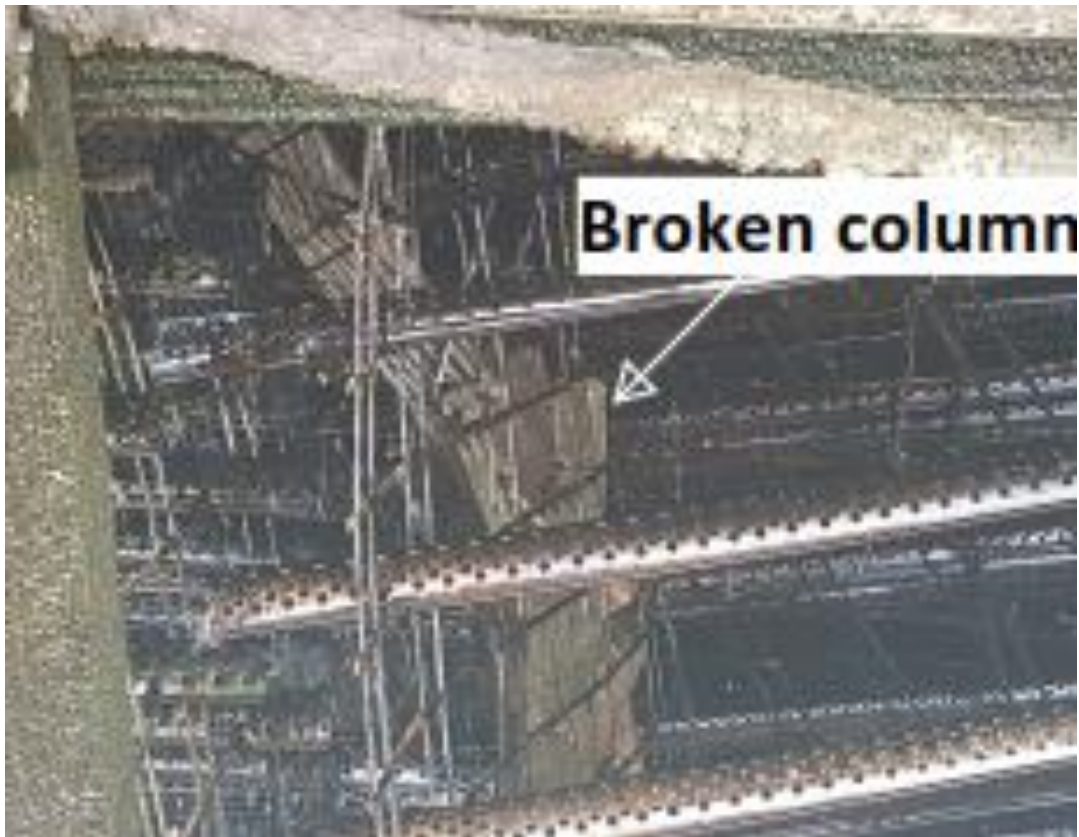
*Figure 7.12 Broken Column CT3 Cell 7 - CS Energy*

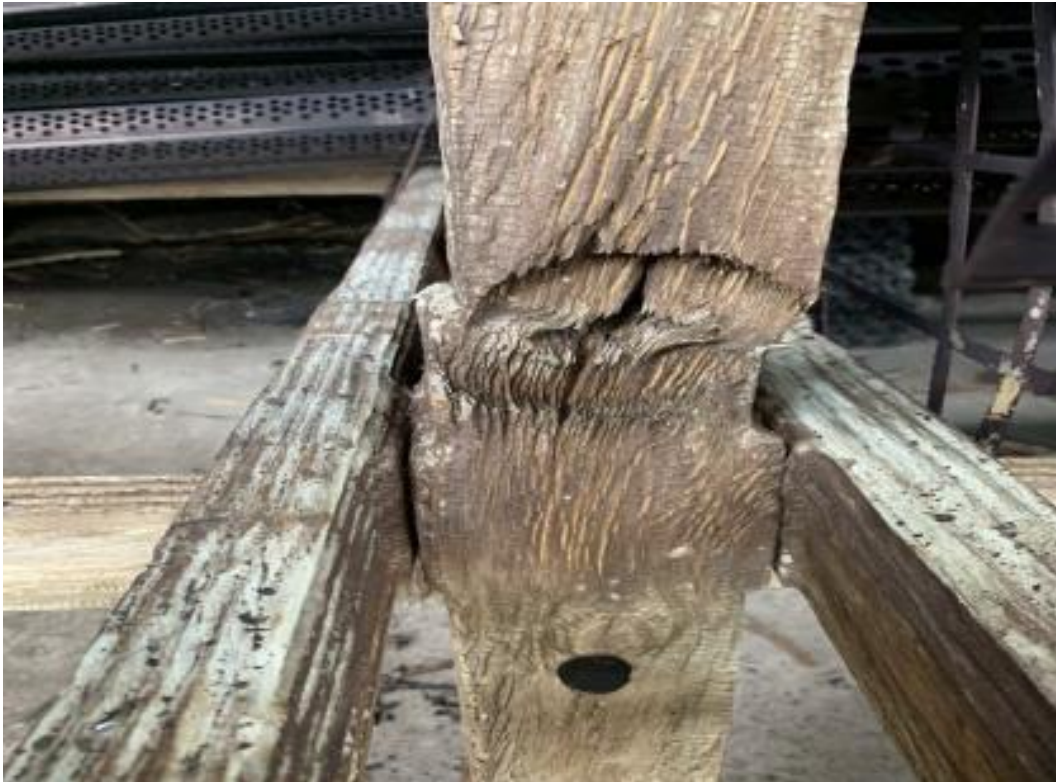
*Figure 7.13 Column distortion CT3 location unknown - Marley 2022*

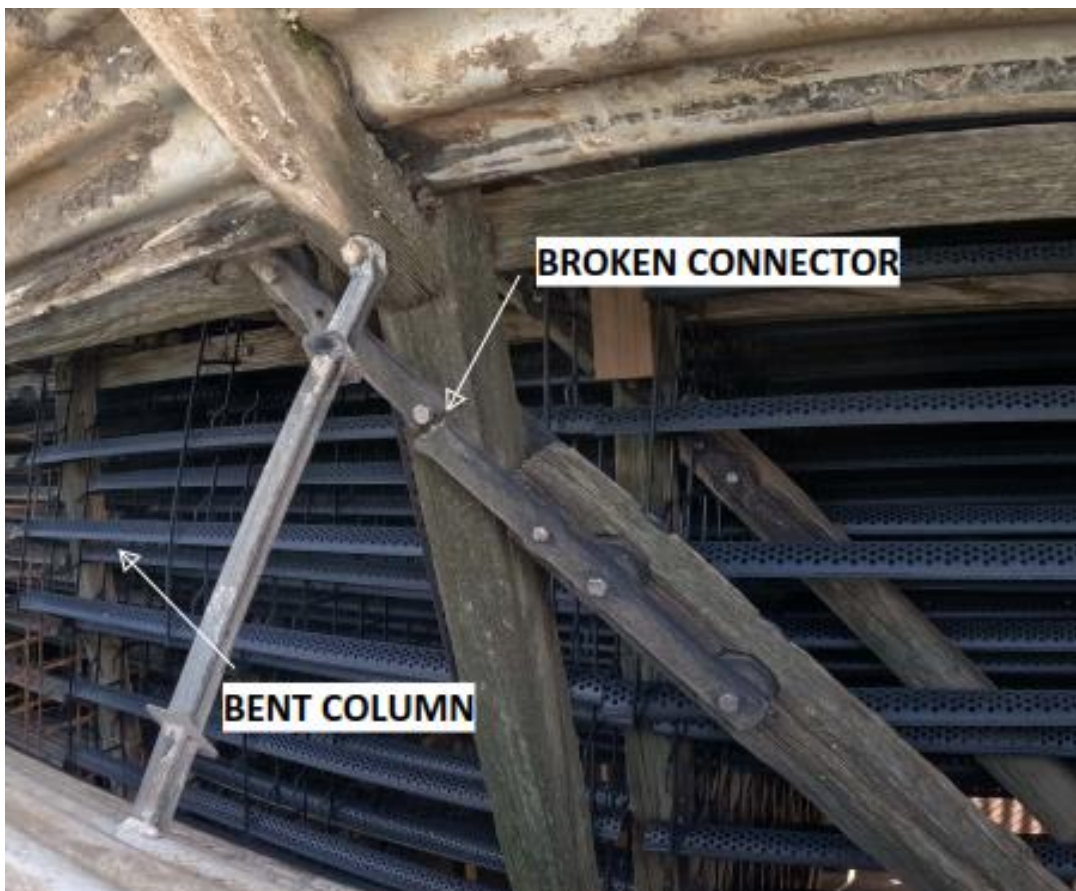
*Figure 7.14 Bent column and broken connector - unknown location*

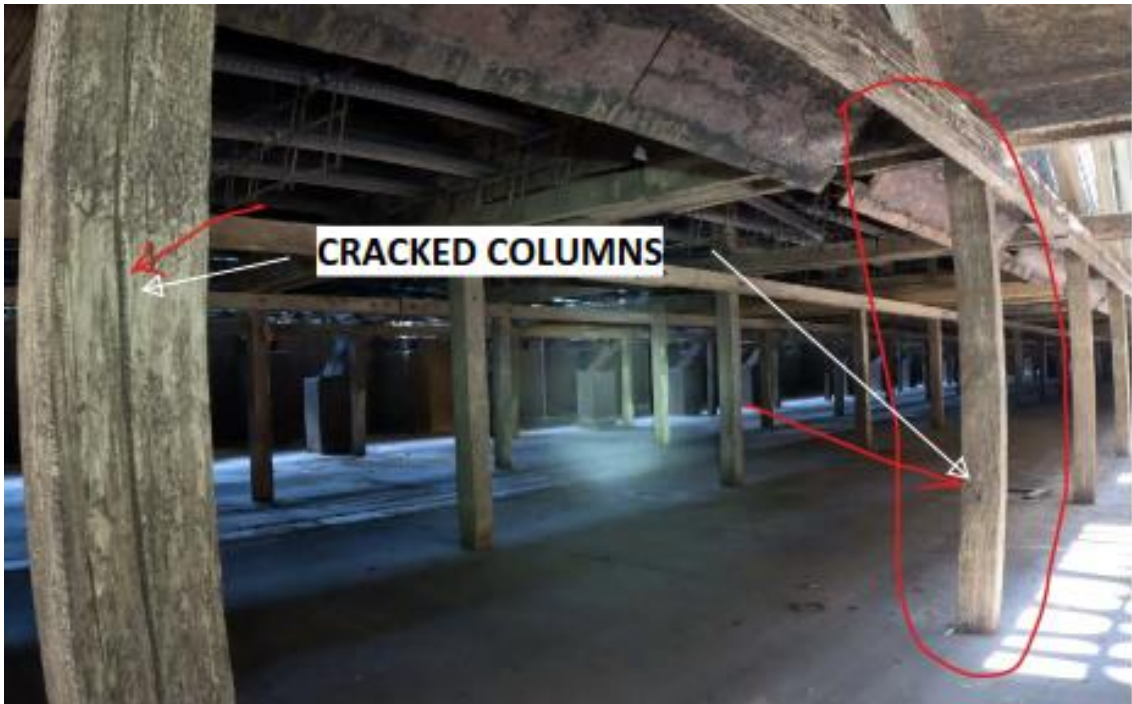
Figure 7.15 Cracked columns in cold water basin - Location unknown

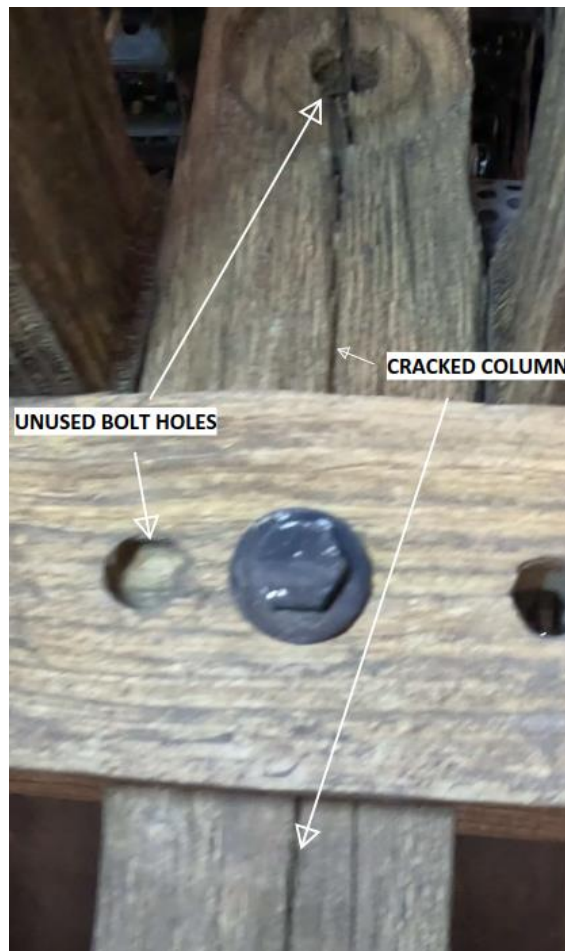
Figure 7.16 Predrilled unused bolt holes and cracked or split column

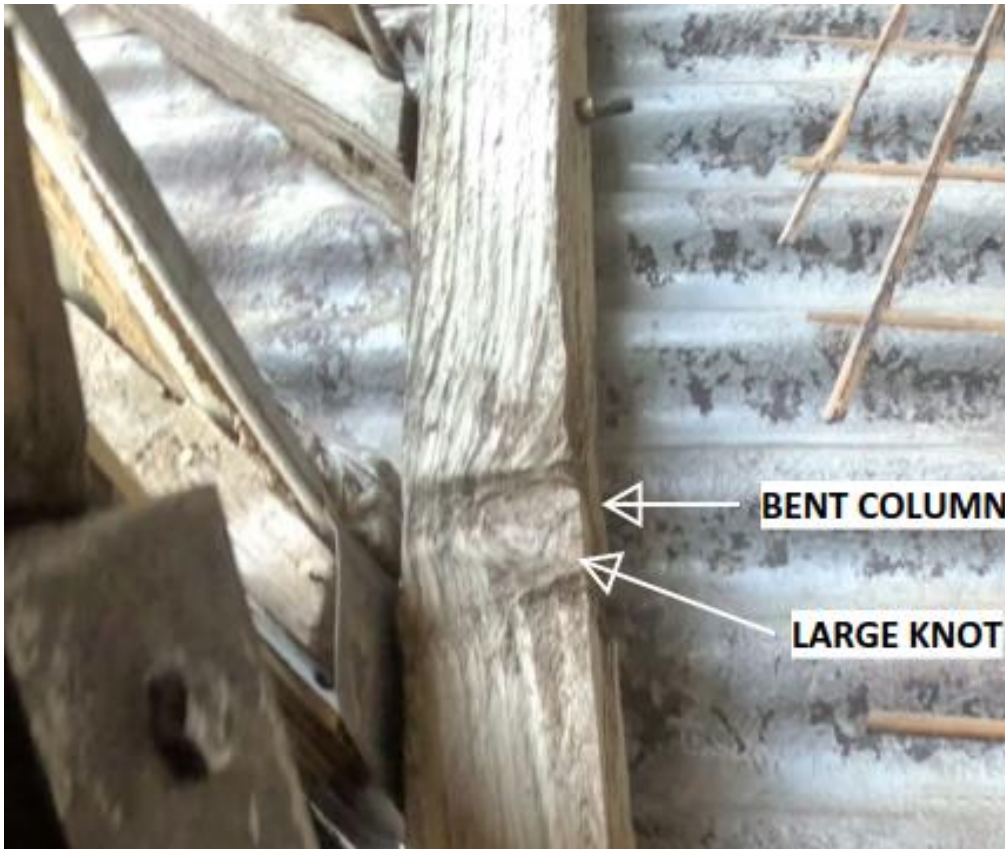
Figure 7.17 Bent end wall column - unknown location

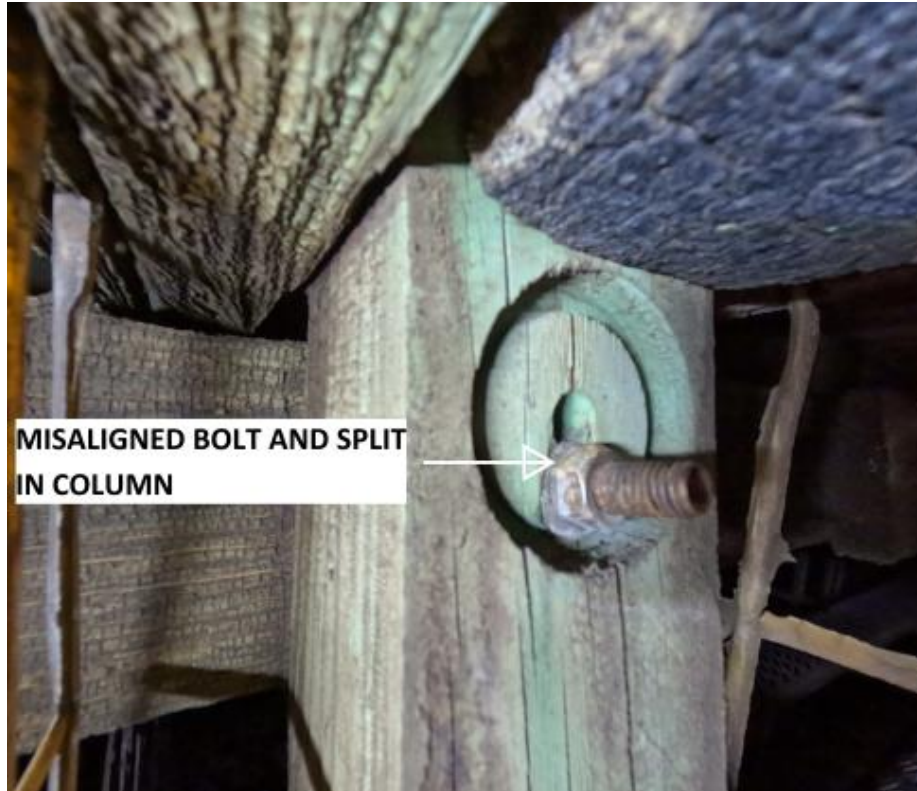
Figure 7.18 Column/Girt bolt misalignment - unknown location

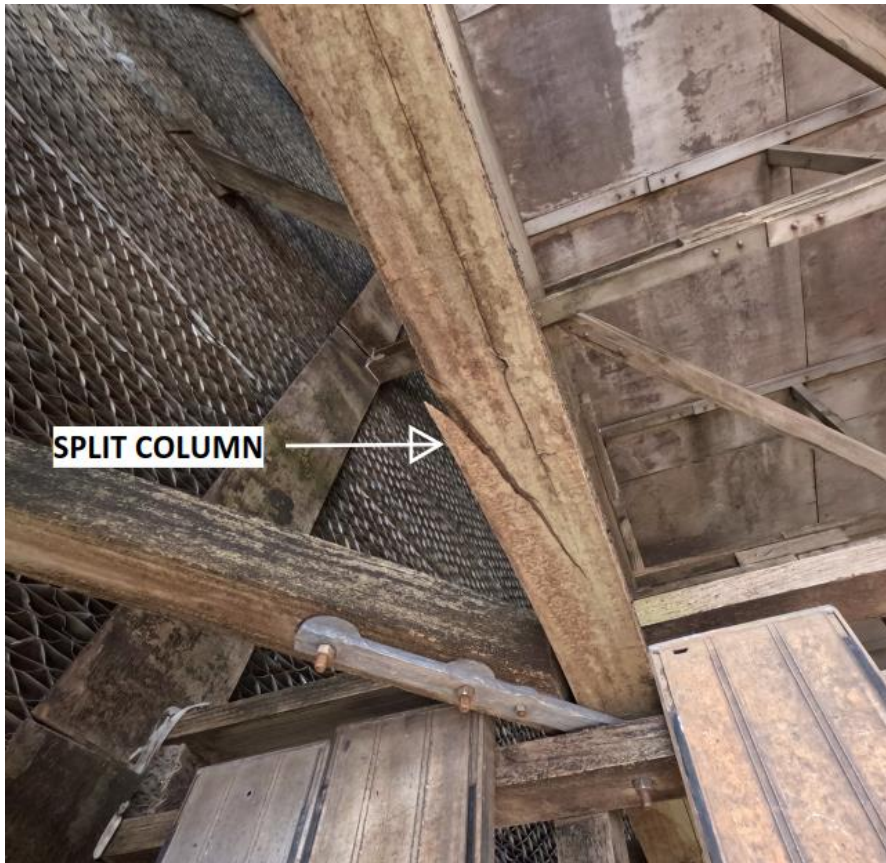
*Figure 7.19 Column split in plenum area*

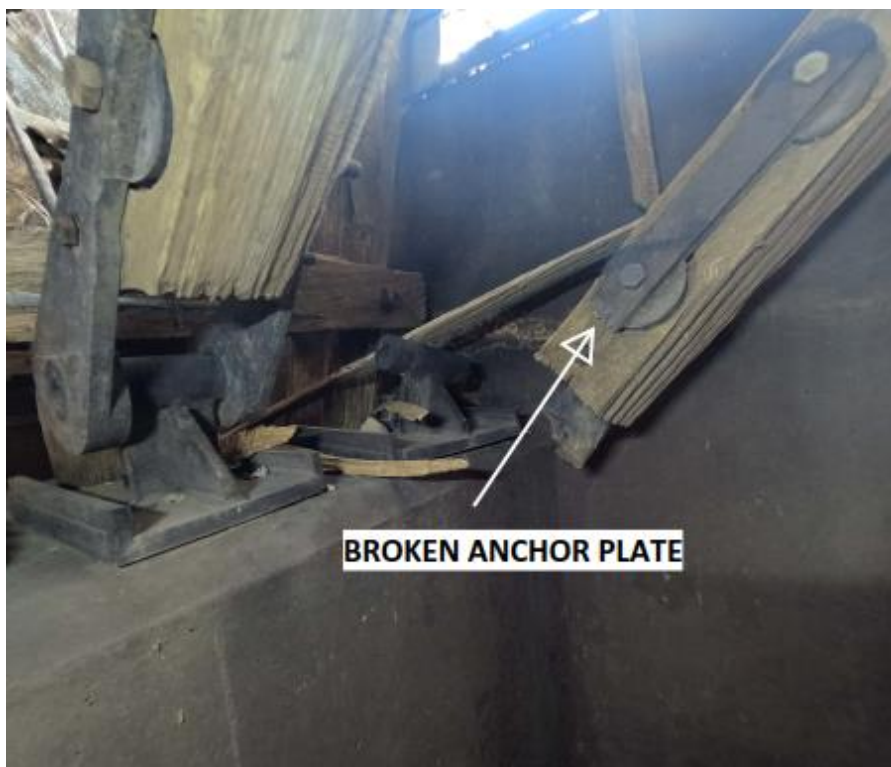
*Figure 7.20 Broken anchor plate on a longitudinal louvre brace*

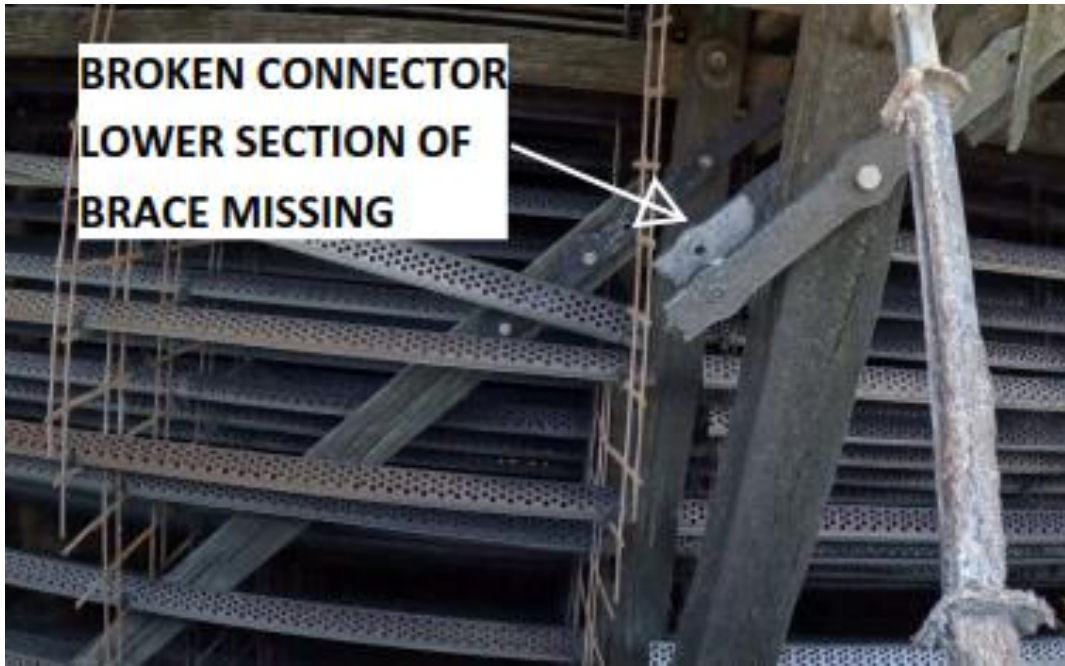
Figure 7.21 Broken Connector and part of brace missing

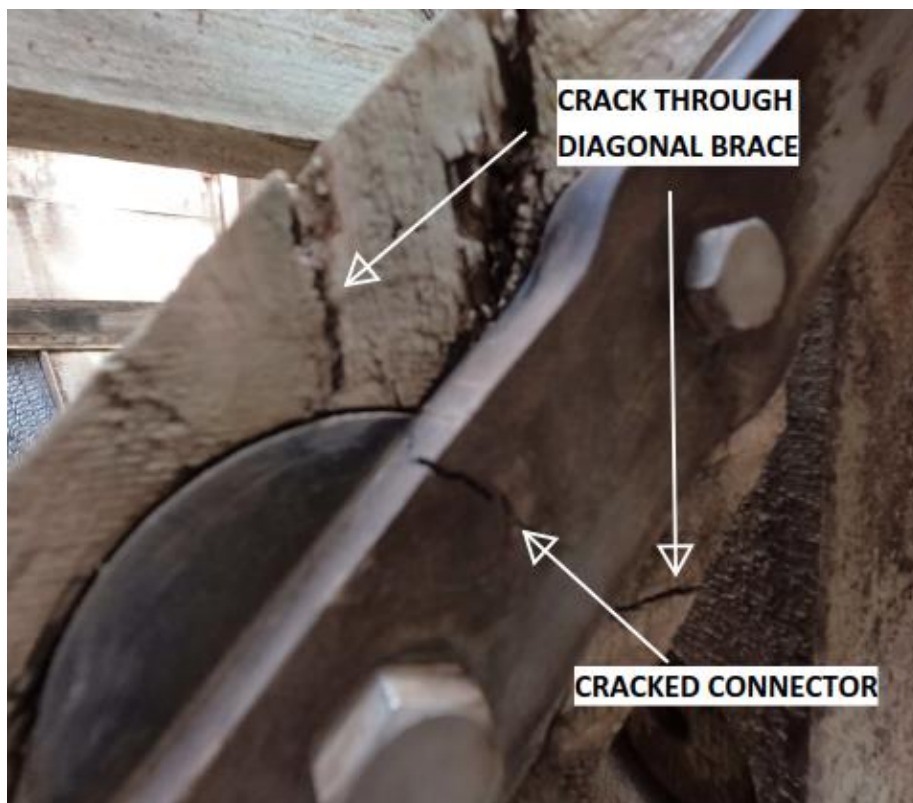
Figure 7.22 Cracked connector and diagonal brace
