Brady Heywood.

Technical and Organisational Investigation of the Callide Unit C4 Incident

DRAFT

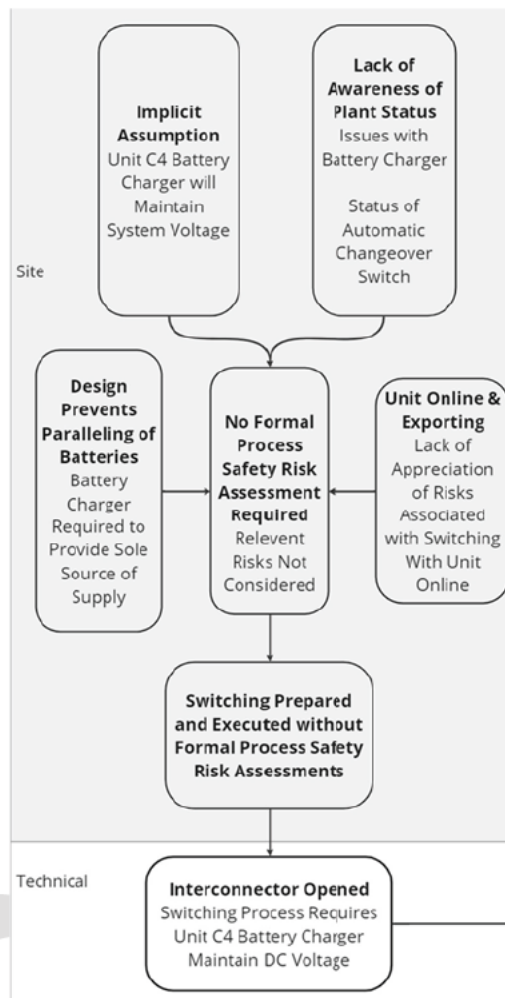
Figure 2 Organisational Causes Relevant to Switching Process

As discussed in Section X, Part A, the switching sequence implemented on 25 May 2021 required the Unit C4 battery charger to be the sole source of supply for the Unit C4 DC system when the interconnector (between Unit C4 and Station) was opened. Neither the design or execution of the switching process identified any process safety risks associated with this requirement.

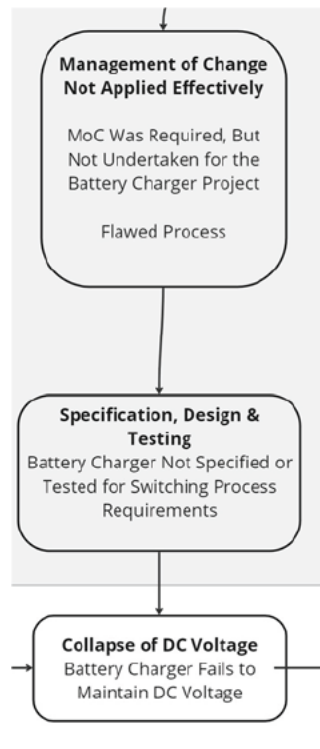
Figure 3 Organisational Factors relevant to Unit C4 battery charger

The collapse of the Unit C4 DC voltage was a result of the Unit C4 battery charger failing to perform as was required by the switching process, see Figure 3.

- (b) **Management of Change:** CS Energy's plant modification procedure⁸ was not effectively implemented in the delivery of the battery charger project.⁹ There is evidence that the battery charger project was considered a like for like replacement (and therefore not subject to the plant modification procedure), but there is also evidence that the battery charger project was treated as a plant modification (the project commenced in accordance with the

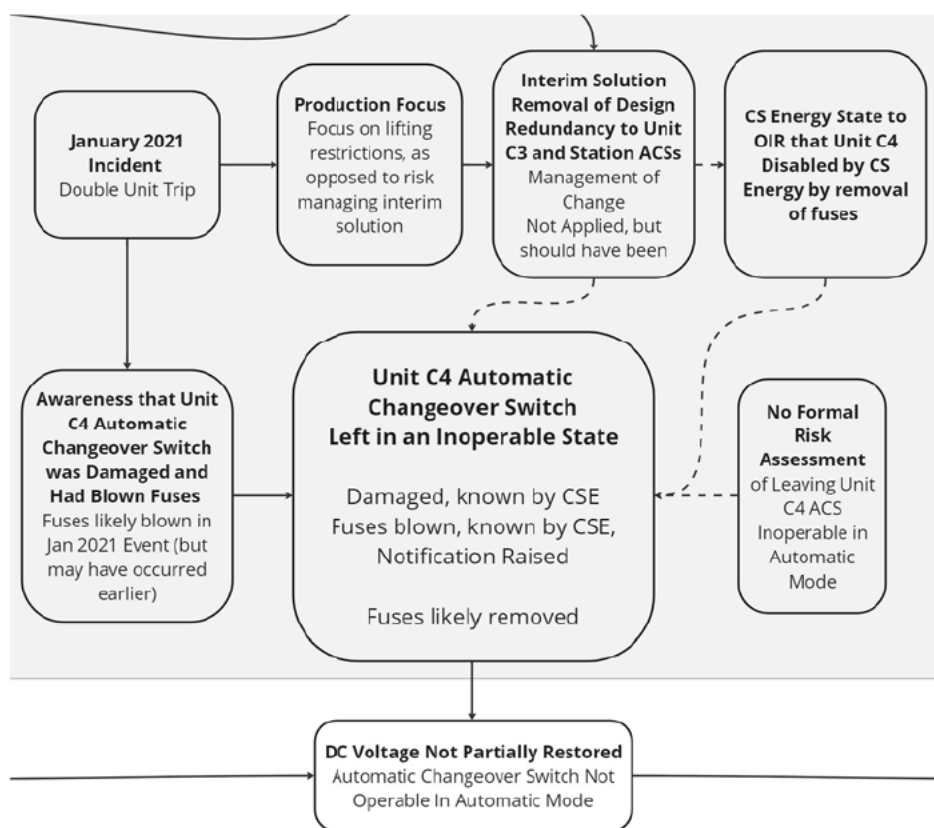
Figure 4 Organisational factors relevant to ACS Isolation

- Awareness of Inoperability:** The Unit C4 ACS was inoperable in automatic mode because it had been damaged, its fuses had been blown (which prevented it operating in automatic mode), and these fuses were also likely removed. This damage, as well as the blown and potentially pulled fuses, likely occurred in an incident in January 2021.

- Production Focus:** In addition to CS Energy becoming aware of the issues with the Unit C4 ACS, the January 2021 incident caused Unit C3 and Unit C4 to trip by the same causative mechanism. In response to this dual trip event, the Australian Energy Market Operator (AEMO), imposed restrictions on CS Energy's generation output until AEMO were satisfied that the risk of a further dual unit trip could be avoided.

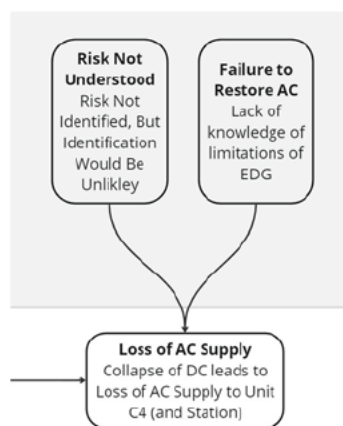
Figure 5 Organisational factors relevant to the loss of AC

Figure 5 shows the organisational factors related to the loss of Unit C4 AC supply resulting from a collapse of the Unit C4 DC supply.

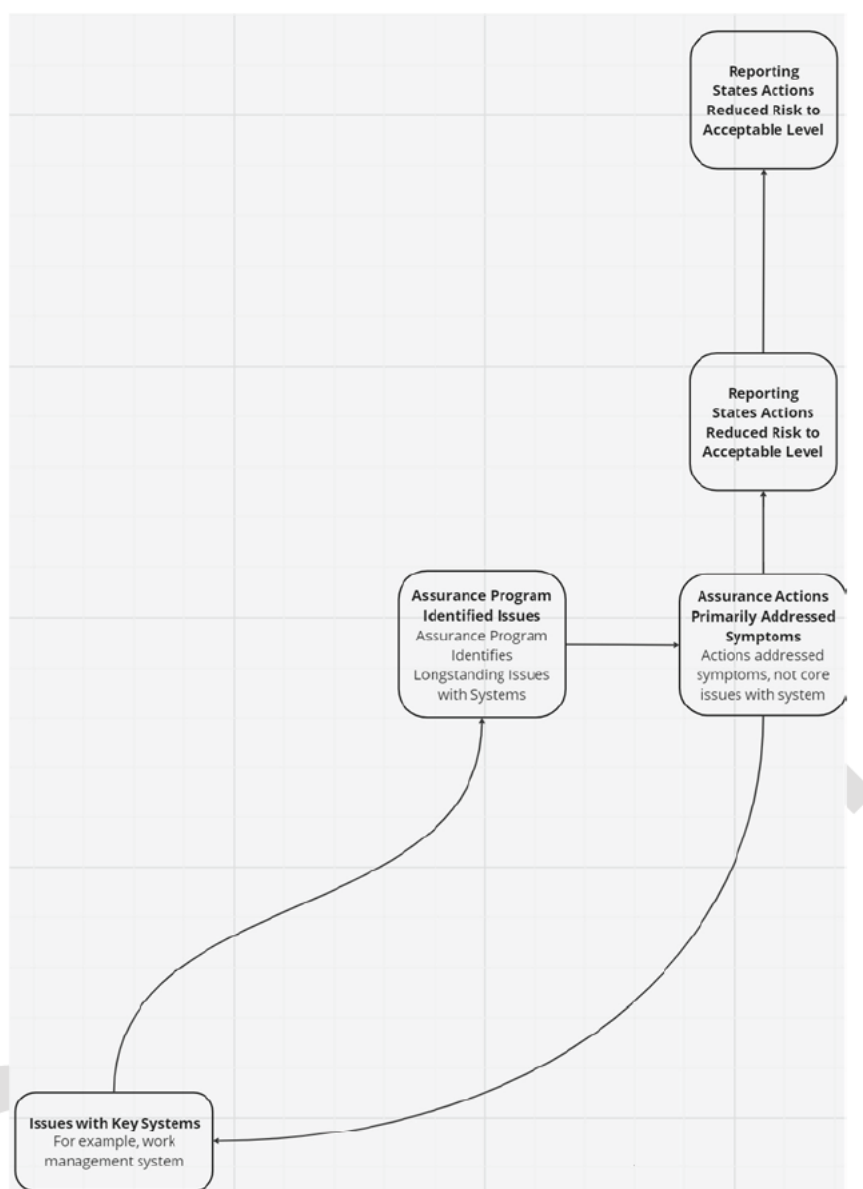
Figure 6 Organisational factors relating to key systems

- (c) **Actions Typically Focus on Symptoms Instead of Root Causes:** The actions that flowed from the assurance reviews typically treated the symptoms, as opposed to the causes of the issues.¹⁴ These reviews raised concerns about the process being poorly understood and implemented, as well as ambiguity surrounding its approach to risk assessment. This approach led to little improvement of systemic issues.

- (d) **Assurance Program only addressed symptoms:** The actions that flowed from the assurance reviews primarily focused on treating the symptoms of these reviews, as opposed to understanding and addressing the causes of these issues.

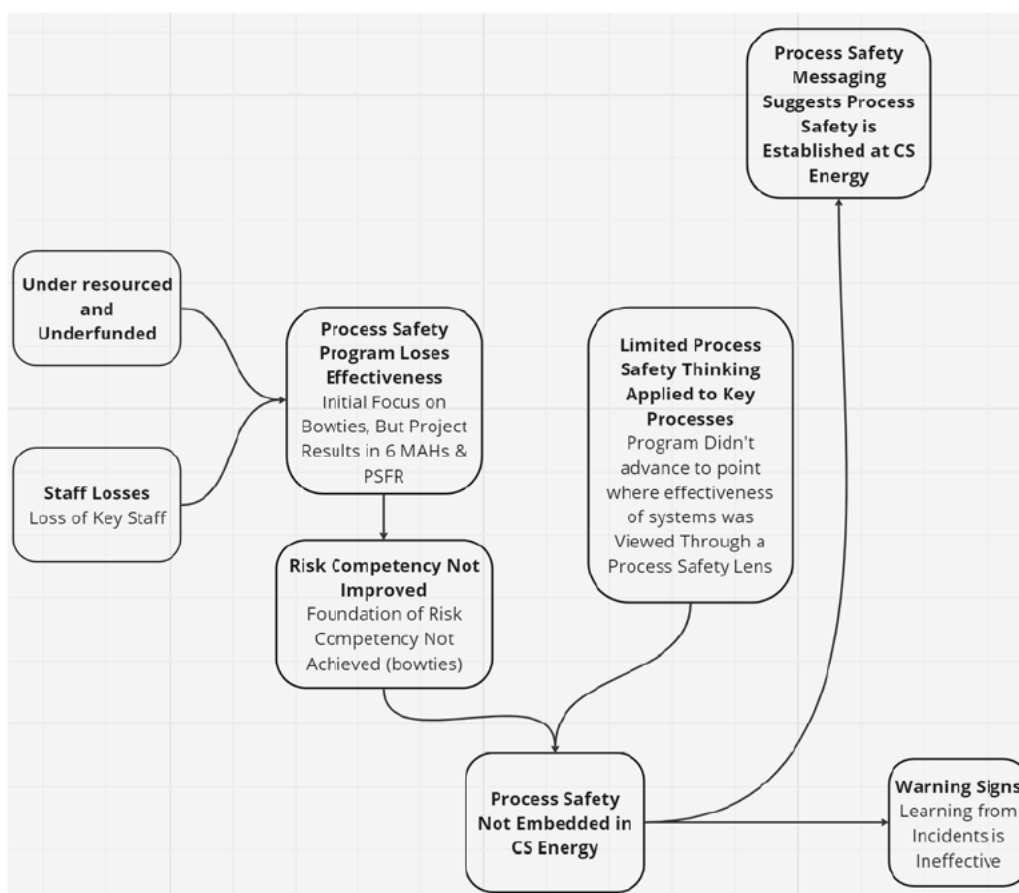
Figure 7 Organisational factors relevant to the process safety program

The program was further compromised when redesigned in 2020, leading to Callide not developing the foundational information necessary for effective process safety. This included an ability to identify their risks and ensure controls were in place.

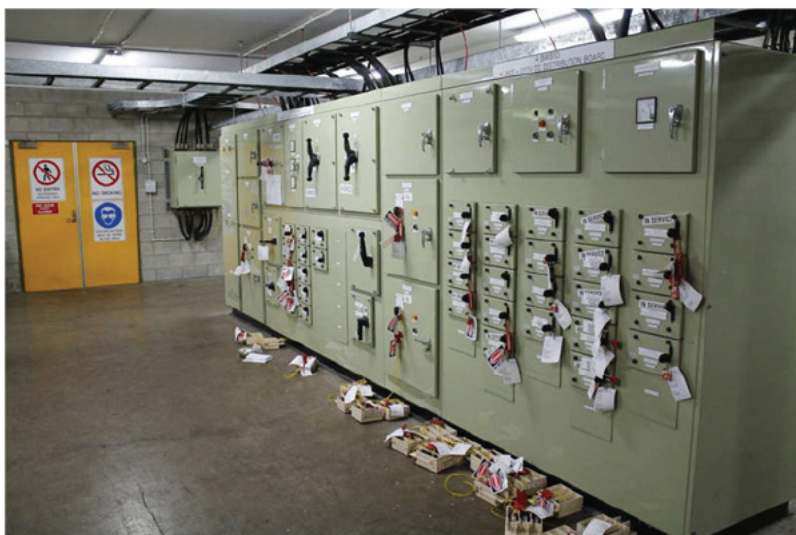
Figure 12 DC switch room

Unit C4’s DC system is fed from the Unit C4 DC switch room. Electrical technicians were performing switching activities in this room on the day of the incident.

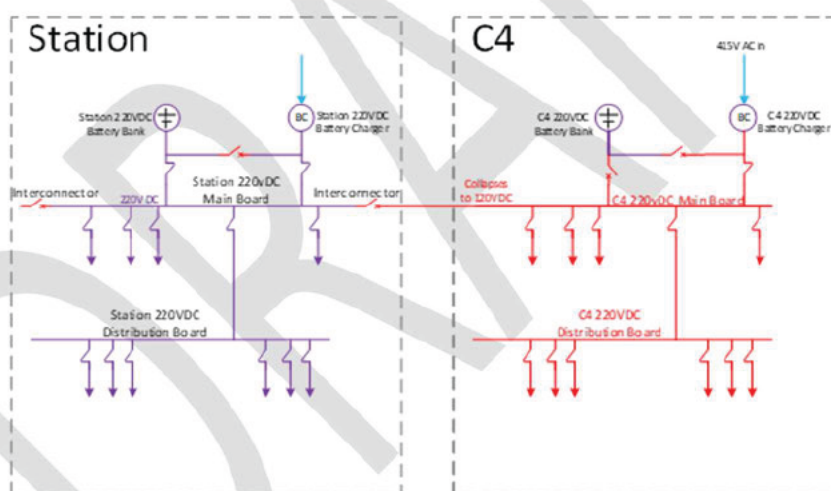
logged the information in the 'J5' electronic email diary. They also checked their emails for any operational updates from the previous shift, and then focused on checking the active daily permits.¹⁹

The next step in the switching sequence was to open the interconnector between Station and Unit C4. This would remove supply to Unit C4 from the Station battery and Station battery charger. It was at this point that the collapse of the DC supply to Unit C4 was initiated. This occurred because the newly installed Unit C4 battery charger failed to maintain the DC voltage level as required by the, see Figure 38.

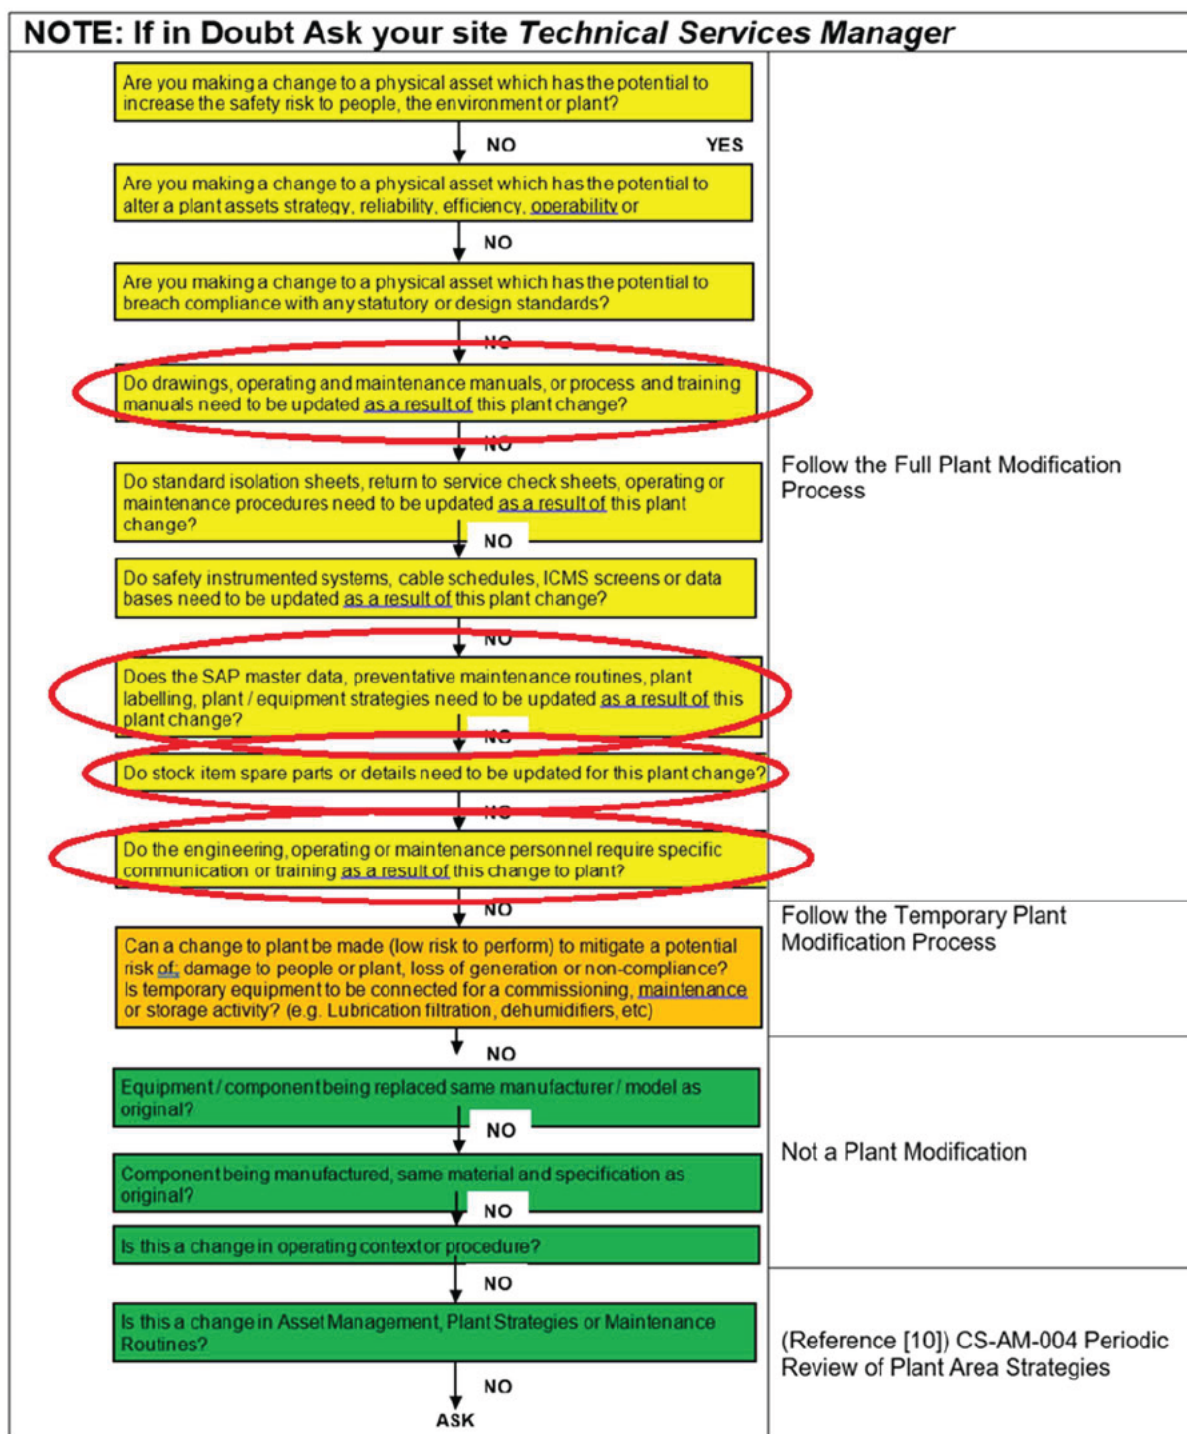
Figure 44 Assessment of the battery charger project against the guidance in Attachment 1 to the Plant Modification Procedure (2016). The red circling indicates those questions that would have been answered 'yes'.

In accordance with the Plant Modification Procedure, the replacement of the battery charger was a plant modification.

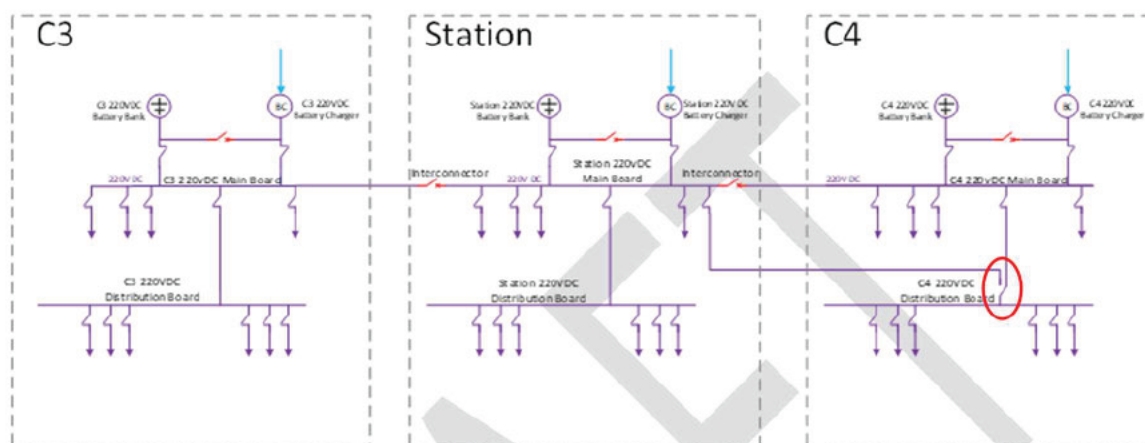
Figure 61 Location of Unit C4 Automatic Changeover Switch

On the day of the incident, the Unit C4 ACS was inoperable in automatic mode, resulting in it being unable to respond to the collapse of DC. If it had operated successfully and restored DC supply to the Unit C4 distribution board, it would have likely mitigated the severity of the incident, as discussed in detail in Section X.

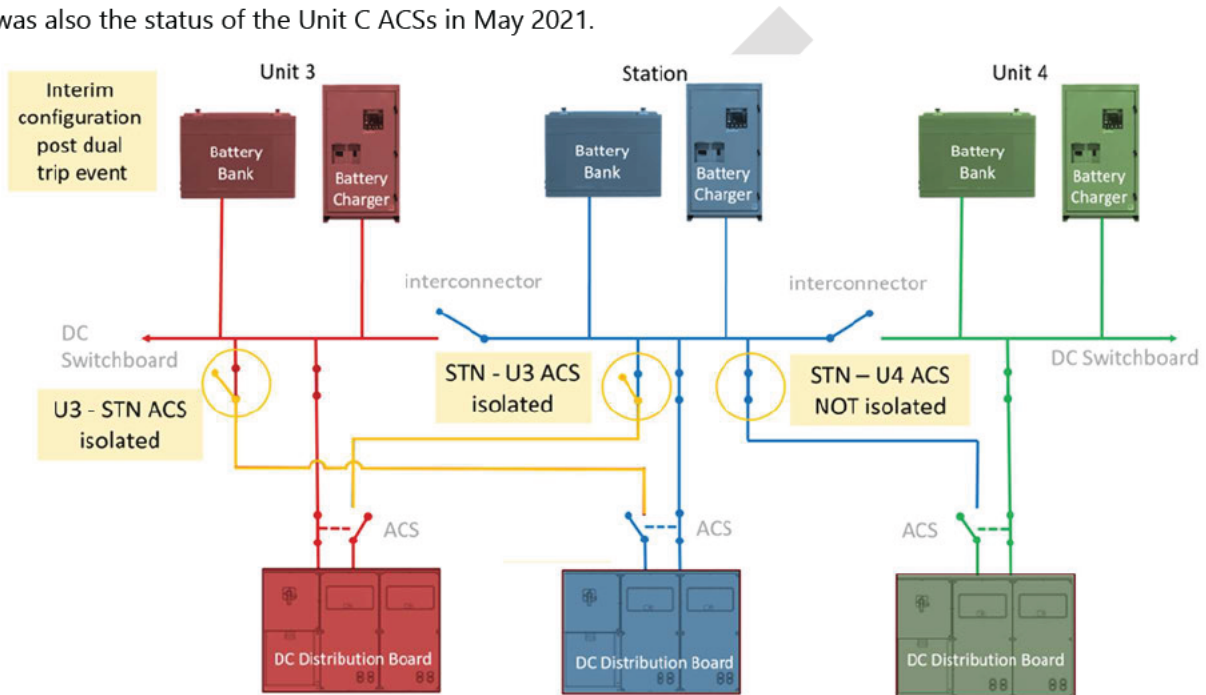
Figure 65 ACS configuration post the 13 January 2021 incident

Figure 81 below shows the status of the three ACSs in Unit C following the January 21 incident. This was also the status of the Unit C ACSs in May 2021.

Note that there is no evidence that this isolation was made to the Unit C4 ACS. It is unclear whether this was because CS Energy never specifically intended to isolate Unit C4 (in the same manner as Unit
