Brady Heywood.

Technical and Organisational Investigation of the Callide Unit C4 Incident

July 2024

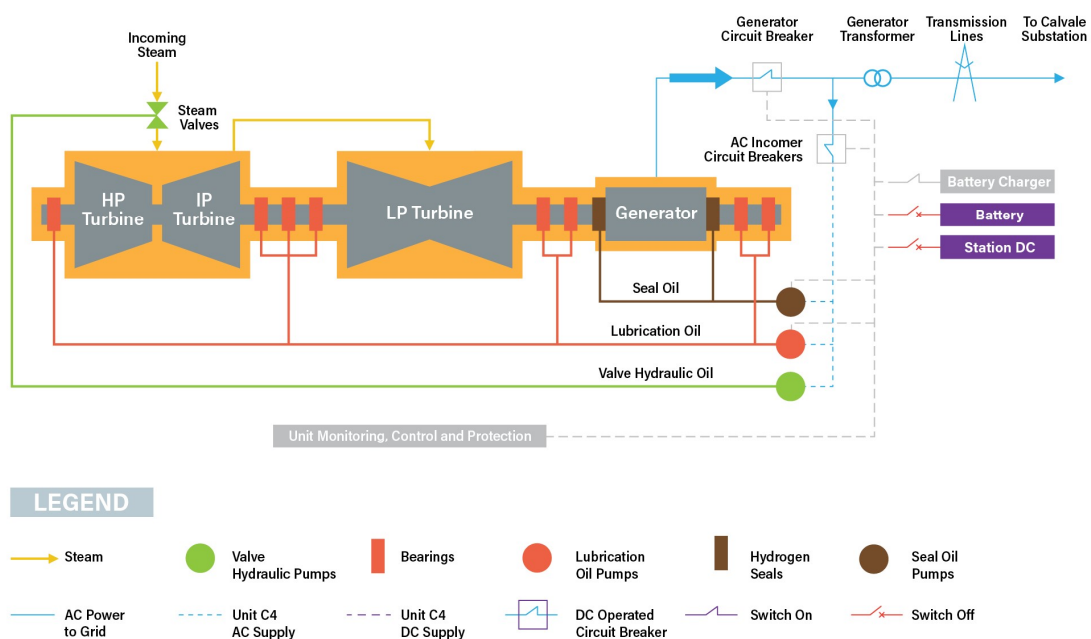
Figure 26 Loss of Unit C4 DC supply

When Station DC was disconnected from Unit C4, the voltage in the Unit C4 DC system instantly collapsed from ~243 V to ~120 V. This collapse occurred because the Unit C4 battery charger failed to maintain the voltage in the Unit C4 DC system. The voltage in the Unit C4 DC system then decayed rapidly over a period of two seconds to ~0 V, leading to a complete loss of DC supply to Unit C4.³⁵ This loss of DC supply is indicated by the dotted grey line in Figure 26.

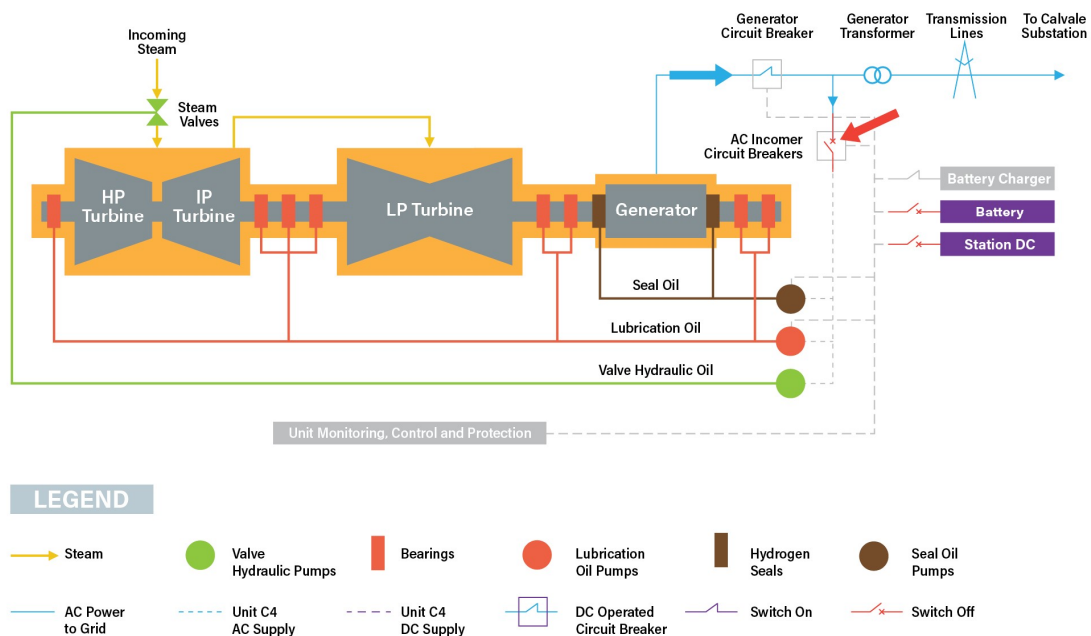
Figure 28 AC incomer circuit breakers trip and disconnect AC supply to the unit

The voltage collapse in the Unit C4 DC system directly led to the loss of Unit C4 AC supply. In simple terms, the voltage collapse in the DC system caused one of the unit's protection systems, known as arc flap protection, to respond as if a fault had occurred on the unit's AC system. Despite no such fault actually occurring, the arc flap protection activated and disconnected the AC supply to Unit C4. Chapter 8 *How Arc Flap Protection Led to the Loss of AC Supply* discusses how this occurred in more detail. The loss of AC supply to the unit is illustrated in Figure 28.

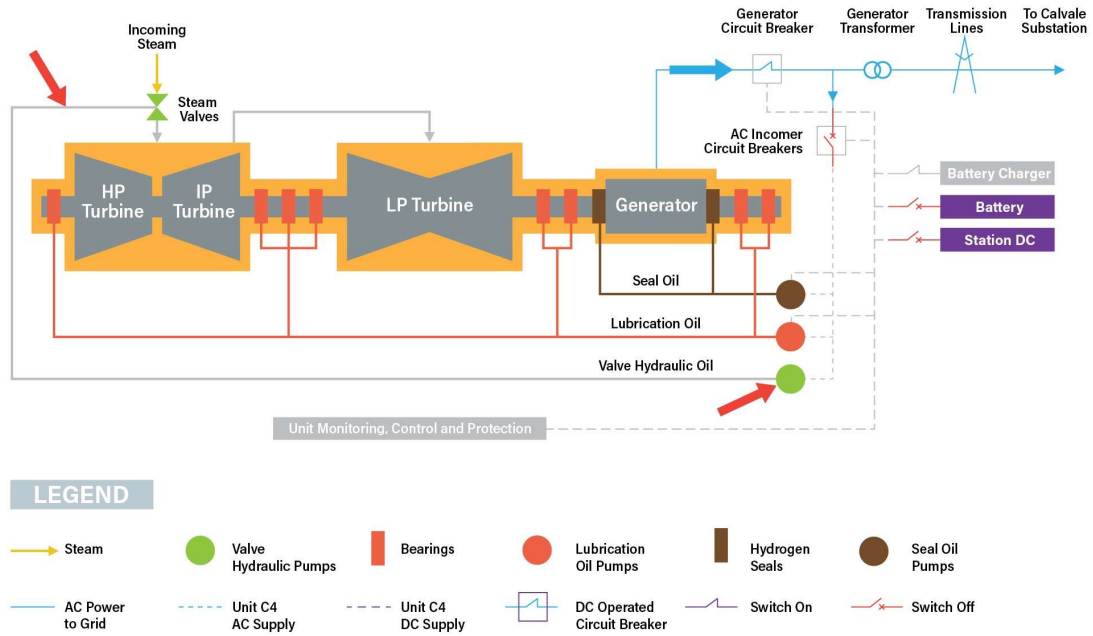
Figure 29 Loss of AC supply to steam valve hydraulics

First, it led to the failure of the hydraulic oil system that operates the steam valves, causing the valves to close (due to their fail-safe design). This meant steam was no longer entering and driving the turbine, see Figure 29.

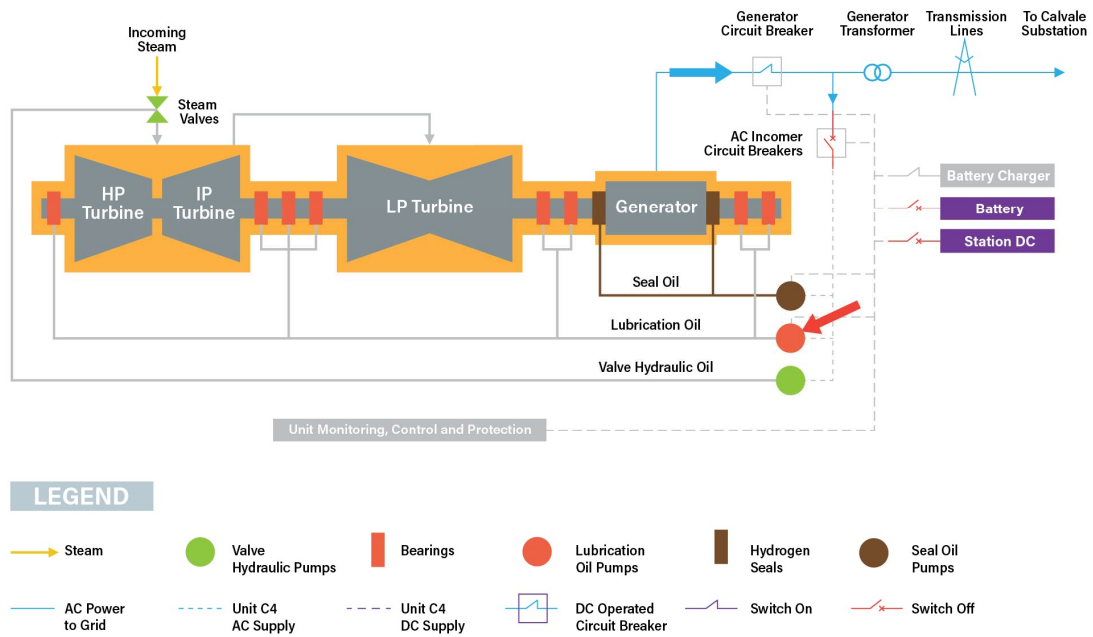
Figure 30 Loss of AC lubrication oil pumps

Second, the loss of AC supply led to the loss of the AC lubrication oil pumps, see Figure 30.

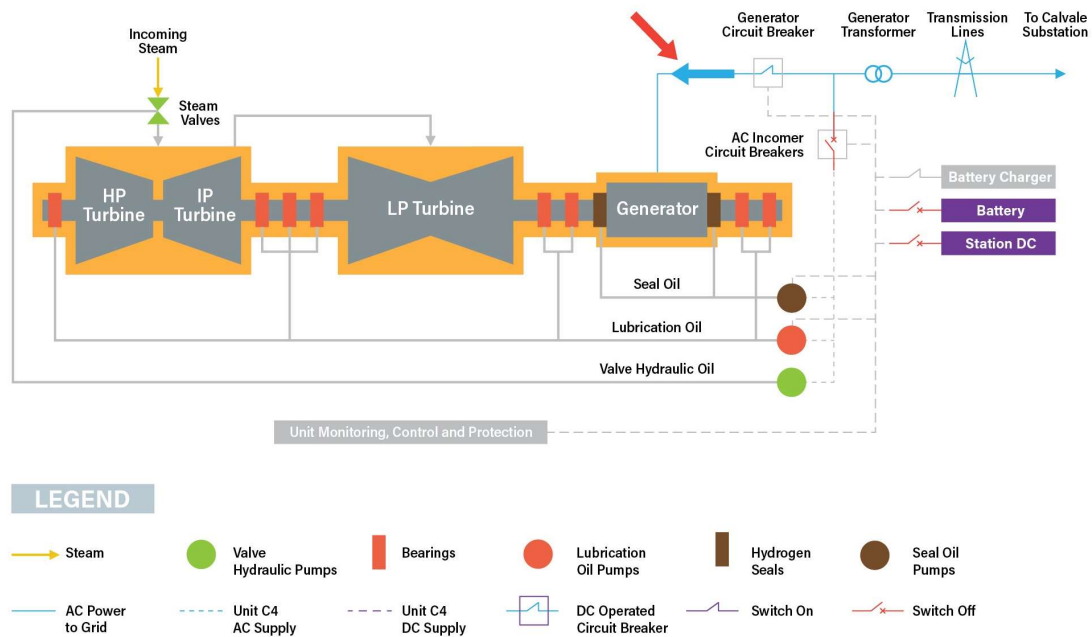
Figure 34 Motoring commences

With no steam driving the unit, but with it still connected to the grid, Unit C4 began 'motoring'. Motoring occurs in a turbine generator when it stops exporting power to the grid, and instead imports power from the grid, becoming an electric motor. Motoring results in the rotor continuing to spin in the same direction at approximately 3,000 rpm.⁴² Unit C4 importing power from the grid is illustrated in Figure 34.

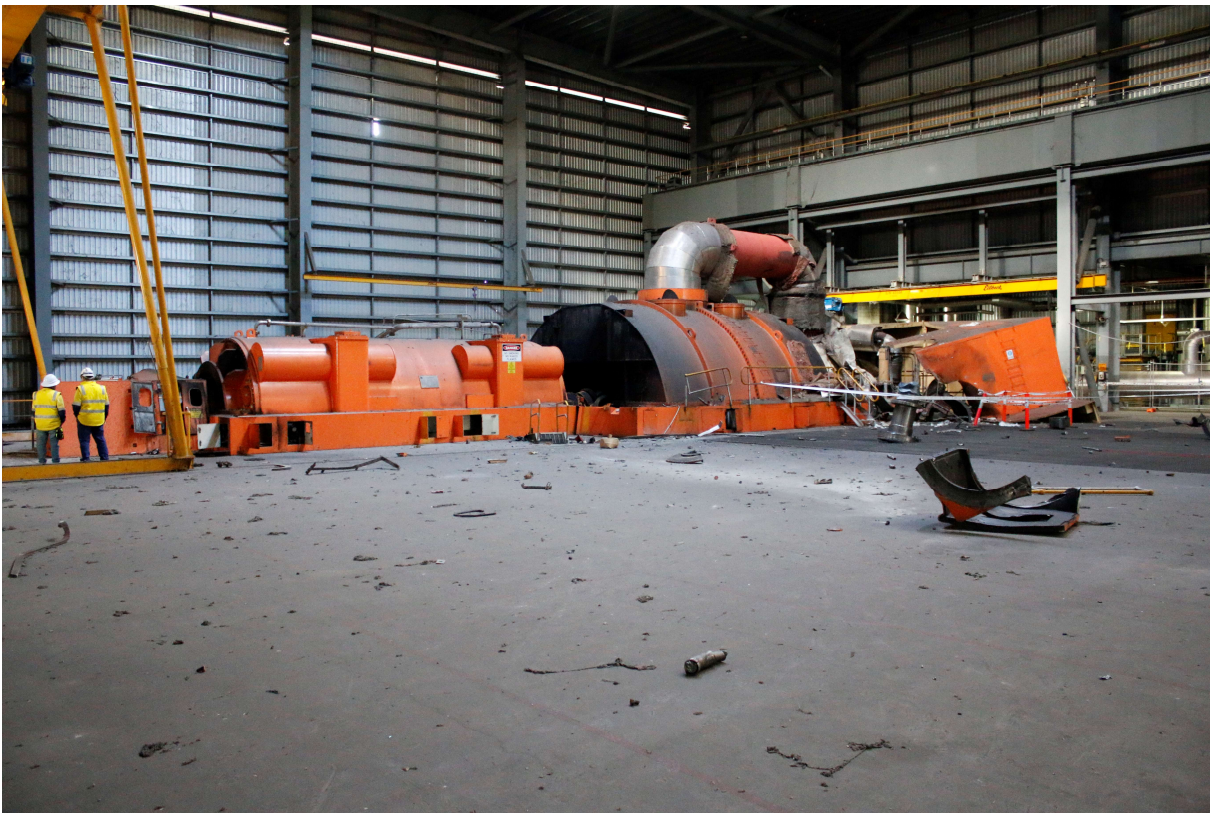
Figure 35 Post-incident damage to Unit C4

A piece of shaft weighing more than two tonnes was thrown five metres across the floor of the turbine hall. A piece of equipment weighing 300 kg, called the barring gear, was thrown metres into the air, punching through the turbine hall roof. The force from the impact also ejected remnants of coupling covers, bearings, and sections of the shaft from the turbine generator, resulting in widespread damage to the surrounding environment, including the floor, walls and roof of the turbine hall. This is referred to as the 'turbine missile event'. The damage to Unit C4 is shown in Figure 35.

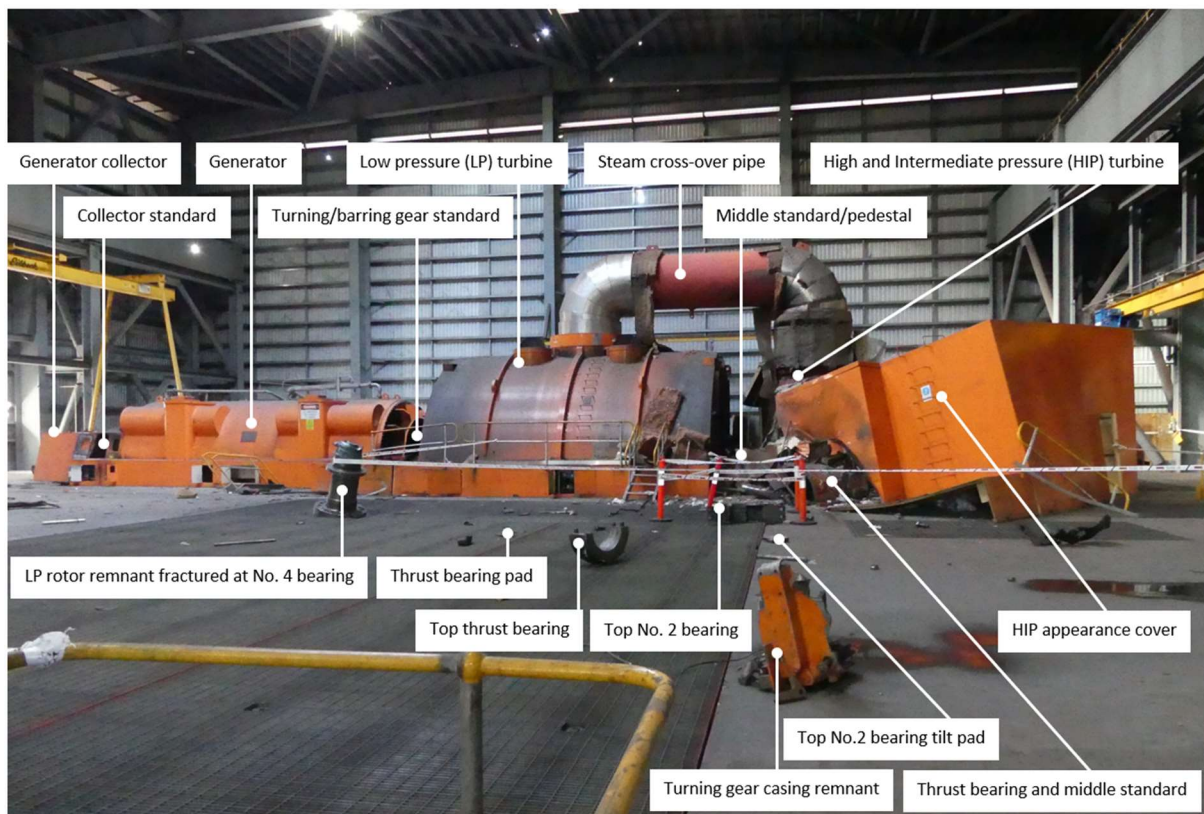
Figure 36 Damage to Unit C4 (eastern side view)

The following series of photographs show the extent of the damage that occurred during the incident. Figure 36 shows the overall damage to the turbine generator from the eastern side of the turbine hall.

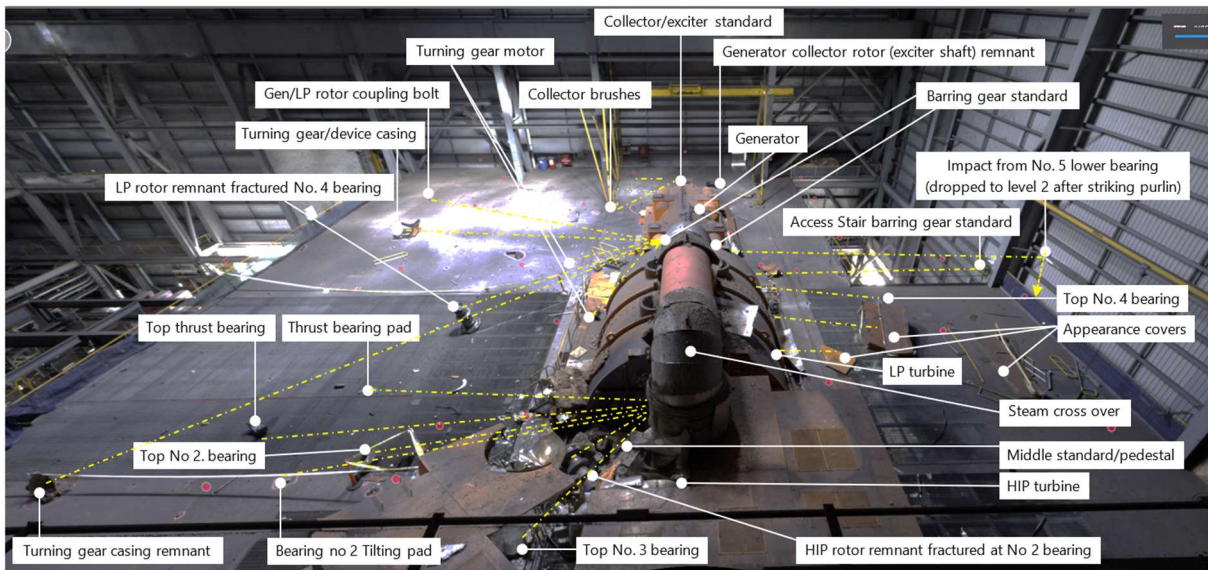
Figure 37 Damage to Unit C4 (aerial view)

Figure 37 shows an aerial view of damage to the Unit C4 turbine generator.

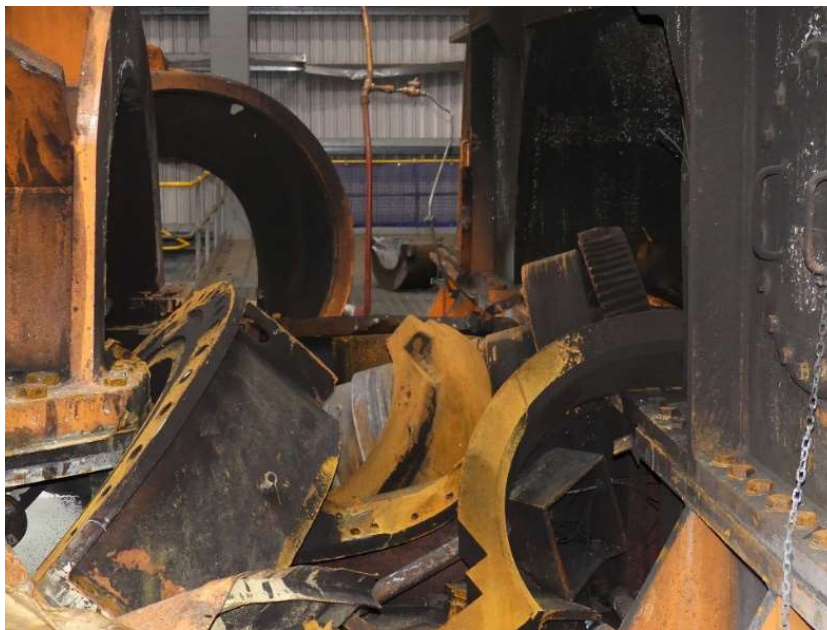
Figure 38 Damage between the generator and the LP turbine

Figure 38 shows the damage between the generator and the LP turbine.

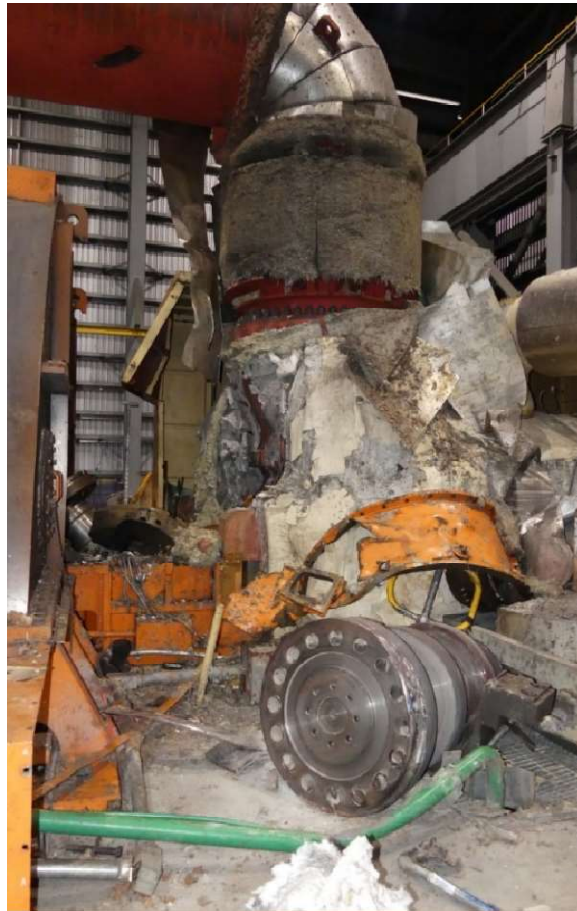
Figure 39 Damage between LP and HIP turbines

Figure 39 shows the damage in the area between the LP and HIP turbines.

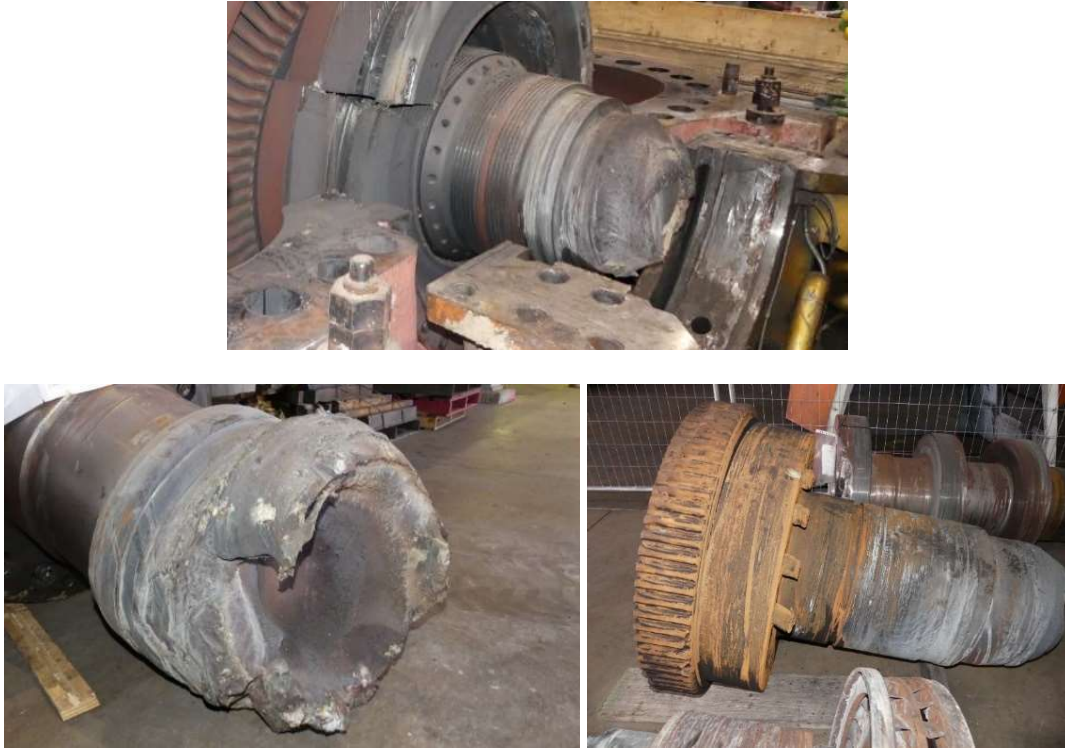
Figure 40 HP turbine, LP turbine and generator shaft damage

Figure 40 is a selection of photographs showing damage to the HP turbine, LP turbine and generator shaft.

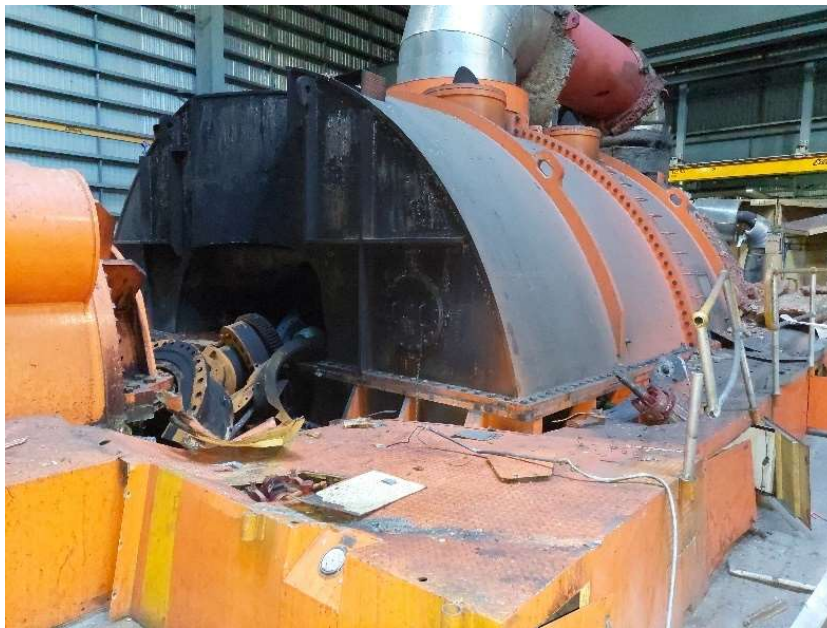
Figure 41 Heat damage to LP turbine casing

Figure 41 shows the heat damage to the orange casing of the LP turbine.

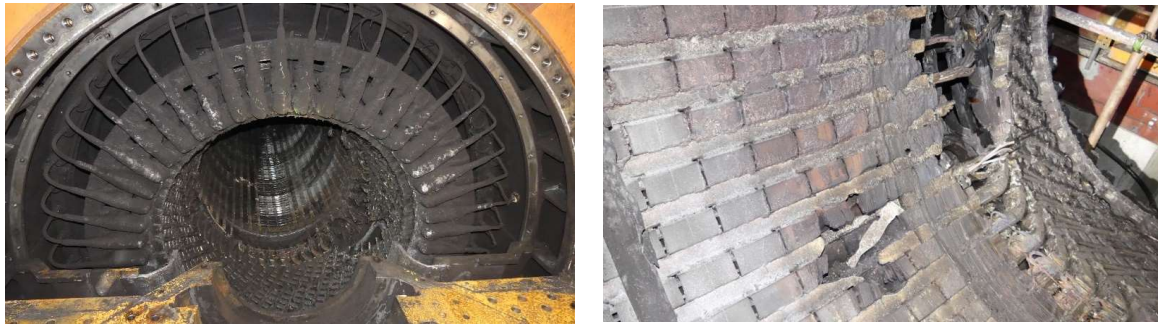
Figure 42 shows the damage to the generator stator.

(a) Generator stator internal condition
