# Technical and Organisational Investigation of the Callide Unit C4 Incident

Between 1:33 pm and 2:07 pm on 25 May 2021, Unit C4 at Callide C power station suffered a catastrophic failure. There were no fatalities, but the incident destroyed the turbine and generator of Unit C4 and had a major impact on the Queensland power grid.

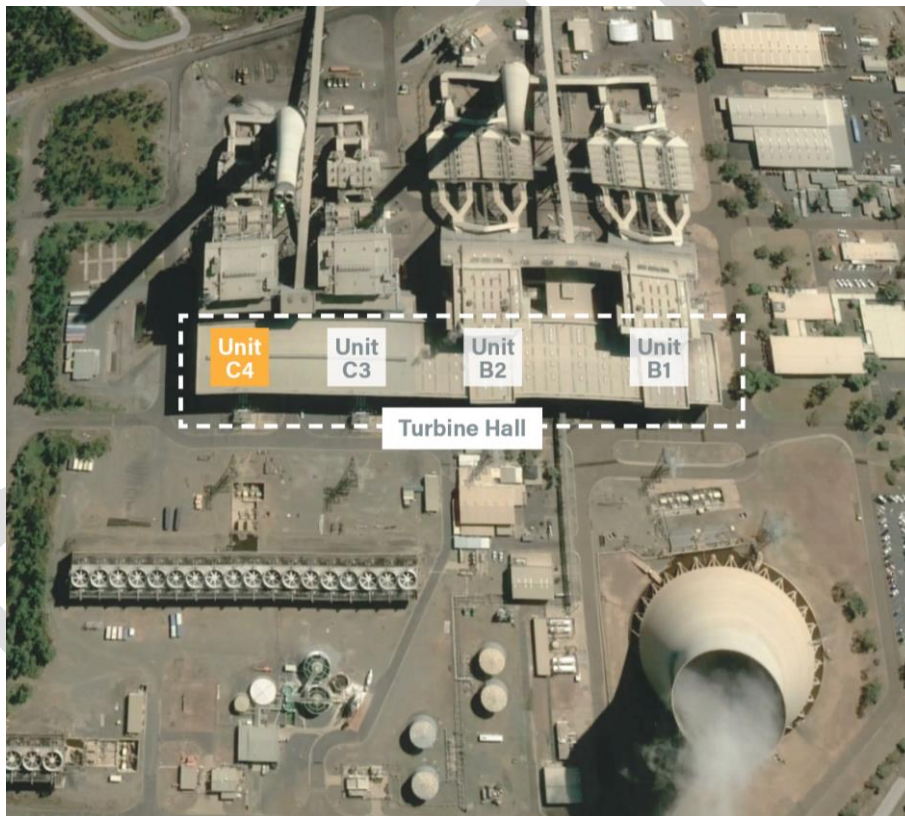
Each of the four units has its own turbine generator, which are located in a single building referred to as the turbine hall.<sup>9</sup> Figure 1 shows the arrangement of the four units.

Figure 1 Site layout of Callide B and C power stations showing position of turbine generators<sup>10</sup>

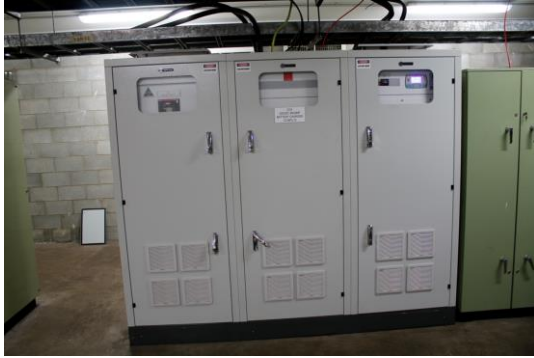
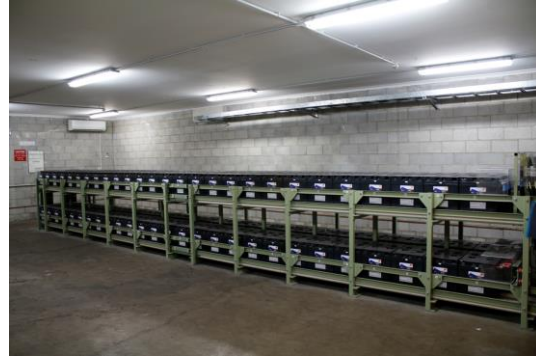
Figure 17 Unit C4 battery charger and battery

Unit C3, Unit C4 and Station each have two separate DC supplies: a battery charger and a battery. Figure 17 shows the Unit C4 battery charger and battery.

(a) Unit C4 battery charger

(b) Unit C4 battery

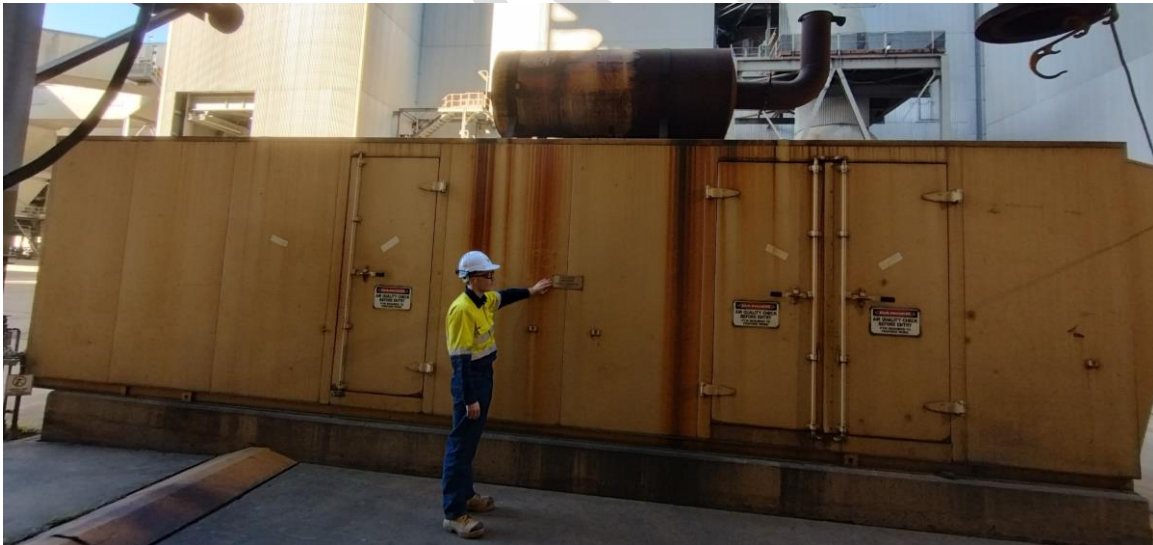
If AC supply is lost to Unit C3, Unit C4 or Station, an emergency diesel generator can operate to restore AC supply to critical equipment.<sup>33</sup> The emergency diesel generator is shown in Figure 19.

Figure 19 Unit C4 emergency diesel generator

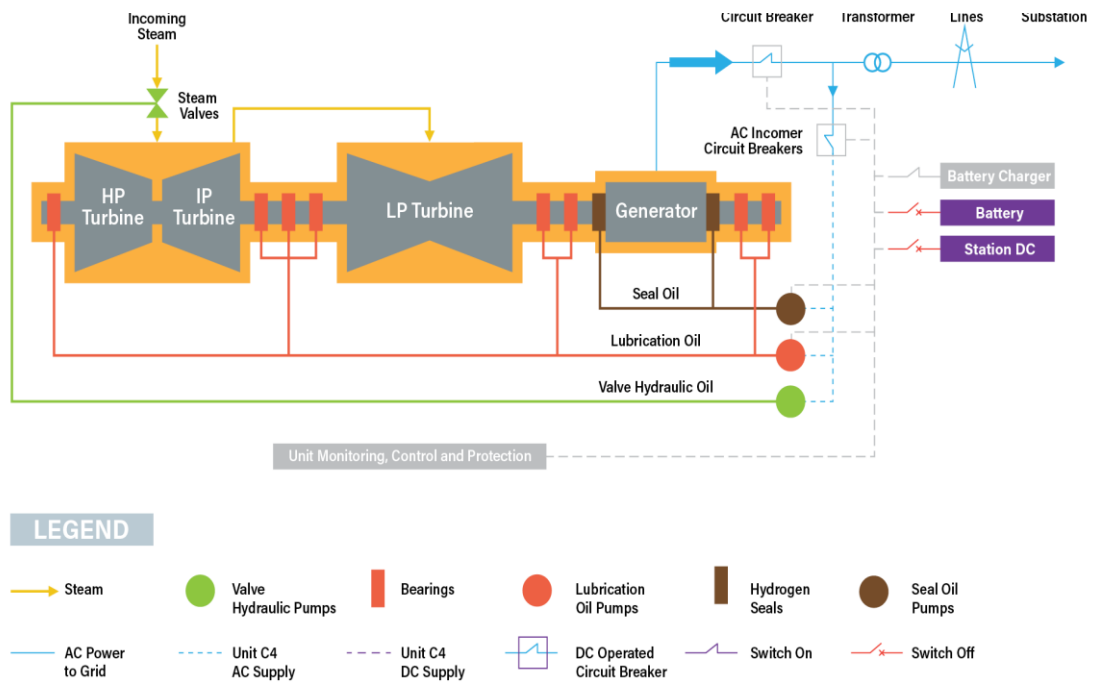
When Station DC was disconnected, the voltage in the Unit C4 DC system instantly collapsed from  $\sim 243$  V to  $\sim 120$  V. It then decayed rapidly over a period of two seconds to  $\sim 0$  V, leading to a complete loss of DC supply to Unit C4.<sup>38</sup> This collapse of the DC supply occurred because the Unit C4 battery charger failed to maintain the DC voltage in the DC system. This loss of DC supply is illustrated by the grey line in Figure 24.

<sup>37</sup> The Brady Heywood investigation determined that under the specific conditions on the day, the battery charger was not capable of responding instantly and maintaining the voltage in the Unit C4 DC system.

Figure 24 Loss of Unit C4 DC supply

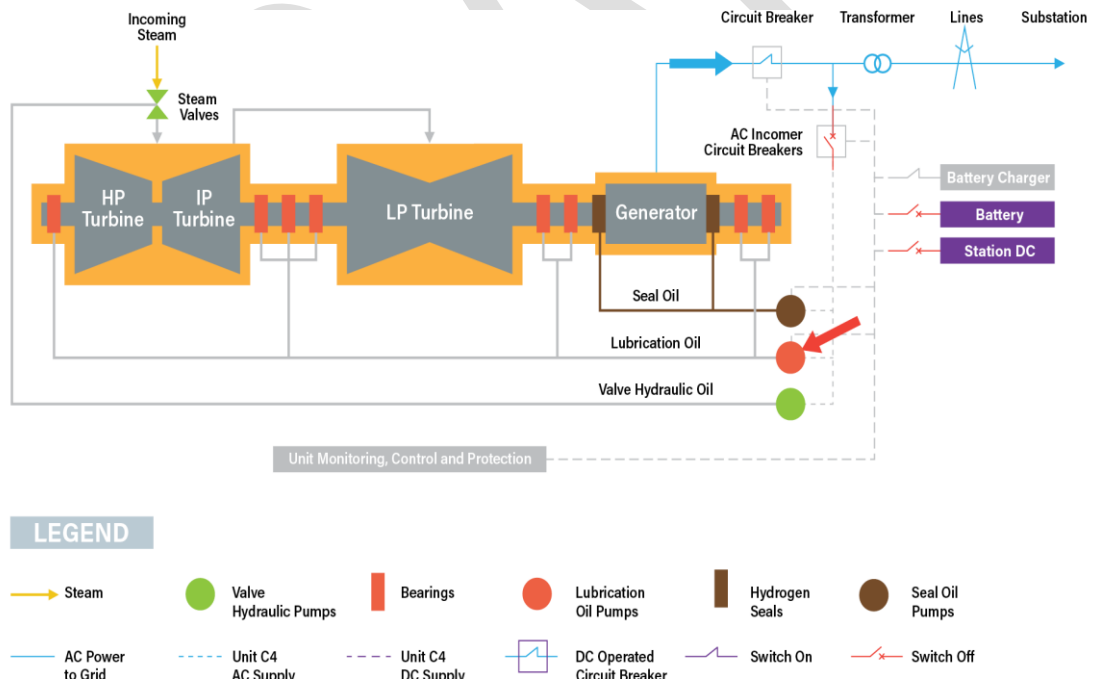
Second, the loss of AC supply led to the loss of the AC lubrication oil pumps, see Figure 28.

Figure 28 Loss of AC lubrication oil pumps

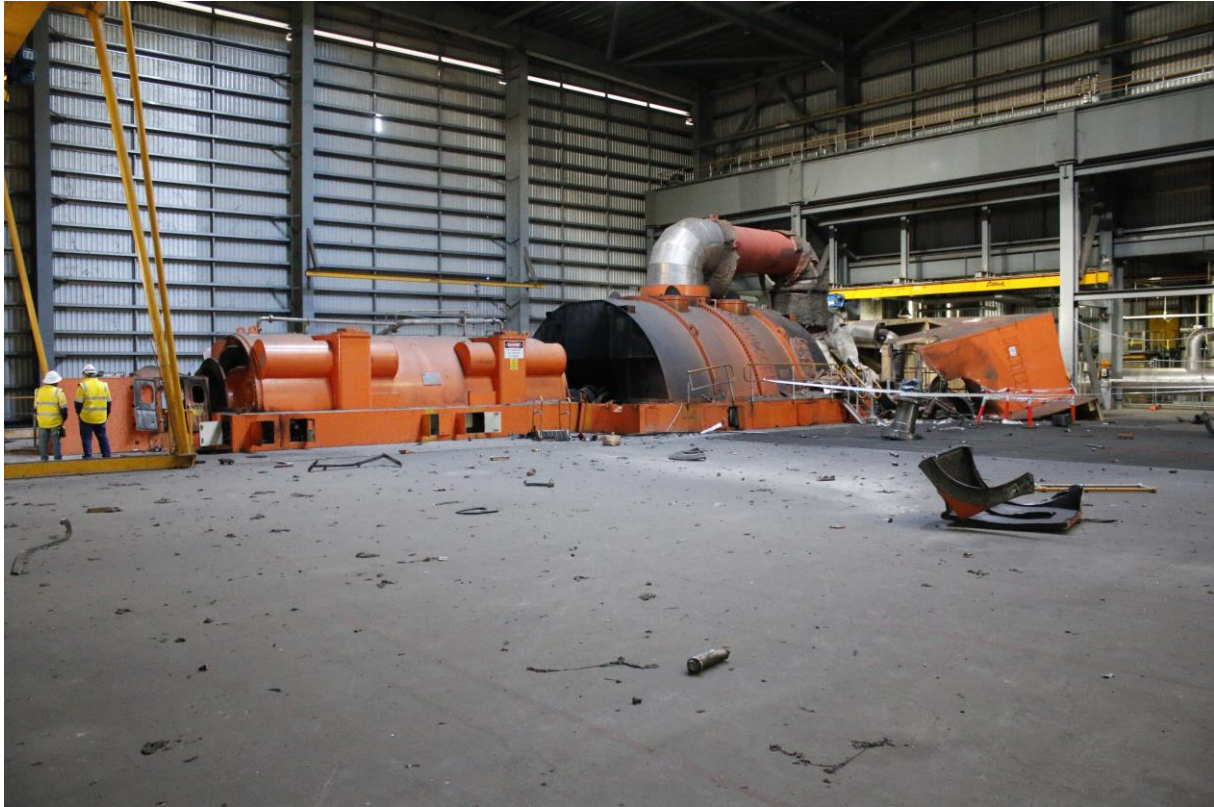
Figure 33 Damage to Unit C4

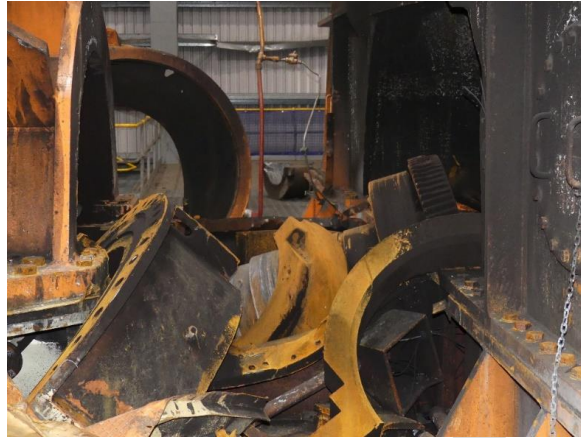
Figure 36 Damage between the generator and LP turbine

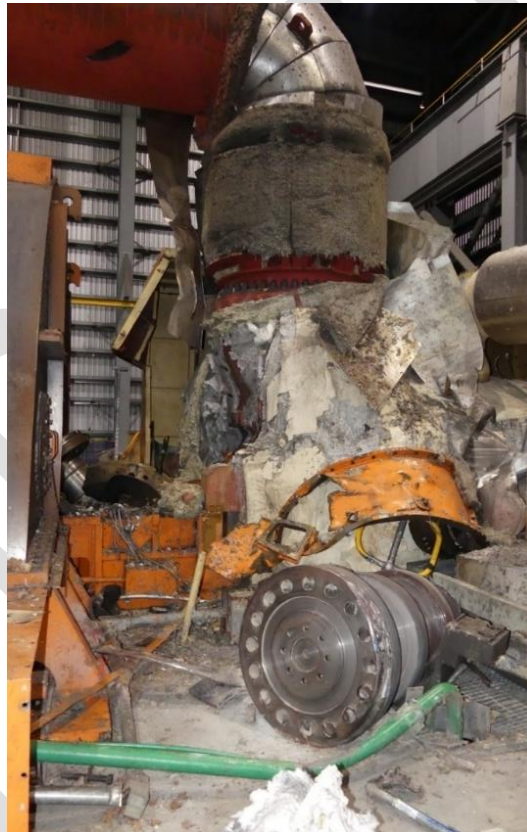
Figure 37 Damage between LP and HIP turbines

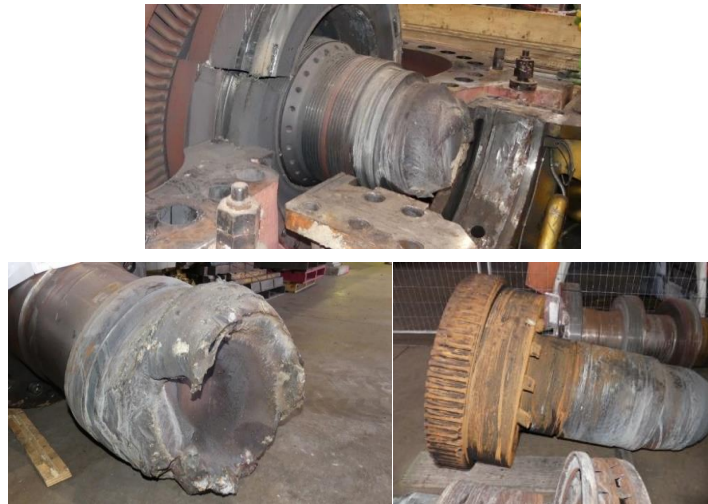
Figure 38 shows a selection of photographs of remnants of the shaft.

Figure 38 HP turbine, LP turbine and generator shaft damage

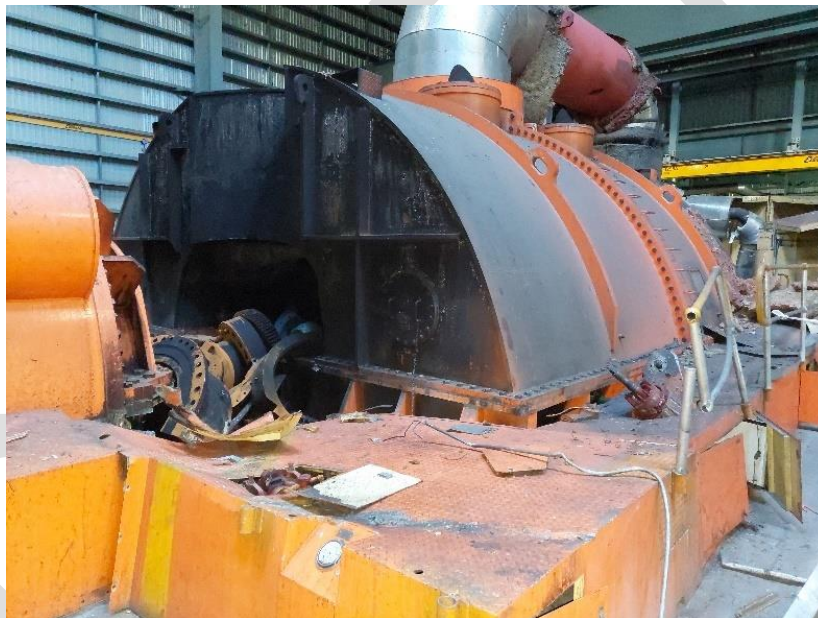
Figure 39 shows the heat damage to the casing for the LP turbine.

Figure 39 Heat damage to LP turbine casing

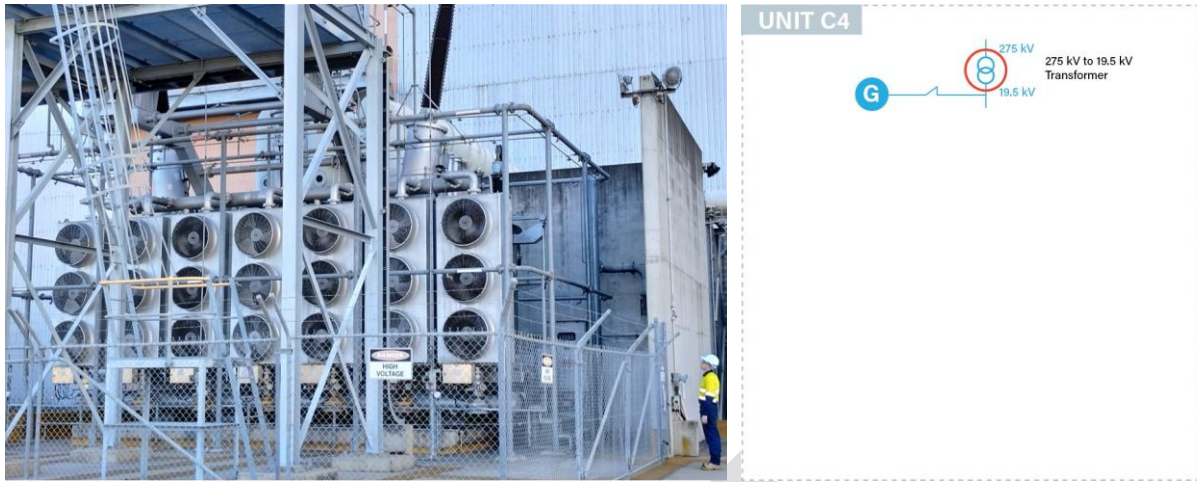
Figure 45 Unit C3 generator transformer (identical to Unit C4)

Figure 45 shows the Unit C3 generator transformer (which is the same as the Unit C4 generator transformer), located outside the turbine hall building.

The role of the generator transformer is to convert electricity produced by the generator from 19.5 kV to 275 kV, which is the transmission grid voltage. The fans that cool the generator transformer can be seen in the foreground of the figure above.

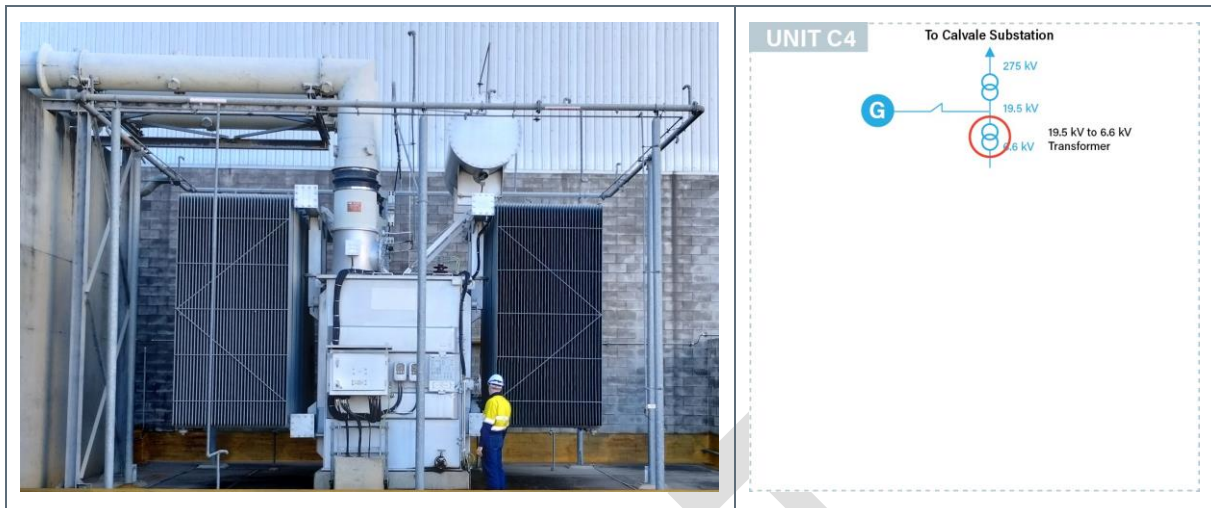
The 19.5 kV supply from the generator is passed through another transformer that steps down the voltage to 6.6 kV. This 6.6 kV voltage supplies the Unit C4 AC system. Figure 47 shows the Unit C3 step-down transformer, which is the same as in Unit C4.

Figure 47 Step-down transformer (circled in red)

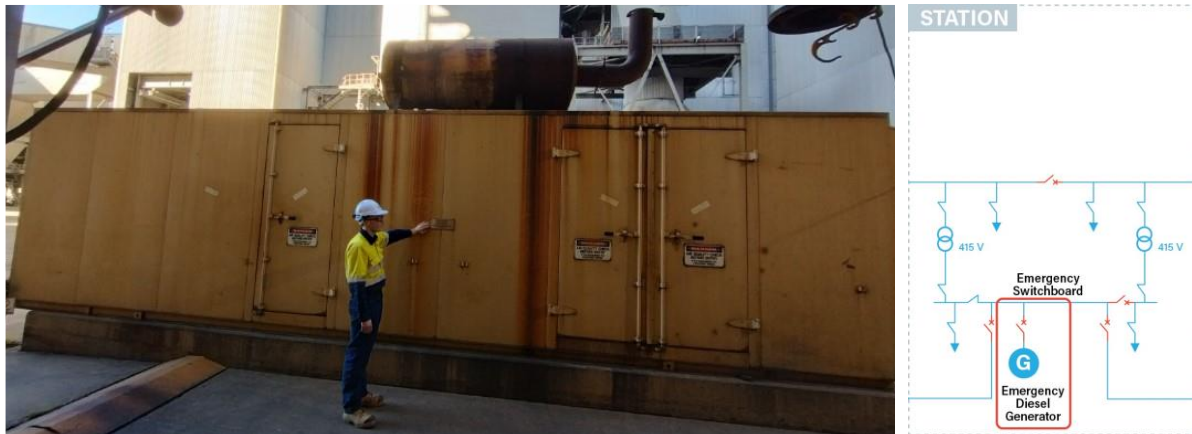
Figure 57 Emergency diesel generator

Figure 57 shows the emergency diesel generator at Callide C, which can provide AC supply to the Unit C3, Unit C4, and Station emergency switchboards in the event of a loss of AC supply.

If a loss of AC supply occurs, the emergency diesel generator will start automatically and connect to the Station emergency switchboard. The Station emergency switchboard can then be configured to supply the Unit C3 and Unit C4 emergency switchboards, via switches. Figure 58 illustrates how the Unit C4 emergency switchboard can receive AC supply directly from the Station emergency switchboard.

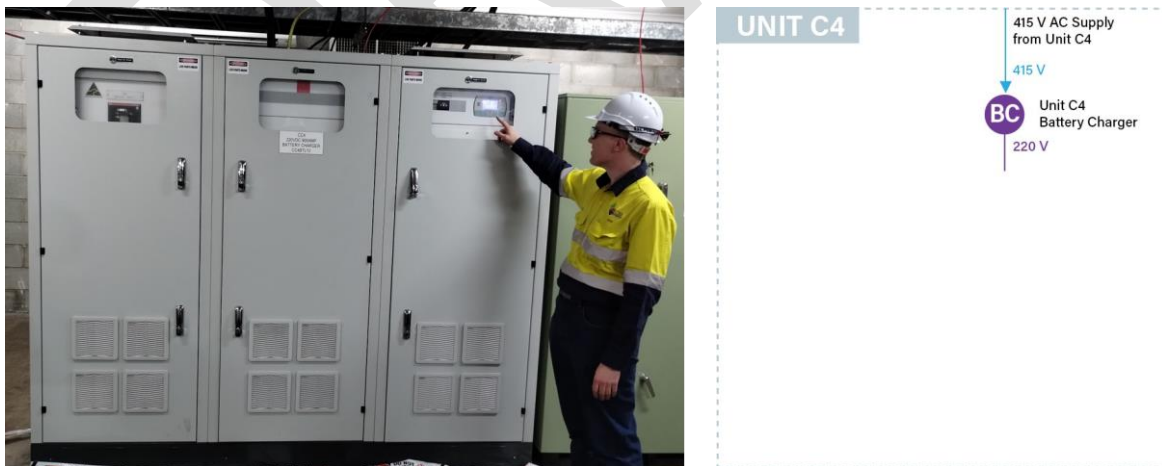
Figure 60 Unit C4 battery charger

The Unit C4 DC system has two sources of supply: a battery charger and a battery. Figure 60 shows the Unit C4 battery charger.

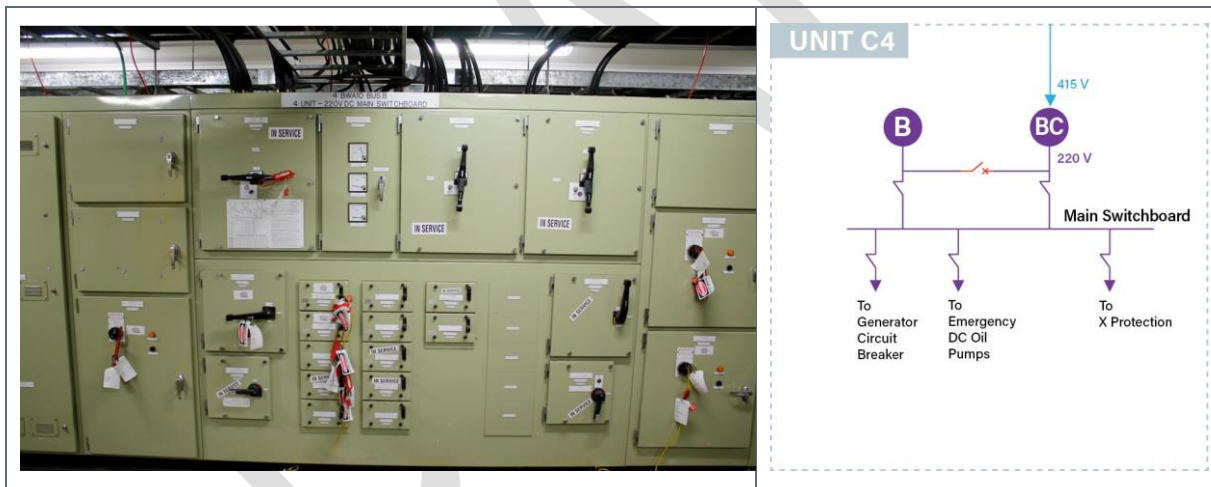
Figure 62 Unit C4 main switchboard

As shown in Figure 62, the Unit C4 battery charger and battery both connect to the Unit C4 main switchboard.

The main switchboard distributes DC supply to a range of systems, including the emergency DC lubrication oil and seal oil pumps. The main switchboard supplies power to the Unit C4 generator circuit breaker, allowing it to operate automatically or to be operated remotely from the control room, if necessary.

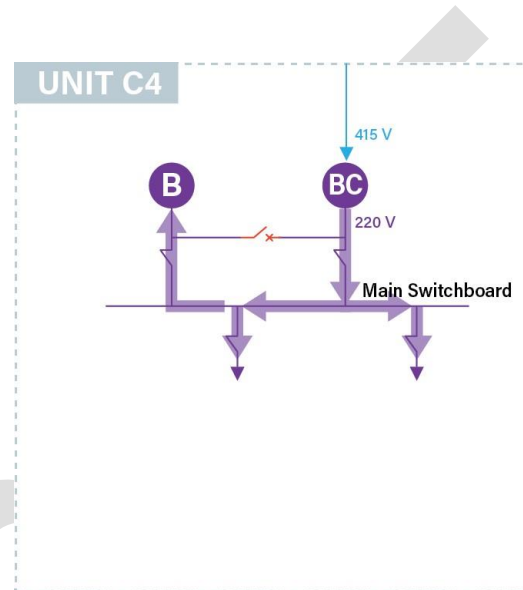
The battery charger and battery are both connected to the main switchboard via their own switches.<sup>59</sup> As discussed earlier, the battery charger primarily provides DC supply to the equipment in the DC system, while also keeping the battery at a full state of charge.<sup>60</sup> Therefore, the battery charger should be considered the primary source of supply to the DC system. Figure 63 illustrates this concept for Unit C4.

Figure 63 Battery charger supplying Unit C4

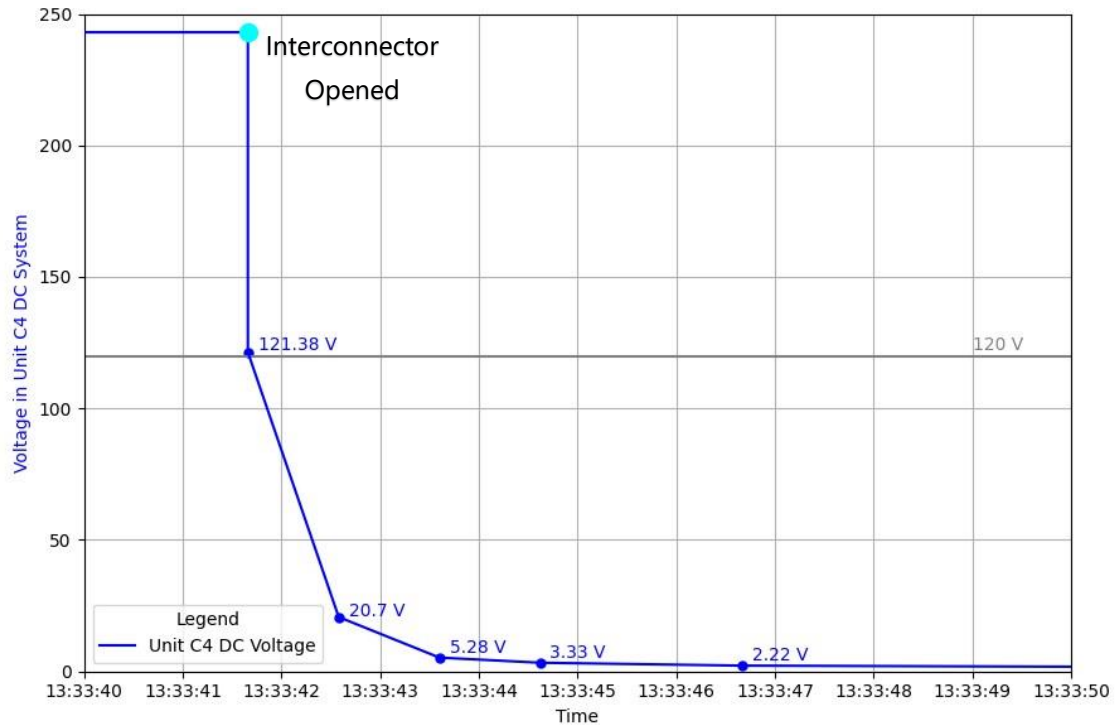
Figure 96 DC voltage in Unit C4 distribution switchboard

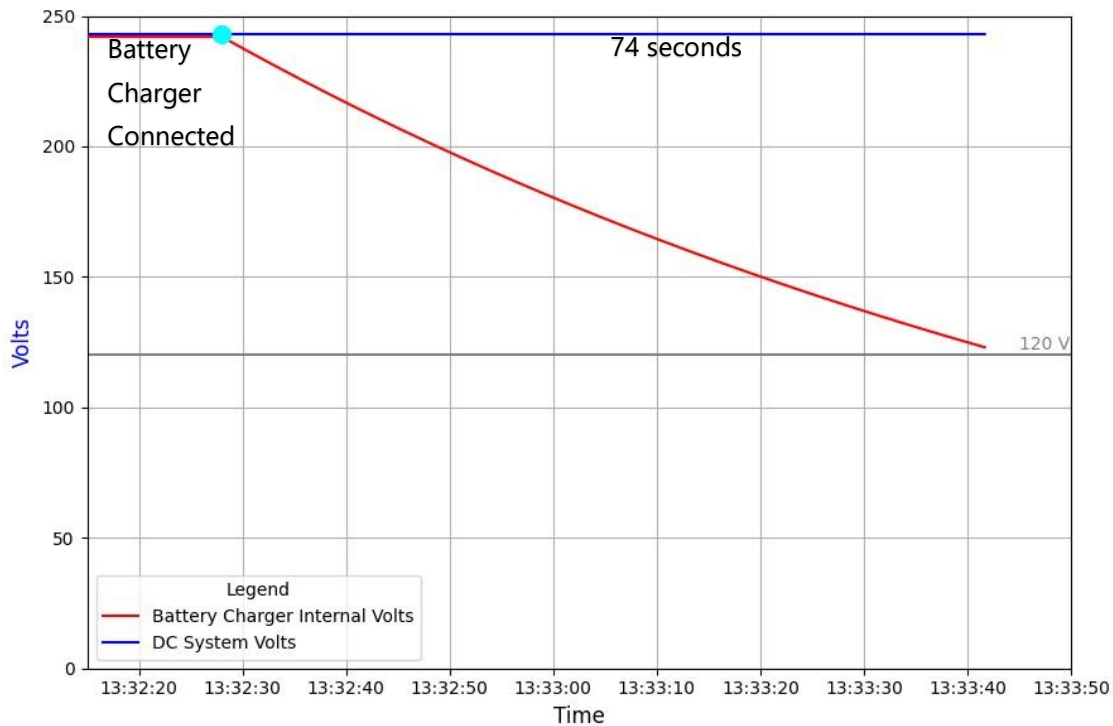
Figure 111 Likely decay of Unit C4 internal voltage to ~120 V

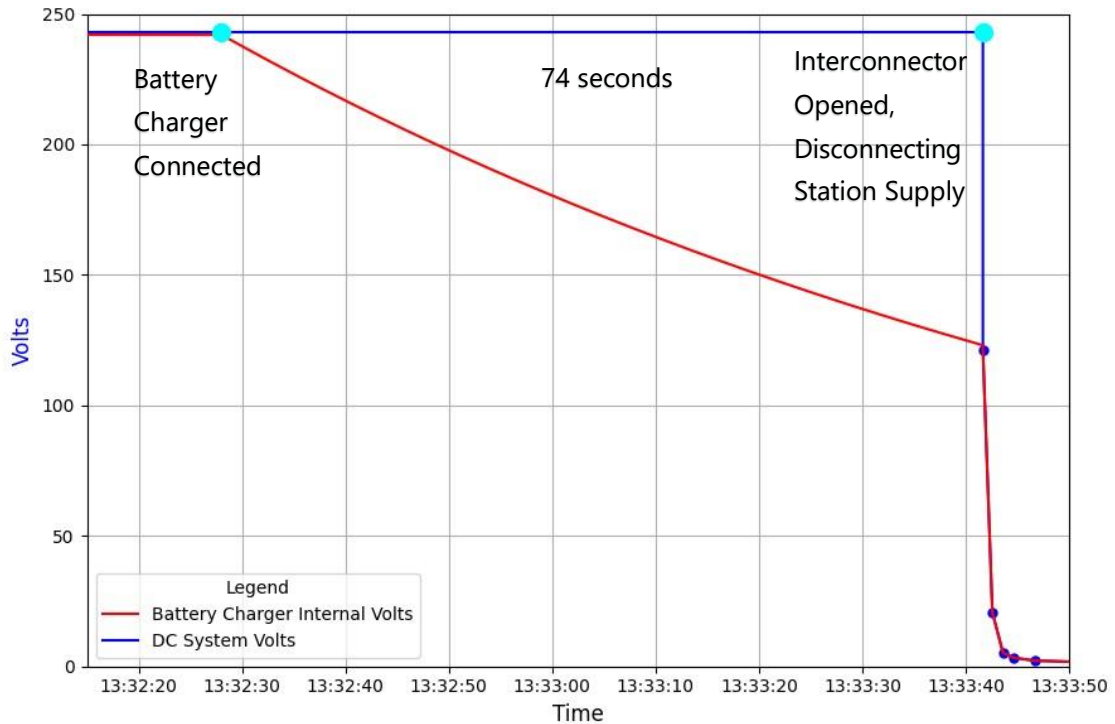
Figure 112 Likely collapse of DC system voltage to level of Unit C4 internal voltage (~120 V)
