## **CS Energy (Callide Power Station)**

**Cooling Towers CT3 and CT4**

**Investigation into Failures and Root Cause Analysis**

**Report No 2210001-RCA1 - Rev 0**

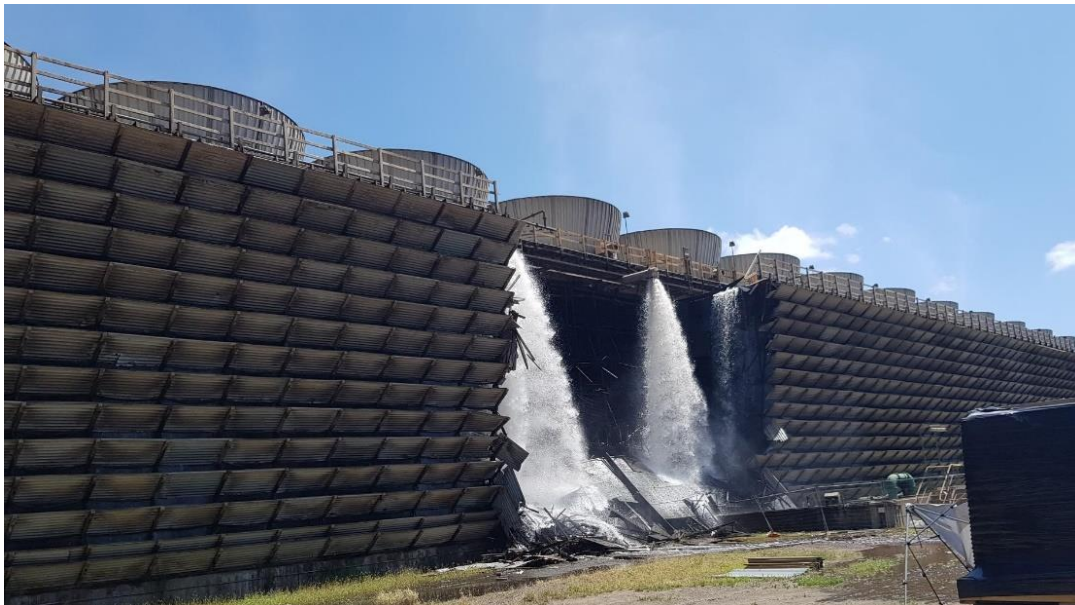
*Figure 1.6 Cooling tower CT3 - Collapsed cells 8 and 9 north (2022 Photo)*

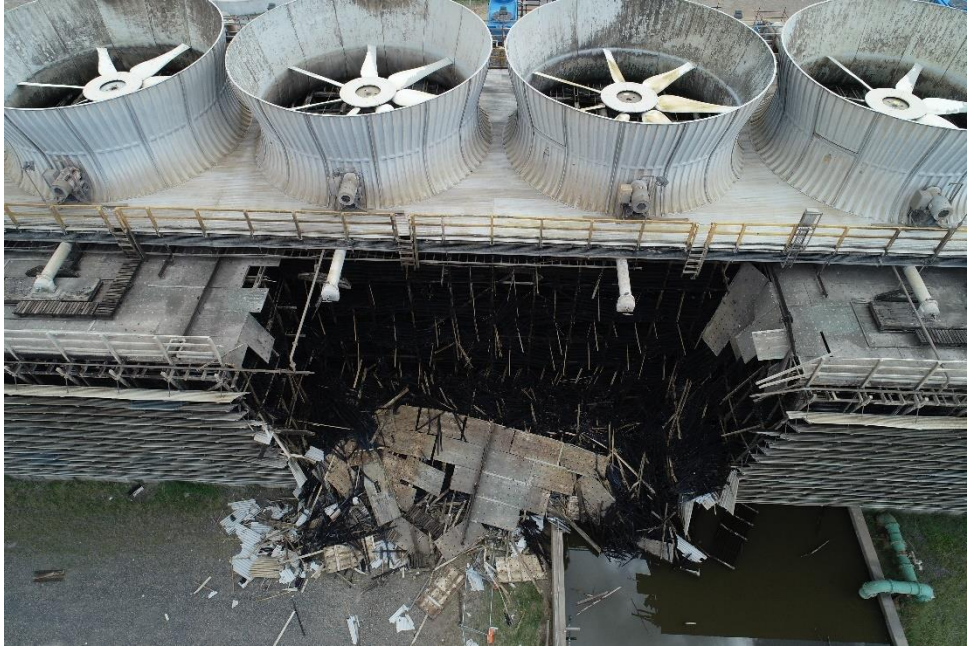
*Figure 1.7 Cooling tower CT3 - Aerial view of cells 8 and 9 collapse (2022 photo)*

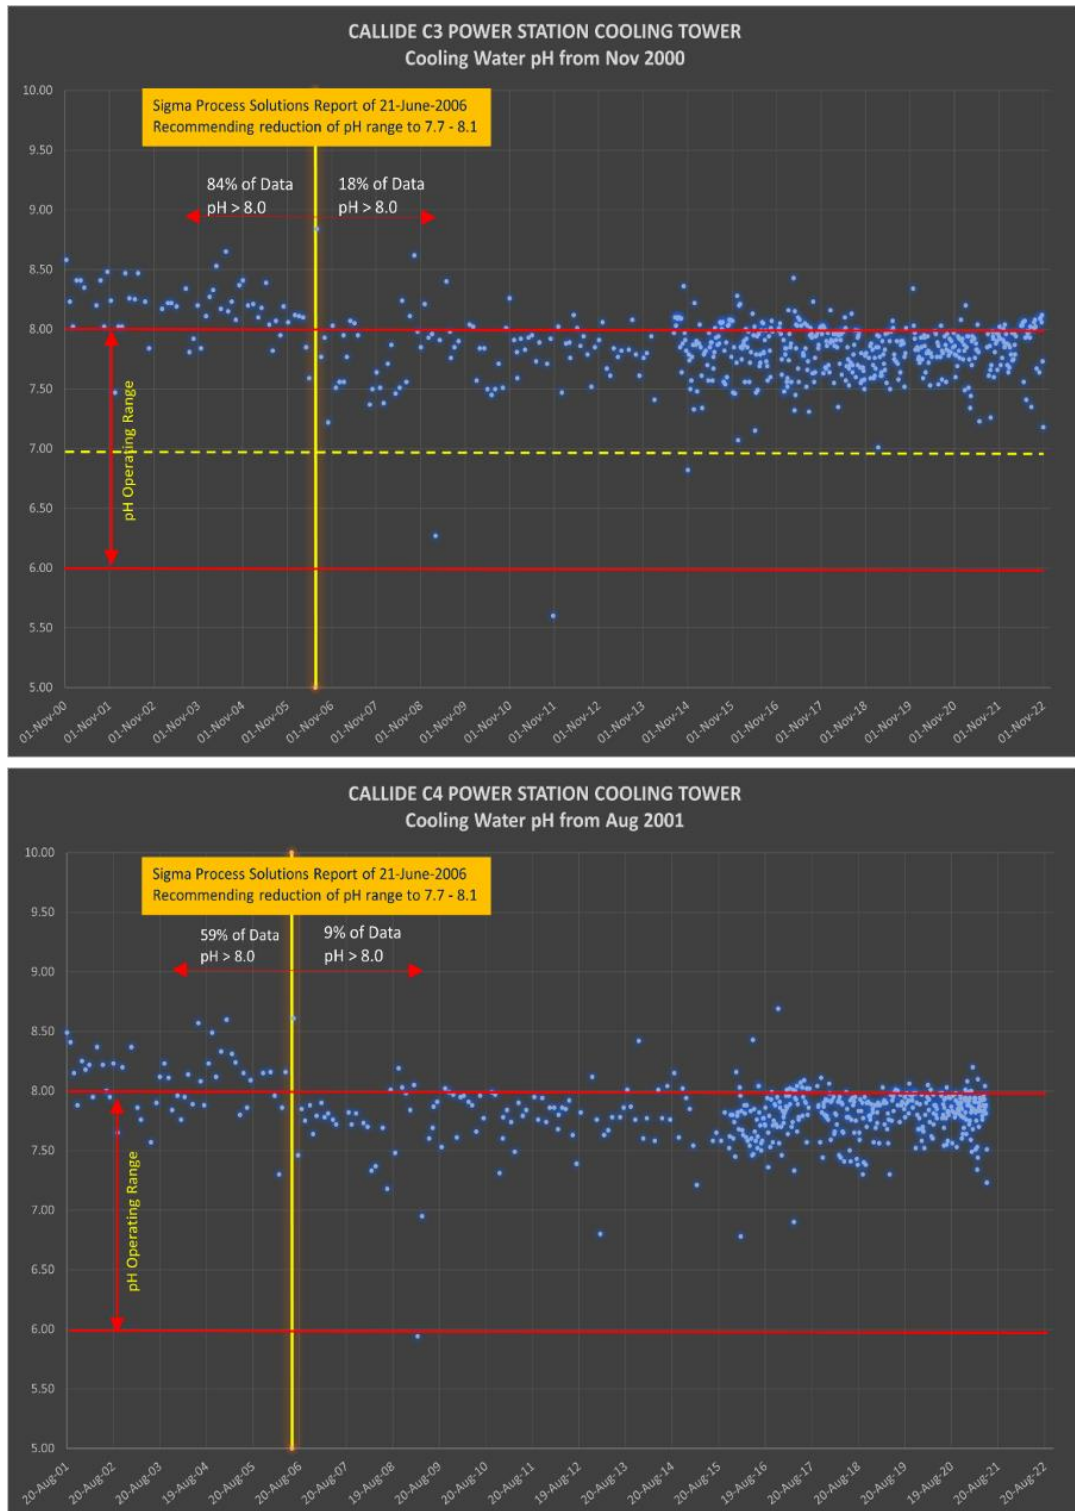
Figure 4.7 C3 & C4 Cooling Water pH Scatter Charts

On closer inspection of Figure 4.7, it is evident that a significant portion of the values for pH lie between 8.0 to 8.5 with regular peaks just above 8.5 prior to 21st June 2006. As shown on Figure 4.7, for CT3 cooling tower, 84% and 18% of the pH are > 8.0 prior to and post this date respectively. The corresponding figures for CT4 are 59% and 9%.

When compared to adopted range of pH as per Table 4.1, cooling tower CT3 had 84% of the cooling water pH values above the maximum value of pH 8.0 before June 2006 and 18% above pH 8.0 post June 2006. The corresponding values for cooling tower CT4 are 59% and 9%.

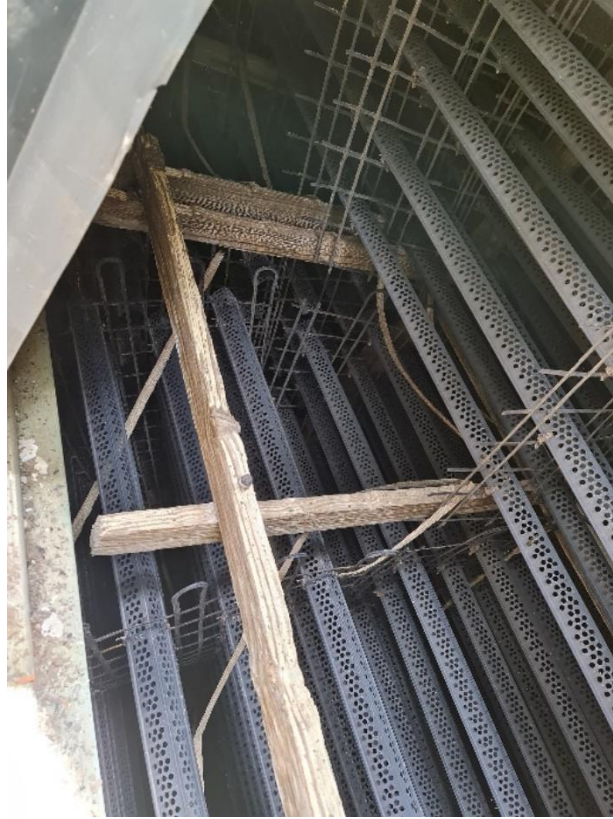
*Figure 5.9 Longitudinal girt with chemical erosion*

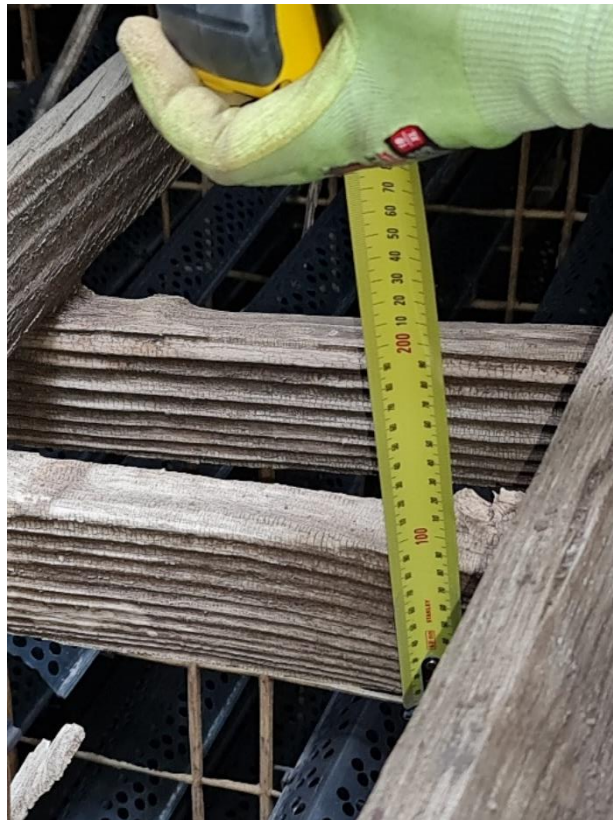
*Figure 5.10 Transverse girts chemical erosion, original depth 100mm and 80mm remaining*

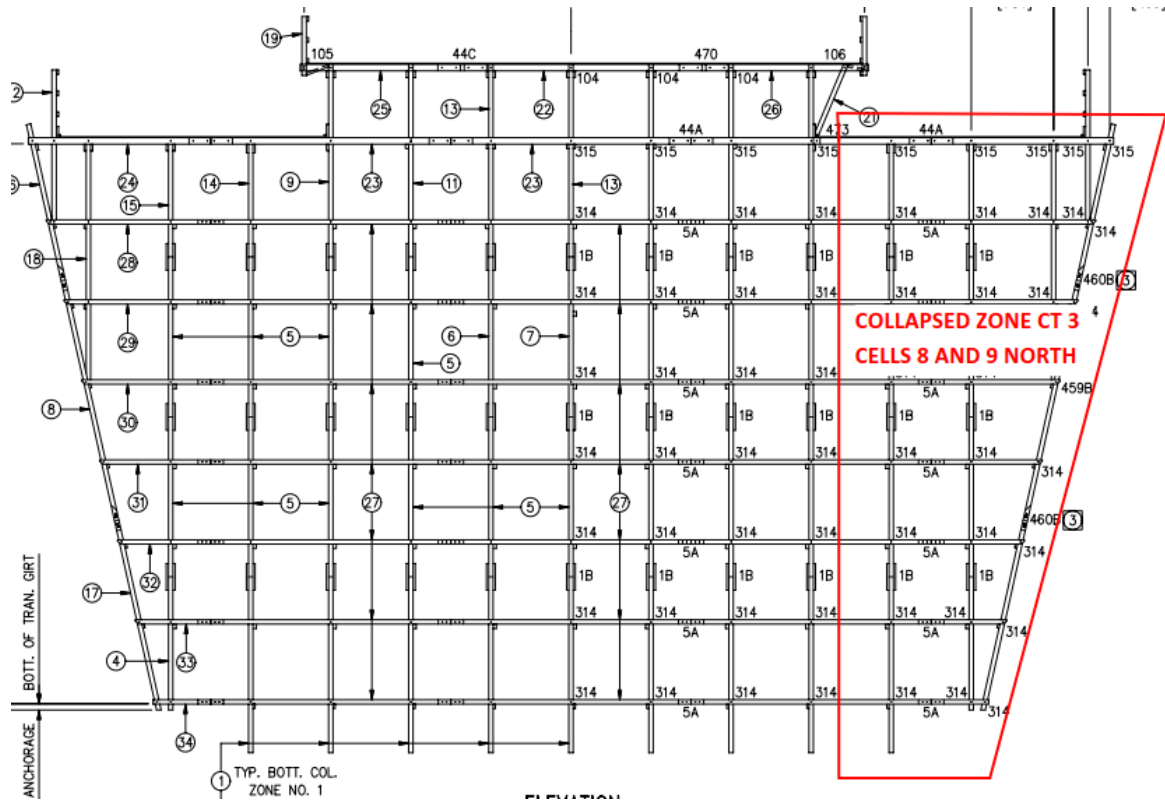
Figure 7.3 Failure zone

It is also noted that the failure in cells 8 and 9 occurred in the North wet zone of CT3 , leaving the structure supporting the fan deck intact. The volume under the fan deck is mostly in the plenum or dry zone where the timbers are in good condition.

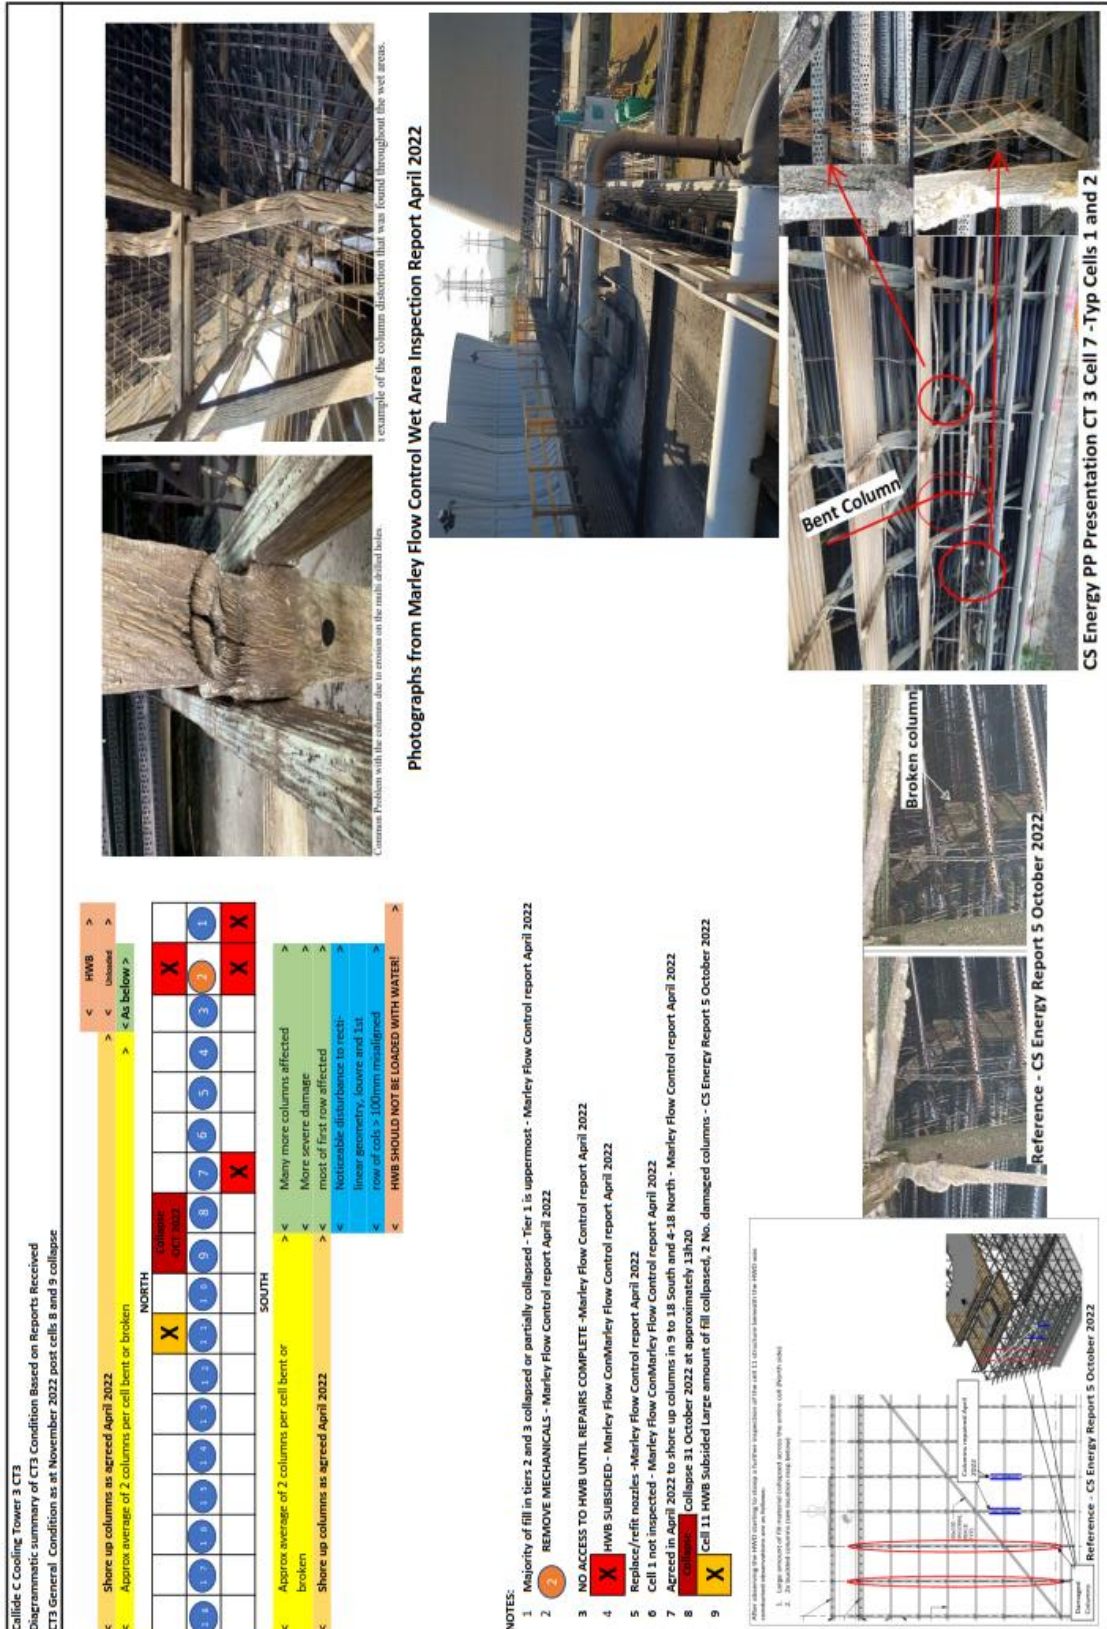
Figure 7.7 Cooling Tower 3 Condition Summary October 2022

A summary of the condition of CT3 just prior to the collapse is shown diagrammatically below.

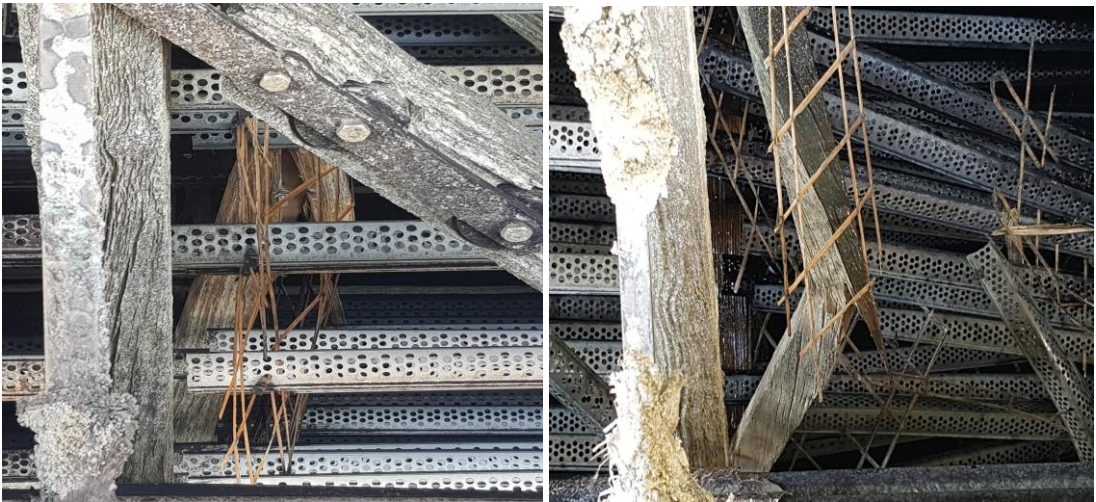
*Figure 7.10 Split columns CT3 Cell 7. Note in first row of vertical columns – CS Energy October 2022*

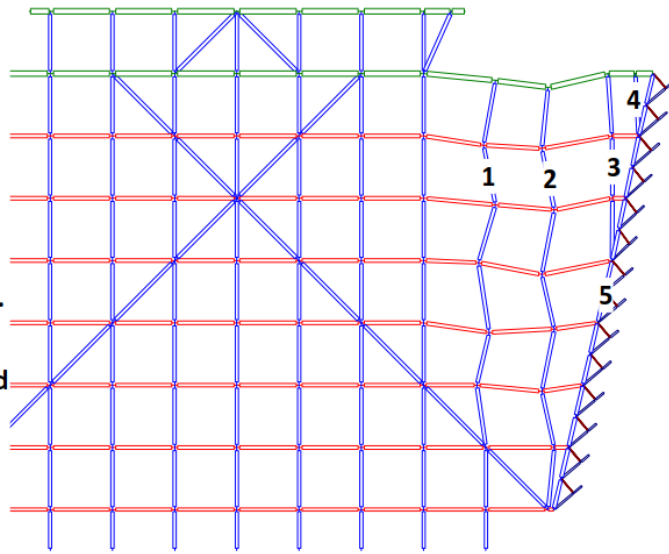
As the hot water basin sags further, water load increases.

Structure is now unstable and begins to accelerate due to gravity.

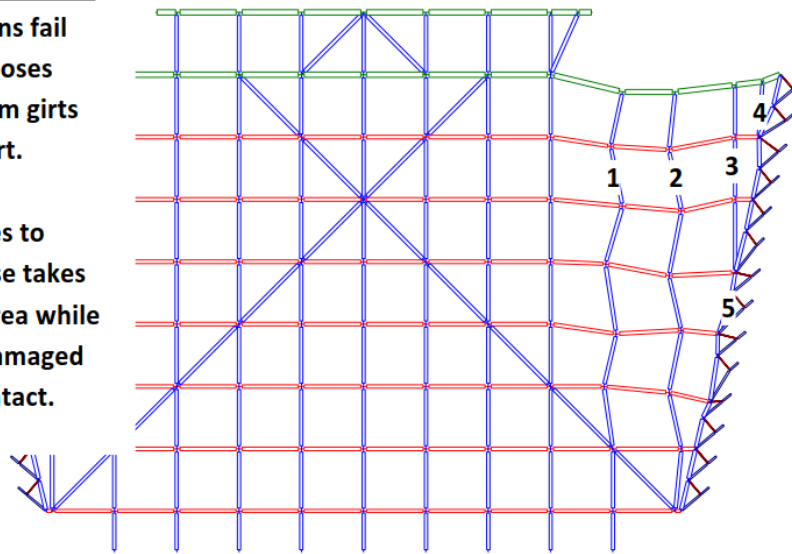
## Stage 5: Adjacent Columns

As adjacent columns fail louvre column 5 loses lateral support from girts and starts to distort.

Structure continues to accelerate. Collapse takes place in the wet area while the relatively undamaged plenum remains intact.

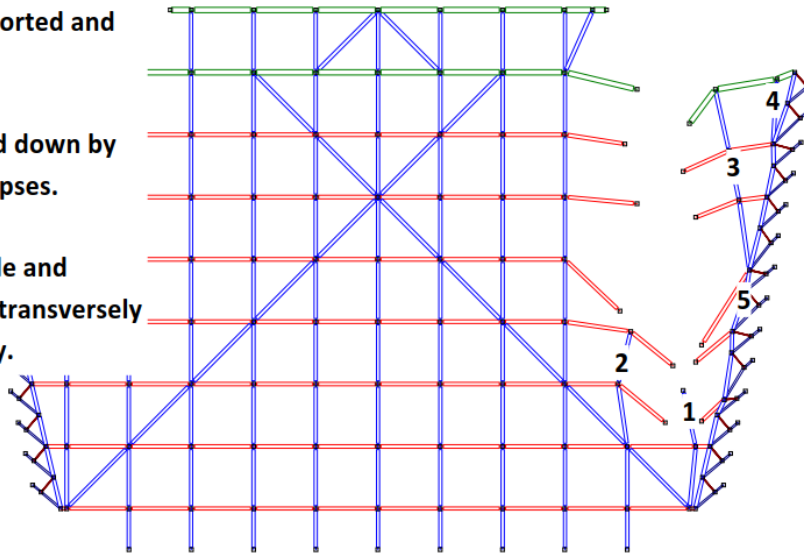
## Stage 7: Collapse

Column 5 unsupported and collapses.

Collapse inevitable and proceeds quickly transversely and longitudinally.

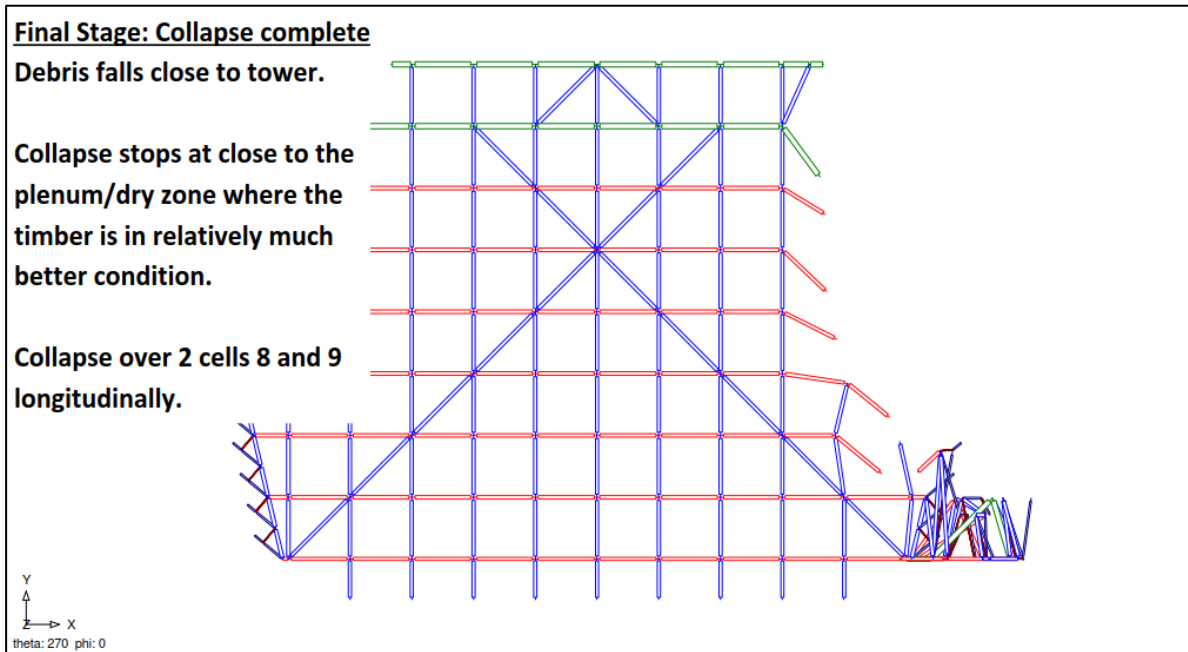
As noted, the sequence shown above is not the only one that could have occurred, and it centres on the known damage to the columns in the wet zone and in particular, the first vertical column from the outside of the tower, or column 1 in the above diagrams. Column 2 was easily observable from outside of the cooling tower as was the louvre column, column 5. It is likely that column 1 was as damaged as column 2 but perhaps not observed as readily. Other points of initiation that are possible are as follows:

- Collapse could have initiated with column 1.
- Collapse could have initiated with the louvre column 5.
- Failure of one or more longitudinal or transverse girts would result in increased column buckling lengths and therefore column slenderness ratio would increase resulting in a significant loss of column axial capacity.
