Brady Heywood.

Technical and Organisational Investigation of the Callide Unit C4 Incident

DRAFT

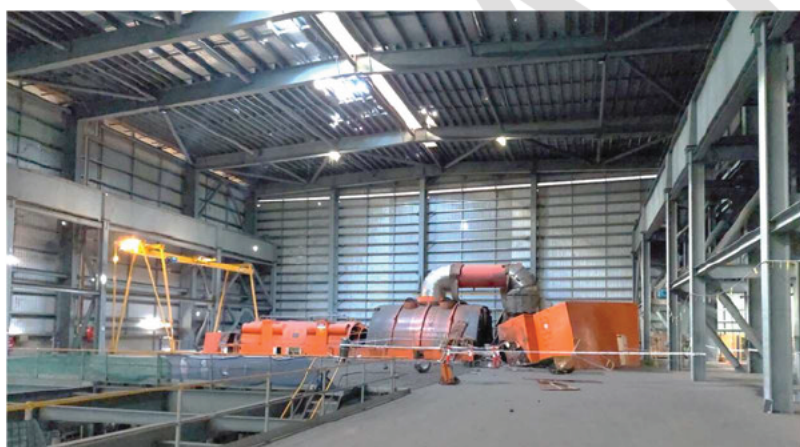
Figure 11 Turbine hall

The turbine hall at Callide houses the Unit C4 turbine generator (pictured post-incident).

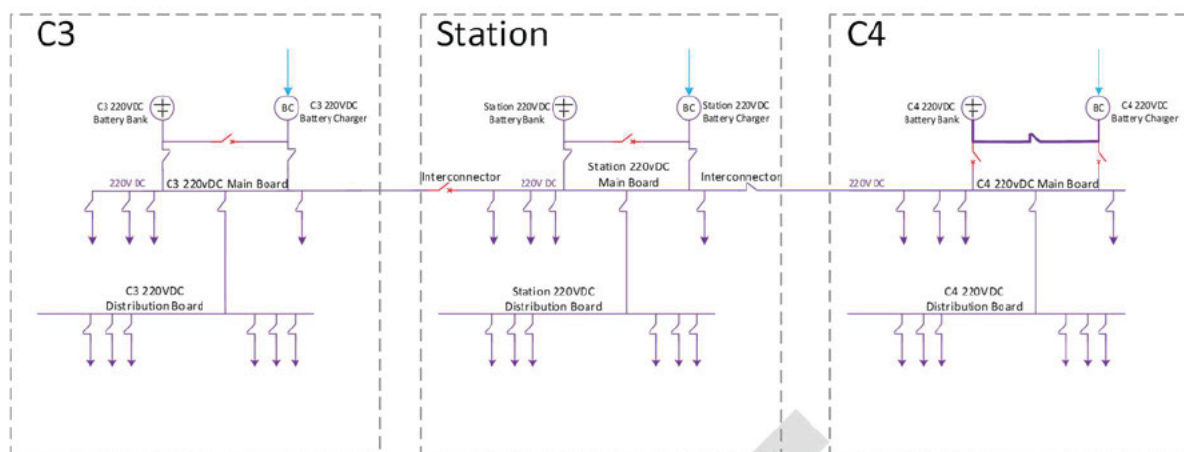
Figure 13 Configuration on the day before and morning of the incident

The **Electrical Supervisor** and **Electrical Technician** then successfully followed Steps 180 to 200 using the sequence prescribed on the switching sheet.

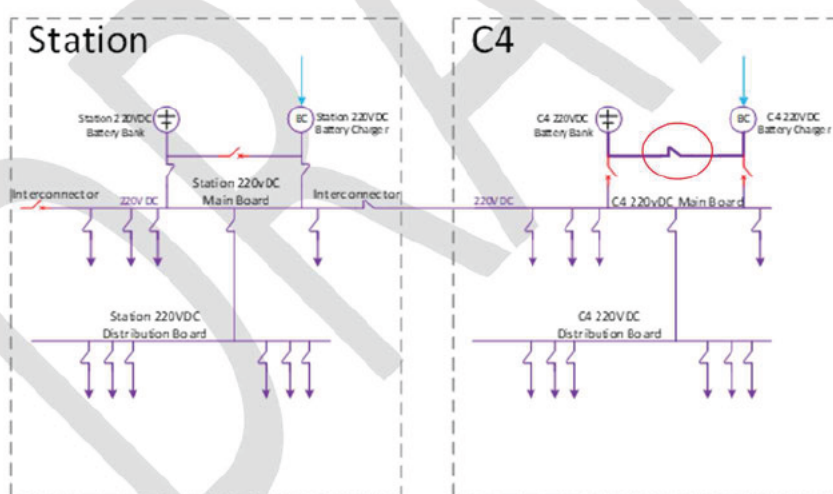
Figure 36 Unit C4 battery charger connected directly to battery

This restoration switching began on 24 May 2021, the day before the incident. The Unit C4 battery had been dormant for many months and was no longer at full charge. The battery charger was connected directly to the battery to charge it overnight in a configuration referred to as 'offline charging', see Figure 36.

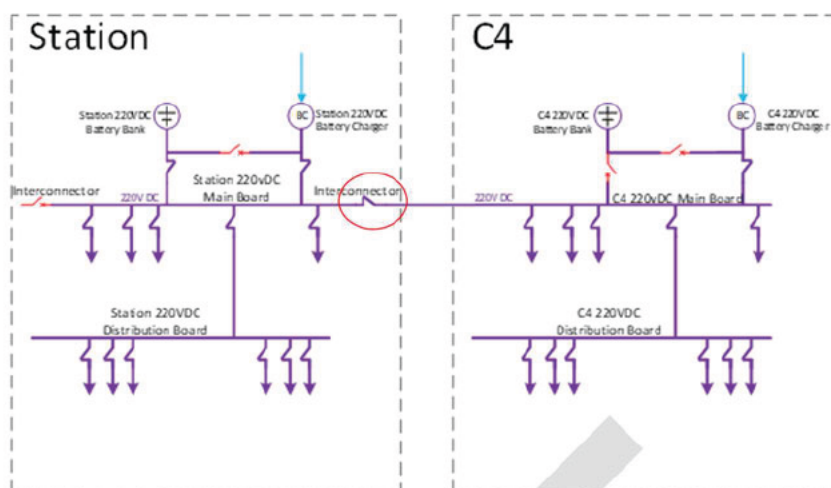
Figure 37 Unit C4 DC system supplied from Station and Unit C4 battery charger

At this point in the switching sequence, the Station and Unit C4 DC systems were still connected and had three independent sources of supply available; the Station battery, the Station battery charger, and the Unit C4 battery charger, see Figure 37.

The next step in the switching sequence was to open the interconnector between Station and Unit C4. This would remove supply to Unit C4 from the Station battery and Station battery charger. It was at this point that the collapse of the DC supply to Unit C4 was initiated. This occurred because the newly installed Unit C4 battery charger failed to maintain the DC voltage level as required by the, see Figure 38.

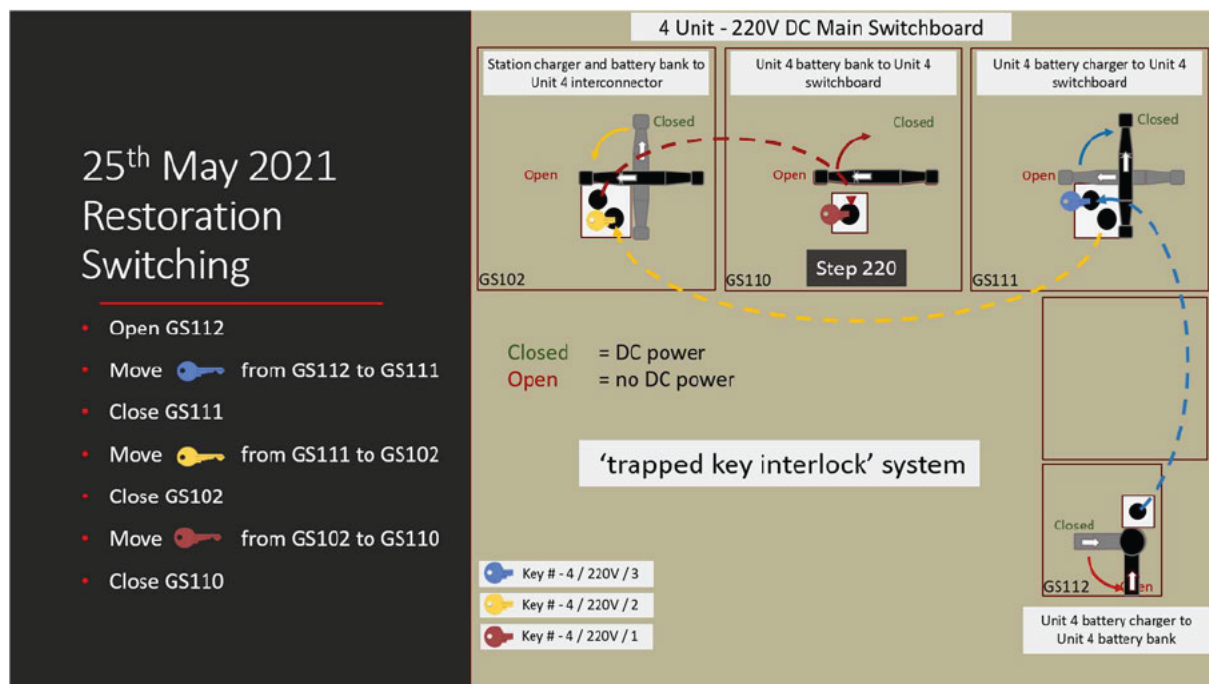
Figure 39 Restoration switching sequence using the keyed interlock system for the for the new battery charger

These interlocks result in only one way to restore the Unit C4 battery and battery charger to their typical configuration, which was the basis of the switching sheet used on 25 May 2021. The restoration step when the interconnector between Station and Unit C4 is opened, results in the battery charger being the sole source of DC supply, see Figure 39.

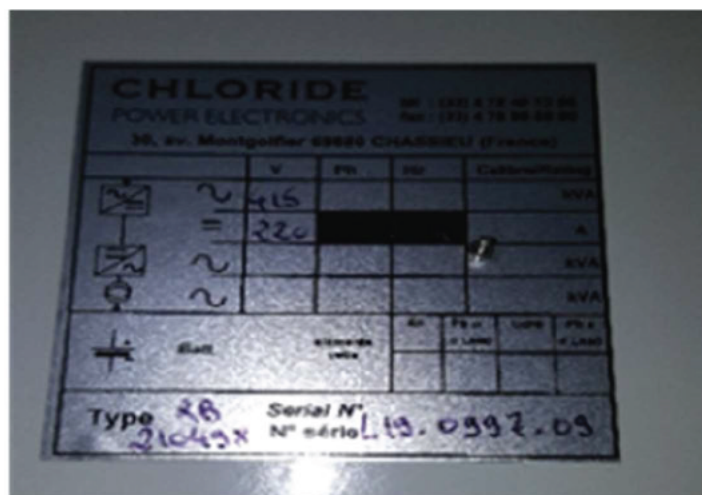
Figure 47 Old battery charger ratings plate

Upon request from Magellan, the CS Energy Technical Officer provided a photo of the existing battery charger and its name plate. The photograph sent has not been located, however, for illustrative purposes Figure 47 is a photograph of a nameplate of one of the existing chargers, which was provided in the Specification for the Callide C battery charger replacements. Nameplates provide only basic information such as voltage and current.²⁹¹

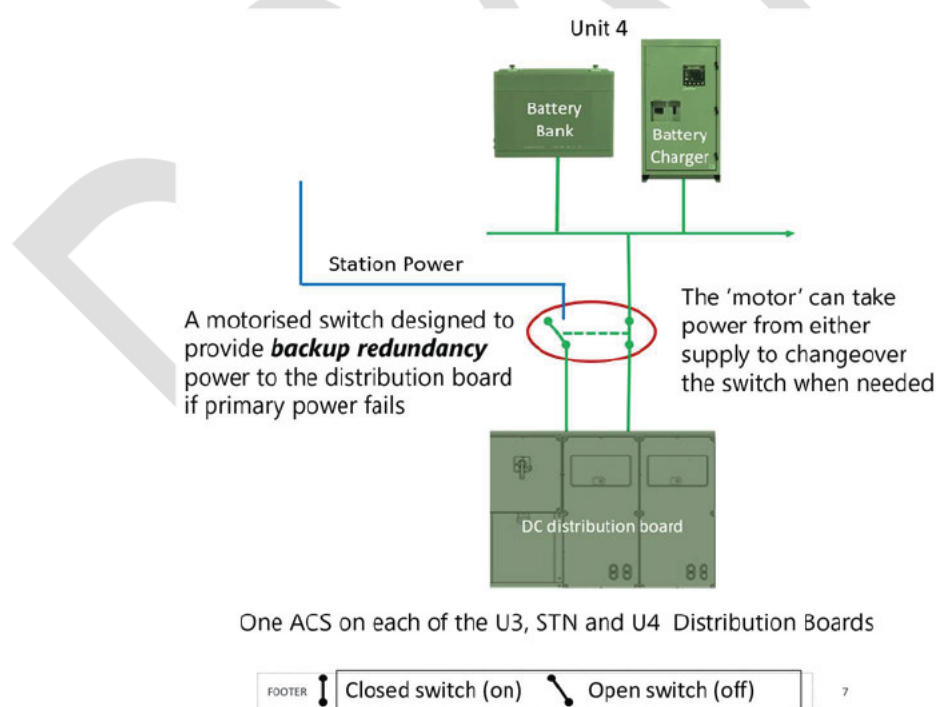
Figure 62 Operation of Automatic Changeover Switch

The ACS is a switch that provides partial redundancy to the DC systems on each of Unit C3, Station, and Unit C4. With respect to Unit C4, the battery and battery charger provide supply to the Unit C4 mainboard. Supply from this main board is then routed to the distribution board, as per the figure below.

If DC supply is lost to the main board, it will also be lost to the distribution board. The Unit 4 DC distribution board contains a number of key systems which are important in relation to the incident on 25 May 2021 and ACS is designed to provide backup redundancy from the Station supply to the Unit C4 distribution board. These key systems include:
