Brady Heywood.

Technical and Organisational Investigation of the Callide Unit C4 Incident

July 2024

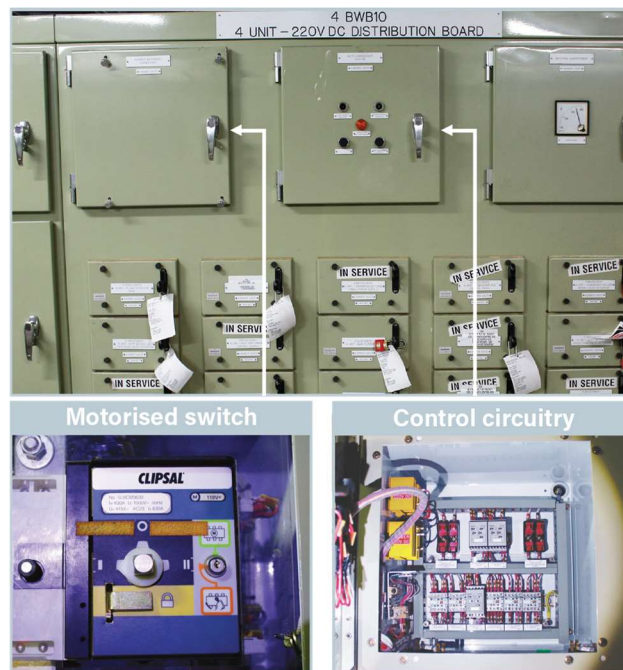
Figure 20 Unit C4 automatic changeover switch

On the day of the incident, the Unit C4 automatic changeover switch was inoperable in automatic mode.²⁹

²⁹ In this report, 'inoperable' means 'inoperable in automatic mode', unless otherwise stated. While the Unit C4 automatic changeover switch was operable in manual mode on the day of the incident, manual operation of the switch was not a practical response to the collapse and loss of DC supply in Unit C4.

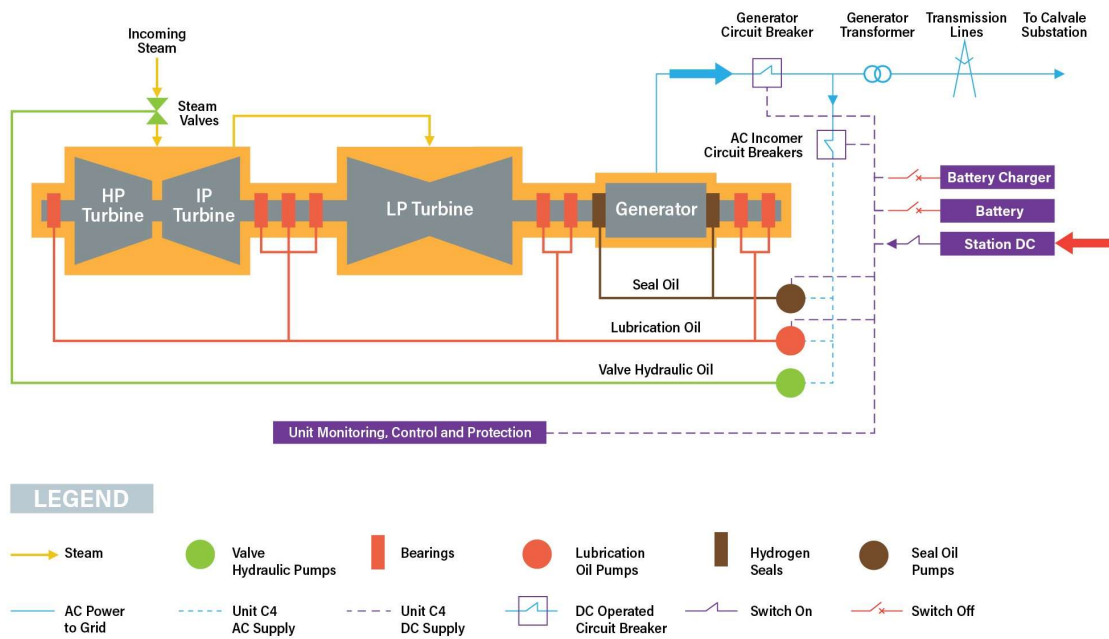
Figure 23 Unit C4 DC system supplied from Station DC system

In February 2021, the Unit C4 battery charger and battery were taken out of service to facilitate the battery charger's replacement. With the Unit C4 battery charger and battery out of service, Unit C4 was supplied from Station DC, as depicted in Figure 23.

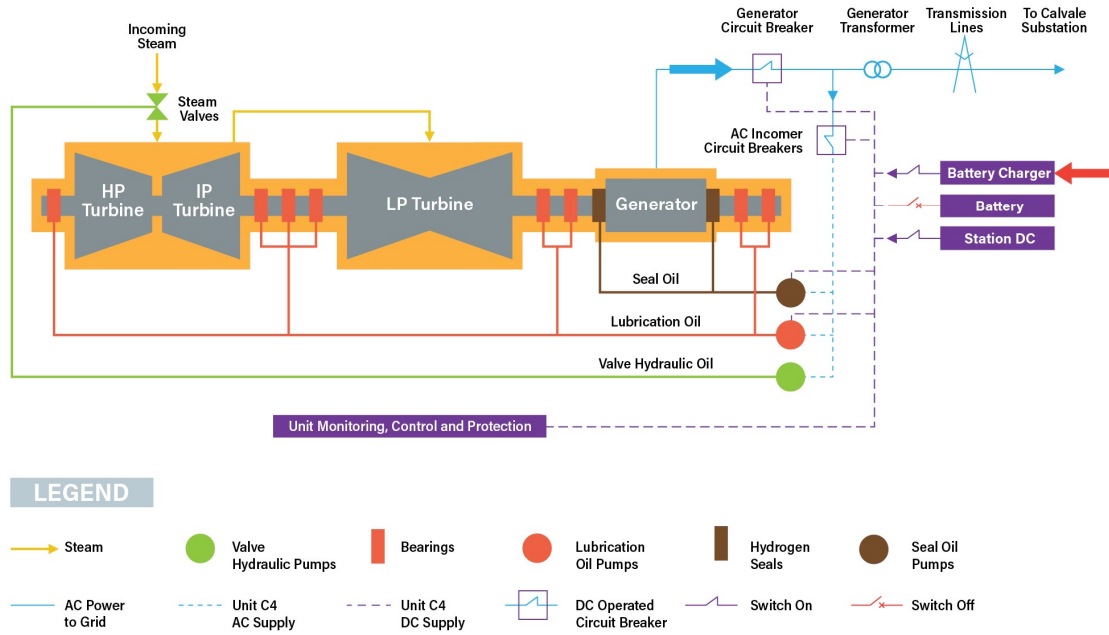
Figure 24 Unit C4 battery charger connected to Unit C4 DC system

By 1:32 pm on the day of the incident, the switching sequence was in progress.³² The next step in the sequence was to connect the replacement Unit C4 battery charger to Unit C4, see Figure 24.

This step was completed successfully, resulting in Unit C4 now having two potential DC supplies: supply from the Station DC system and supply from the Unit C4 battery charger.³³ The next step was to disconnect the Station DC system from Unit C4, see Figure 25.

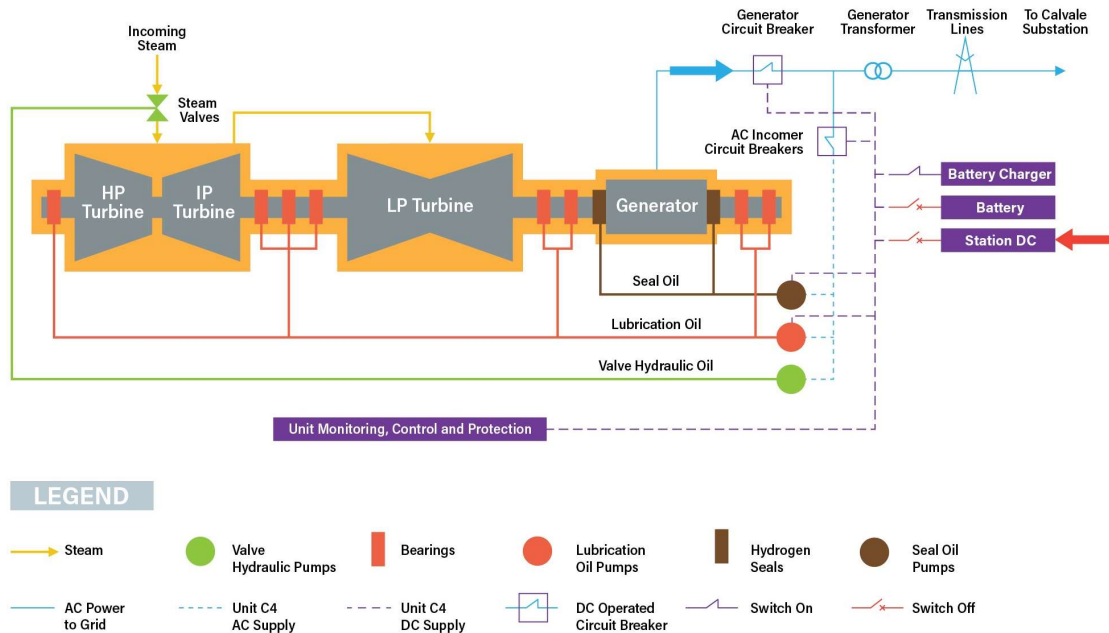
Figure 25 Station DC supply disconnected from Unit C4 DC system

³⁴ The Brady Heywood investigation concluded that, under the specific conditions on the day of the incident, the battery charger was not capable of responding instantly and maintaining the voltage in the Unit C4 DC system.

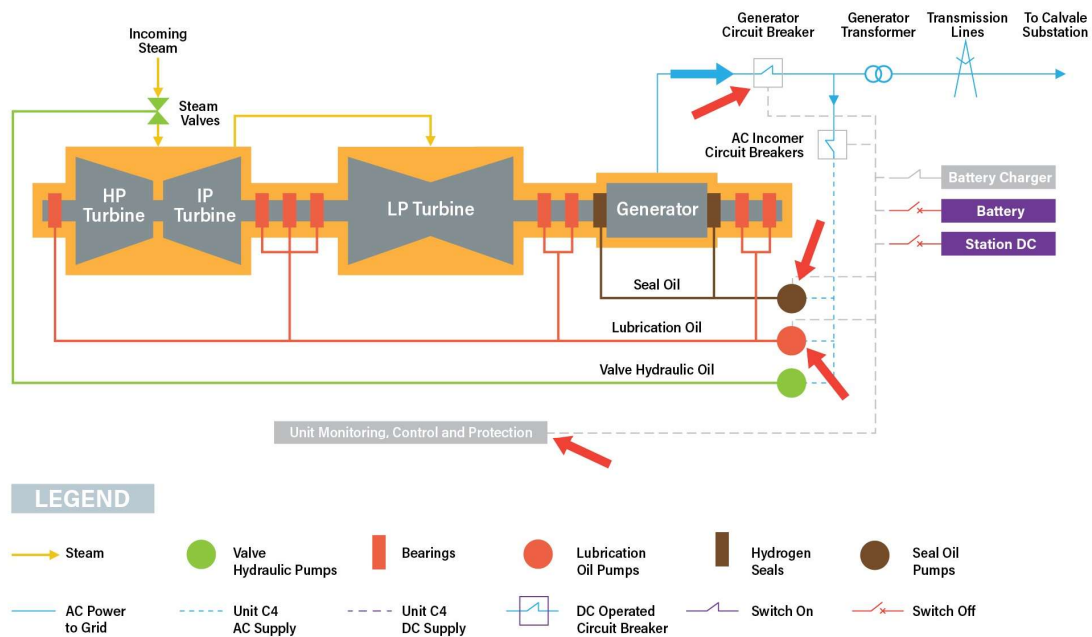
Figure 27 Loss of critical DC systems

The collapse and subsequent loss of DC supply to Unit C4 resulted in an immediate loss of several critical systems, as indicated by the red arrows in Figure 27.

³⁵ As discussed later in this report, the collapse of the Unit C4 DC system voltage to ~120 V directly led to the loss of the Unit C4 AC supply (~0 V), which in turn led to the loss of the Unit C4 DC supply (i.e., the voltage rapidly decayed to ~0 V).

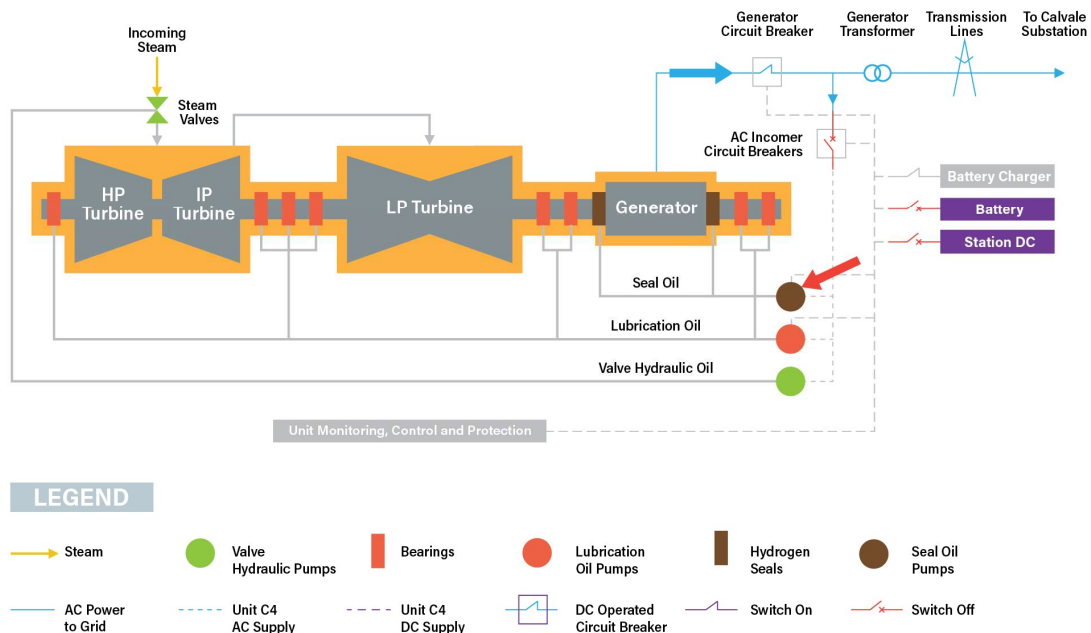
Figure 31 Loss of AC seal oil pump

Third, the loss of AC supply resulted in the loss of the AC seal oil pump, see Figure 31.

The loss of this pump resulted in the loss of oil supply to the generator hydrogen seals. Ordinarily, the DC emergency seal oil pump would automatically start and restore seal oil, but it did not operate because of the loss of its DC supply. This resulted in hydrogen escaping from the generator into the surrounding air.

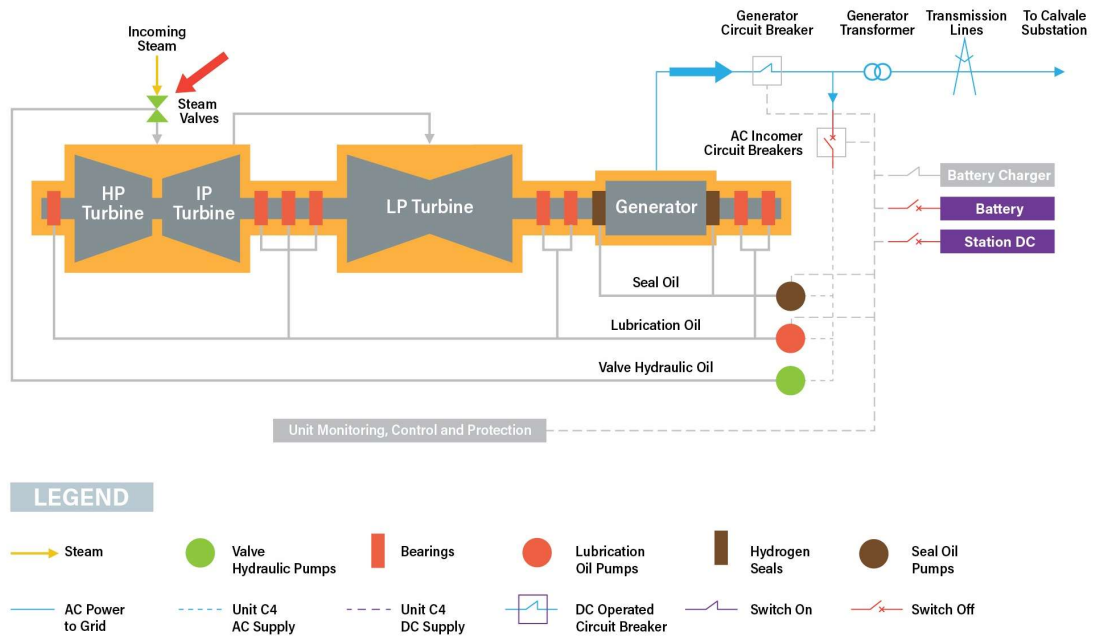
Figure 32 Steam valves close and prevent steam entering turbine

The loss of AC supply led to the failure of the hydraulic pumps, which provide hydraulic pressure to keep the steam valves open. As a result, the steam valves closed (due to their fail-safe design), thus preventing steam from entering the turbine, see Figure 32.

⁴¹ Technically, it is a lack of steam driving the turbine that is the necessary condition. In the incident, the steam valves closing resulted in this condition.

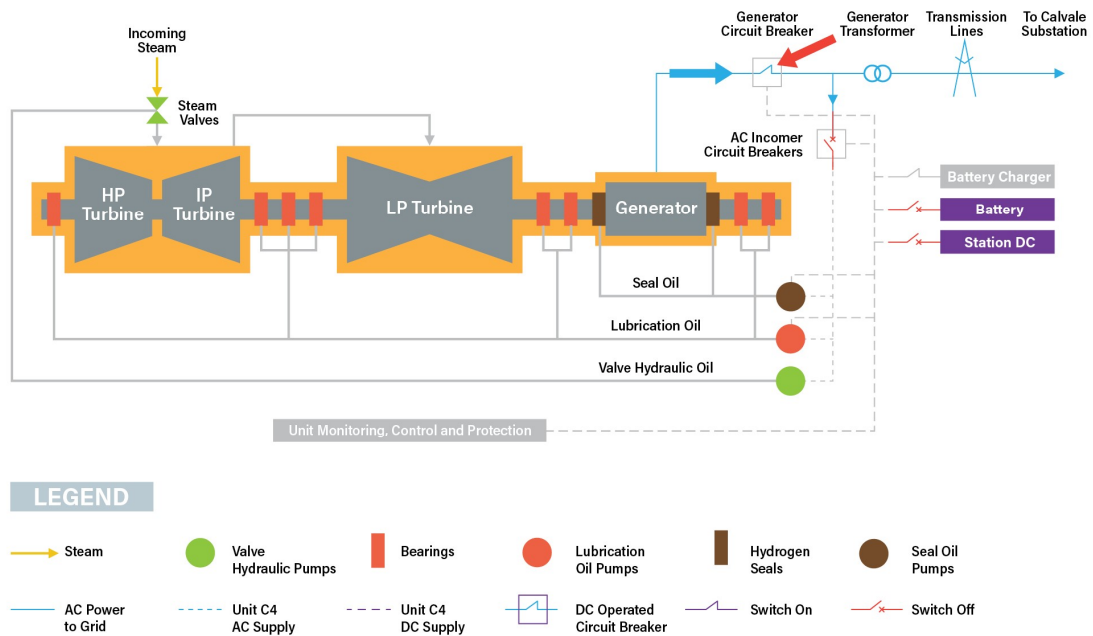
Figure 33 Generator circuit breaker did not disconnect Unit C4 from the grid

A loss of AC supply would typically be detected by the Unit C4 protection systems, which would automatically trip the generator circuit breaker, disconnecting the unit from the grid. However, the loss of DC supply meant that Unit C4’s protection systems were no longer functioning, and there was no DC supply available to open the generator circuit breaker, see Figure 33.

Because the generator circuit breaker did not operate, Unit C4 remained connected to the grid for the duration of the incident.

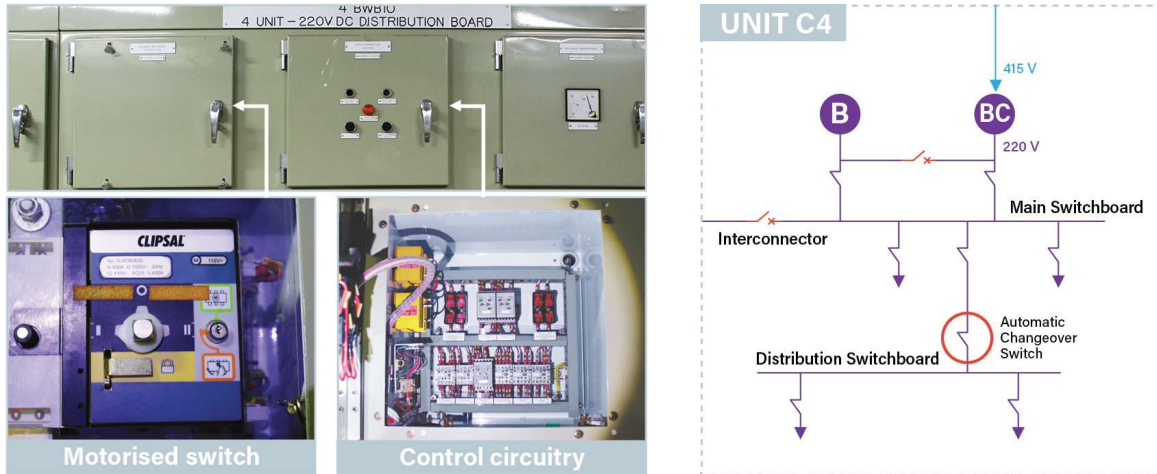
Figure 70 Unit C4 automatic changeover switch

³⁷ The Brady Heywood investigation concluded that prior to the incident, the Unit C4 automatic changeover switch's control circuitry was damaged, its fuses were blown, and the blown fuses were potentially removed. Any one of these three conditions alone would result in the automatic changeover switch being inoperable in automatic mode. (Evidence was

Had the automatic changeover switch been operational, it may have responded to the loss of DC voltage and automatically 'changed over' to supply part of the Unit C4 DC system from the Station DC system.³⁸ While the unit would likely have sustained significant damage, the turbine missile event would likely have been avoided.

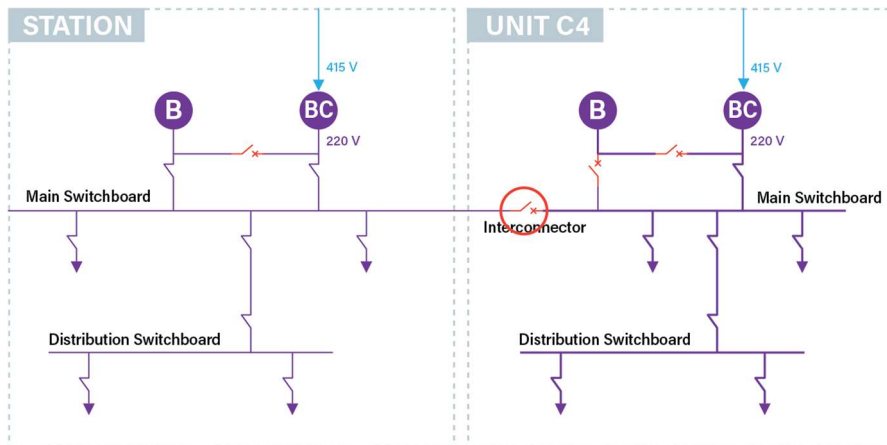
Figure 84 Disconnection of Station DC supply from the Unit C4 DC system

The next step in the planned switching sequence was to disconnect the Station DC supply from the Unit C4 DC system by opening the interconnector between the Station and Unit C4 DC systems. This step was completed at 1:33 pm on 25 May 2021, see Figure 84.

The disconnection of the Station DC supply (by opening the interconnector) initiated the voltage collapse in the Unit C4 DC system.

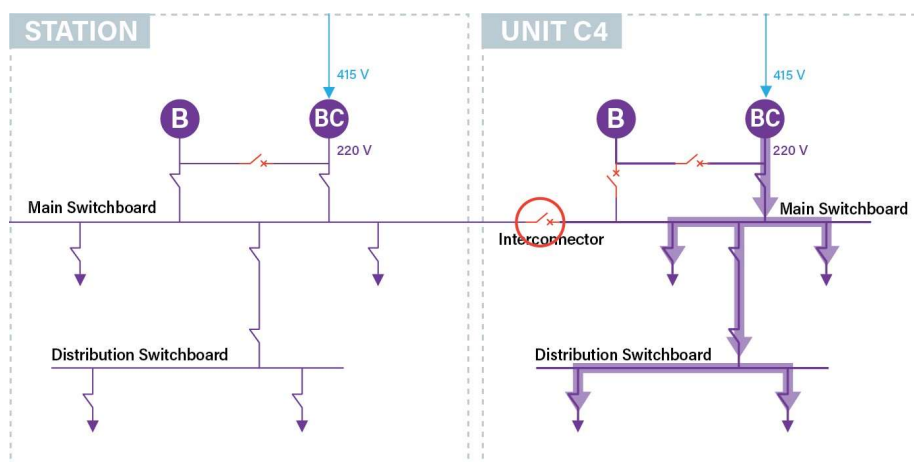
Figure 85 Requirement for the Unit C4 battery charger to maintain Unit C4 DC system voltage

The DC system voltage collapse occurred in the following manner. When the Station DC supply was disconnected, the Unit C4 battery charger became the sole source of DC supply to Unit C4. The switching sequence, therefore, placed a requirement on the replacement Unit C4 battery charger to respond instantly to maintain the voltage in the Unit C4 DC system, as illustrated in Figure 85.

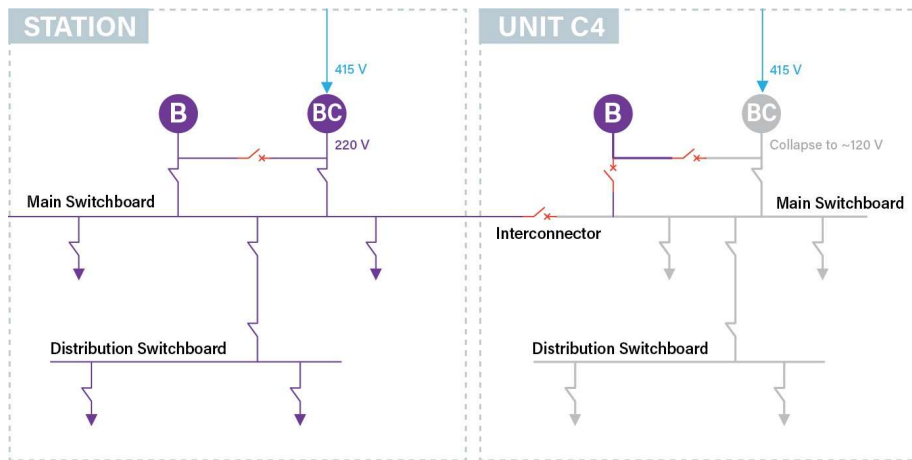
Figure 86 Collapse of DC supply to Unit C4 DC system (indicated in grey)

However, on the day of the incident, when the Station DC supply was disconnected, the replacement Unit C4 battery charger was unable to respond instantly to maintain the DC system voltage. At this

point in the switching sequence, there was an almost instantaneous collapse of voltage in the Unit C4 DC system, as illustrated in Figure 86.

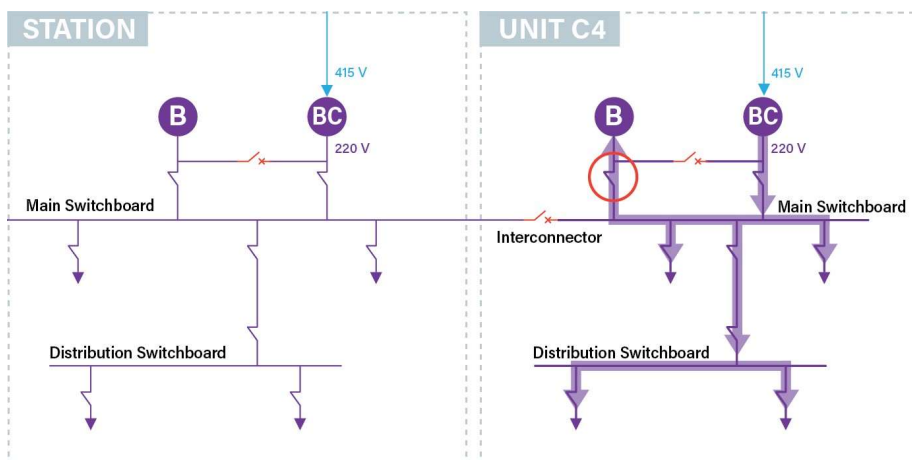
Figure 87 Planned connection of the Unit C4 battery to the Unit C4 DC system (did not occur)

The final step in the planned switching sequence was to connect the Unit C4 battery to the Unit C4 DC system main switchboard, see Figure 87.

This step, however, was not attempted or completed because the switching sequence was abandoned due to the commencement of the incident. If it had been completed, it would have restored the Callide C DC system to its typical configuration.

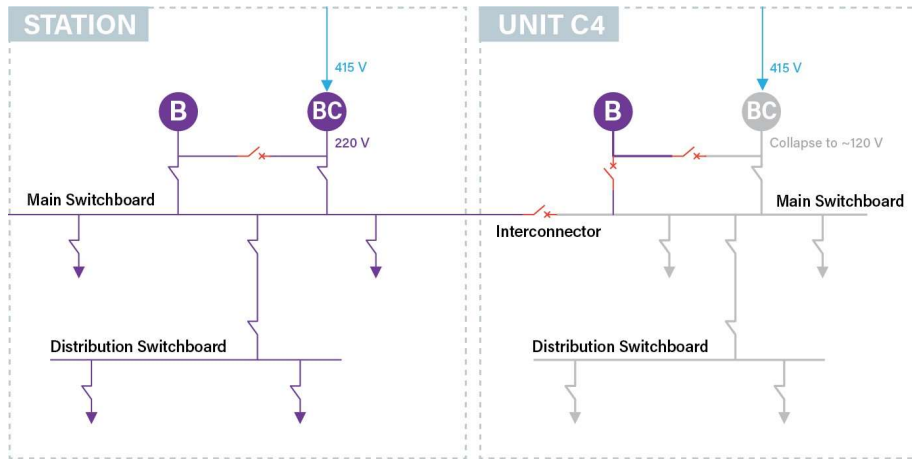
Figure 90 Collapse of DC supply to Unit C4 DC system (indicated in grey)

When the interconnector was opened, the voltage in Unit C4 DC system collapsed to ~120 V, see Figure 90.

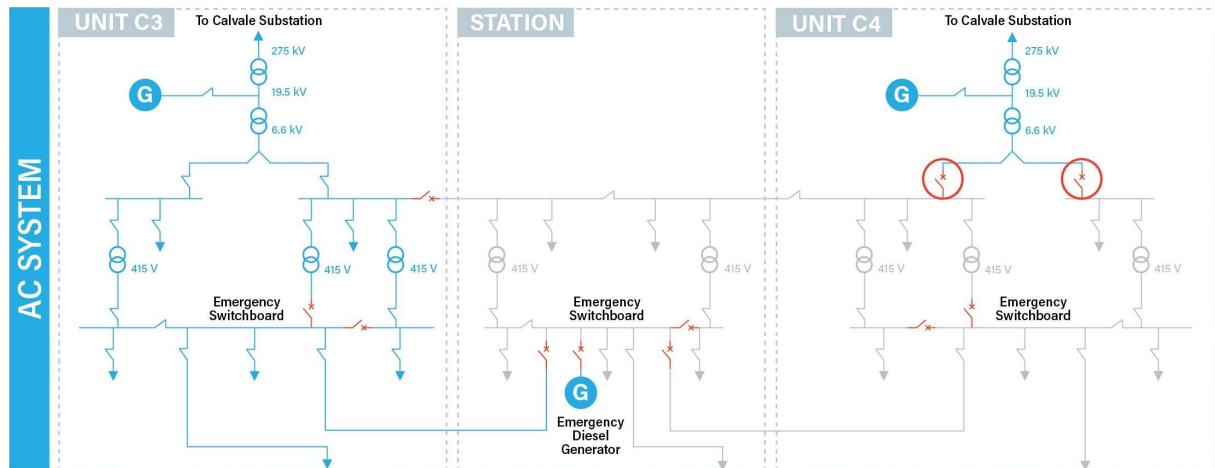
Figure 91 Unit C4 6.6 kV incomer circuit breakers trip (indicated in red)

The collapse in voltage in the Unit C4 DC system directly led to the loss of AC supply to the Unit C4 and Station AC systems. The precise manner in which this loss occurred is discussed in detail in Chapter 8 *How Arc Flap Protection Led to the Loss of AC Supply*. In simple terms, the collapse in DC voltage caused both of the 6.6 kV incomer circuit breakers in the Unit C4 AC system to trip (open automatically), as indicated in red in Figure 91.

The opening of the 6.6 kV incomer circuit breakers resulted in a complete loss of AC supply to the Station and Unit C4 AC systems, as indicated in grey in Figure 91 above.

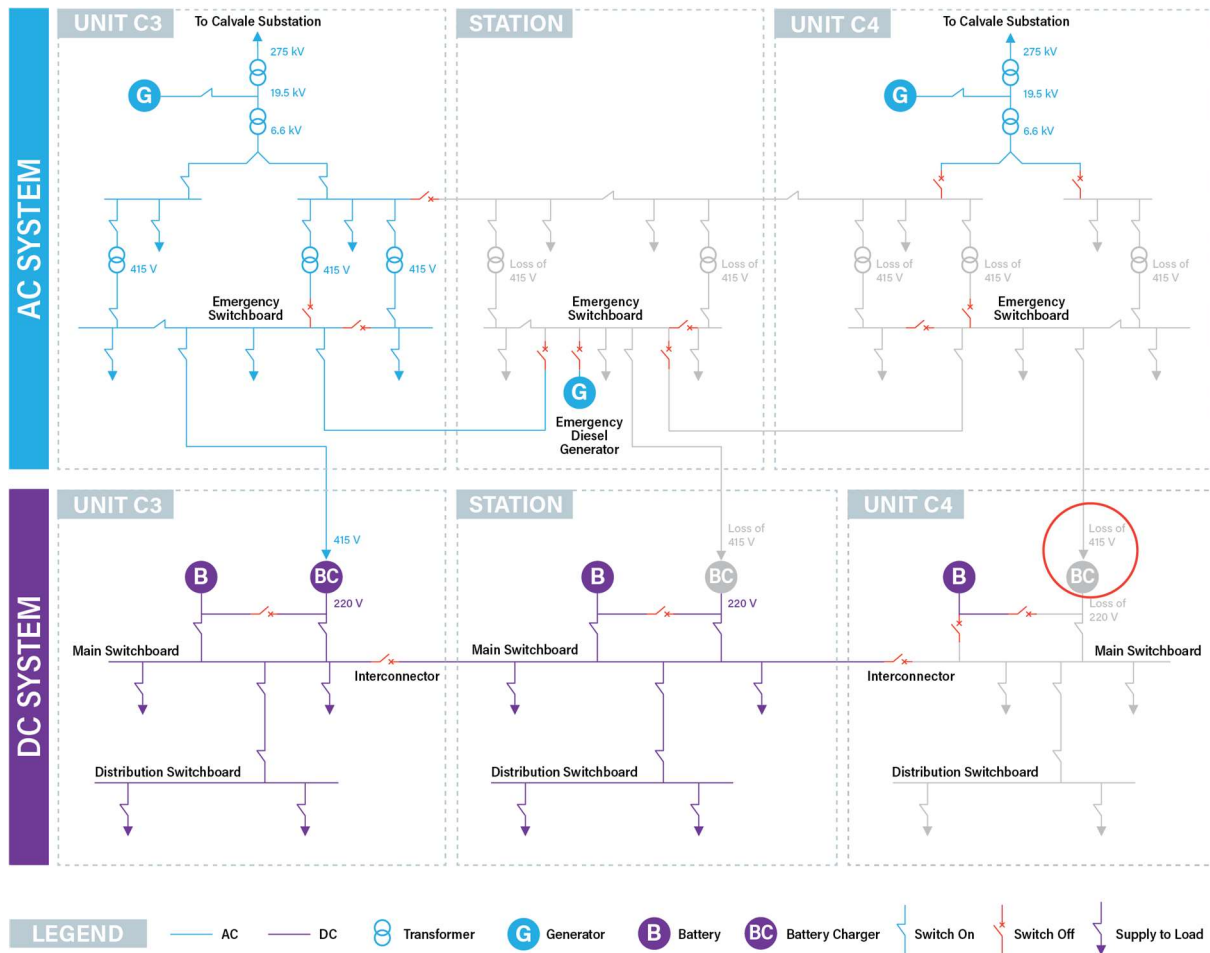
Figure 92 Loss of AC supply to Unit C4 battery charger (circled)

The loss of AC supply to the Unit C4 AC system emergency switchboard resulted in a loss of AC supply to the Unit C4 battery charger, which resulted in the battery charger shutting down, see Figure 92.

Had the Unit C4 battery charger’s AC supply been maintained, it is likely that the battery charger would have restored the DC system voltage to its usual level within 2 seconds. However, the loss of AC supply resulted in the Unit C4 battery charger shutting down before it could restore the DC system voltage.⁷⁴

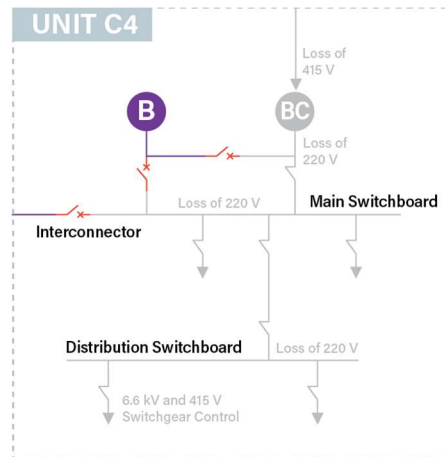
Figure 93 DC supply lost to Unit C4 main switchboard and distribution switchboard

The loss of DC supply (~0 V) resulted in the loss of both the Unit C4 main switchboard and the Unit C4 distribution switchboard, as shown in grey in Figure 93.

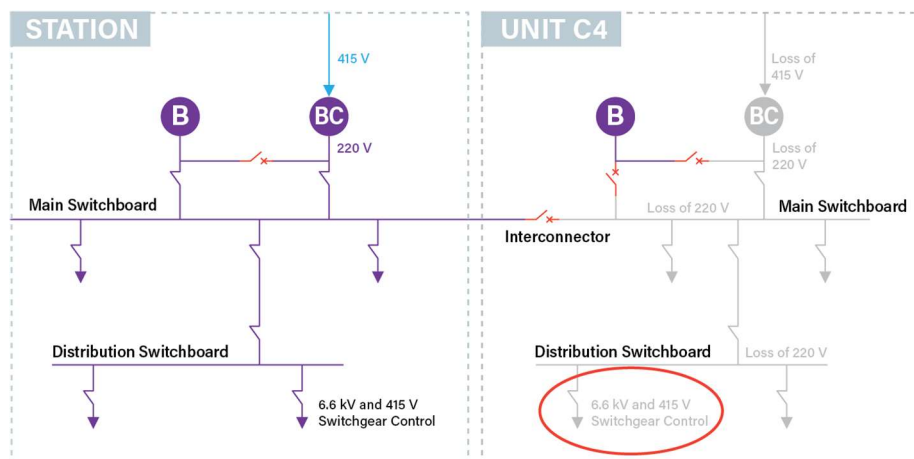
Figure 98 Loss of DC supply to Unit C4 AC switchgear control (indicated in red)

With DC supply lost to Unit C4, there was no supply available to the Unit C4 AC switchgear control, see Figure 98.⁸¹

Without DC supply available for the Unit C4 AC switchgear control, the Unit C4 switches could not operate.

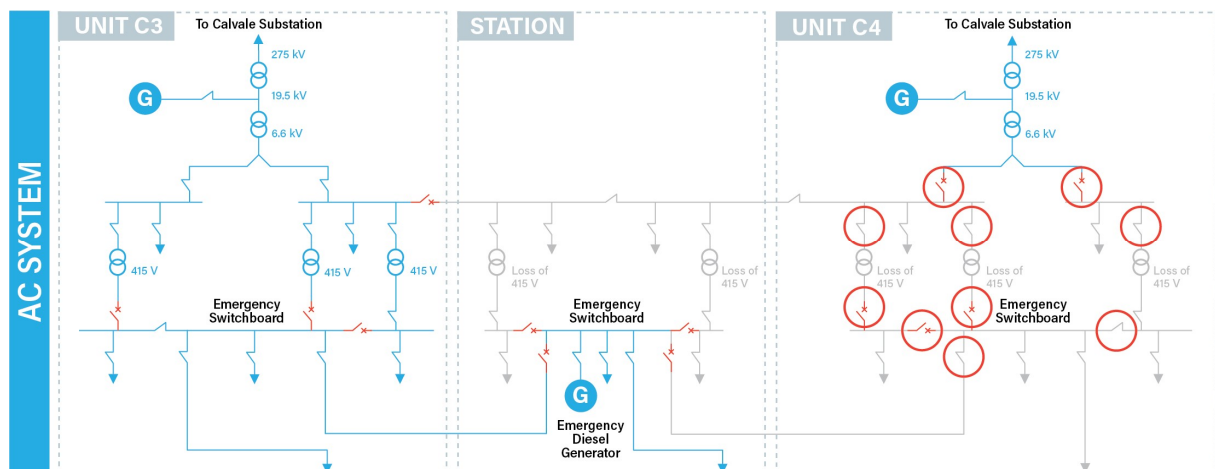
Figure 99 Switches in the Unit C4 AC system could not be configured due to loss of DC supply (indicated in red circles)

Figure 99 illustrates AC switches that could not be configured as a result, indicated in red.

Without the ability to reconfigure the necessary Unit C4 AC switches, AC supply from the emergency diesel generator (via the Station emergency switchboard) could not be restored to the Unit C4 emergency switchboard.

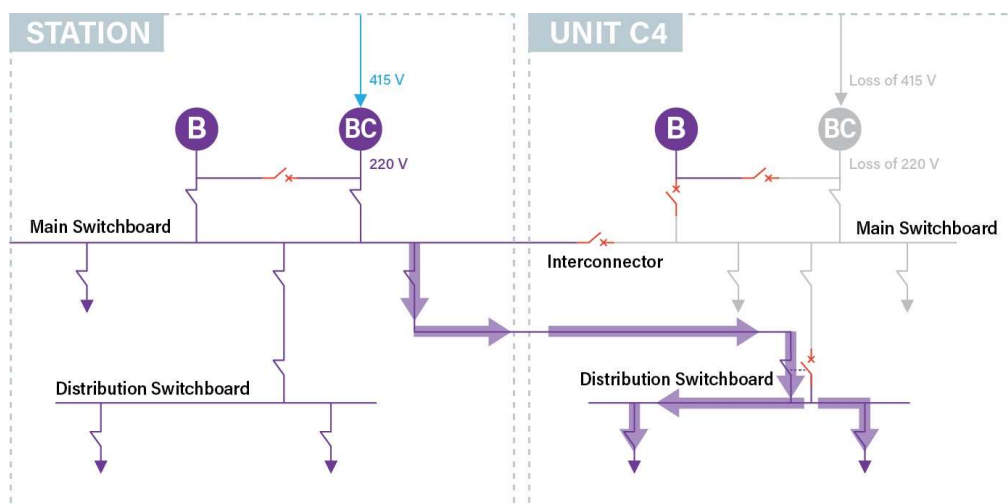
Figure 100 Unit C4 automatic changeover switch supplies Unit C4 distribution switchboard from the Station main switchboard

If DC supply to Unit C4 is lost, then the automatic changeover switch can automatically operate and 'change over' to supply the Unit C4 distribution switchboard from the Station main switchboard, see Figure 100.

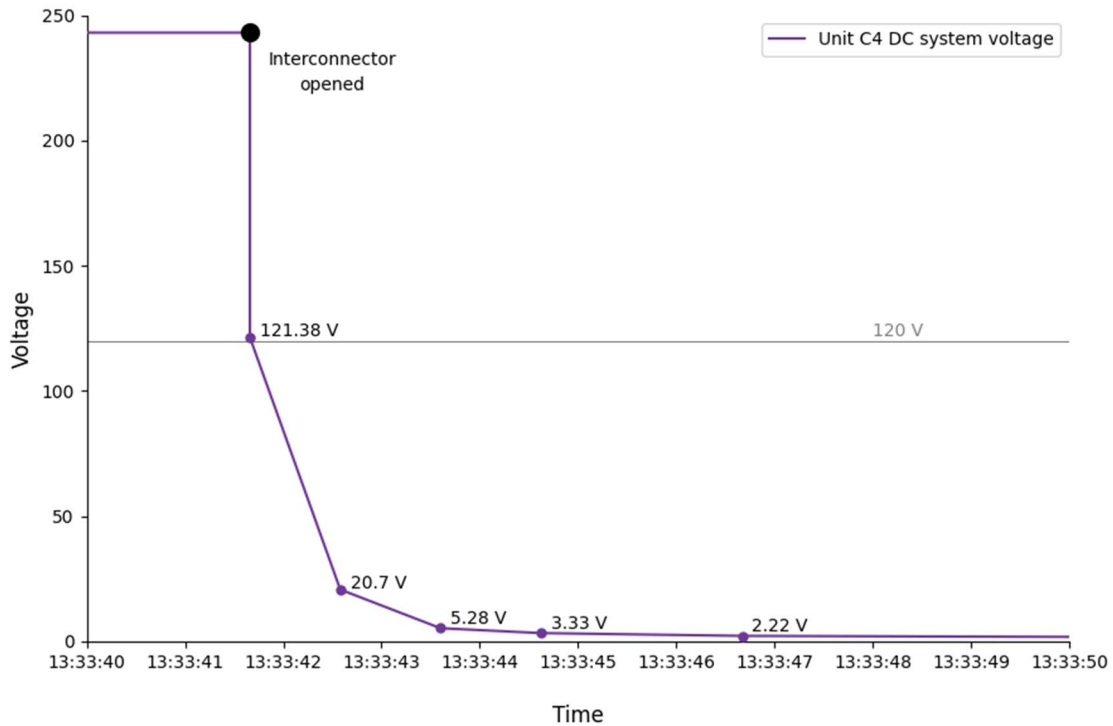
Figure 102 DC voltage in Unit C4 distribution switchboard

The Unit C4 battery charger did not maintain the voltage when the Station DC supply was disconnected, leading to a voltage collapse in the Unit C4 DC system. Figure 102 shows the voltage in the Unit C4 DC system prior to and after the Station DC system being disconnected.⁸⁸

Prior to the interconnector being opened, the voltage in the DC system was ~243 V. When the interconnector was opened, the voltage collapsed to ~120 V, then rapidly decayed to ~0 V.⁸⁹ This voltage collapse was a result of the behaviour of the Unit C4 battery charger, which is discussed in detail in Chapter 9 *How the Battery Charger Led to the DC Voltage Collapse*.

⁸⁹ The purple dots in Figure 102 depict the data as measured by the integrated control and monitoring system (ICMS) on the Unit C4 distribution switchboard. The black dot, however, was not recorded by the system. Rather, it has been included as a likely indicative value at the time immediately prior to the interconnector being opened. The basis for this indicative value is discussed in Appendix A3 *Electrical Investigation*.

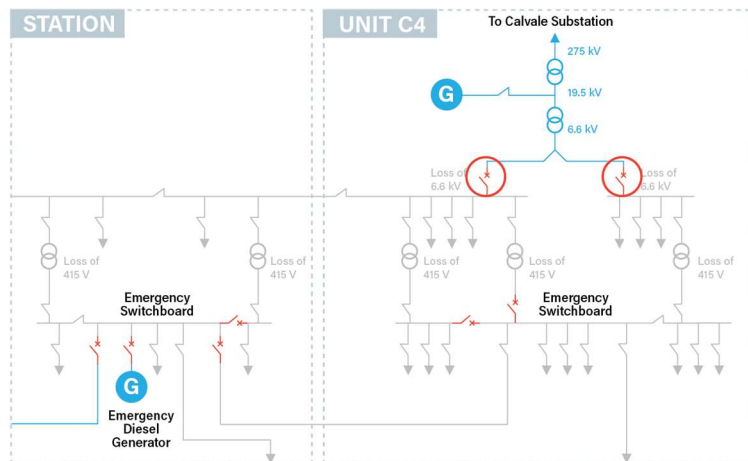
Figure 104 Unit C4 6.6 kV incomer circuit breakers tripped (opened automatically)

On the day of the incident, the voltage collapse in the Unit C4 DC system caused the arc flap protection to respond as if a fault had occurred in the unit’s AC system. Despite no such fault occurring, the arc flap protection activated and disconnected the AC supply to Unit C4.

On the day of the incident, the arc flap protection operated and tripped the two Unit C4 6.6 kV incomer circuit breakers, disconnecting the AC supply to the Unit C4 AC system, see Figure 104.

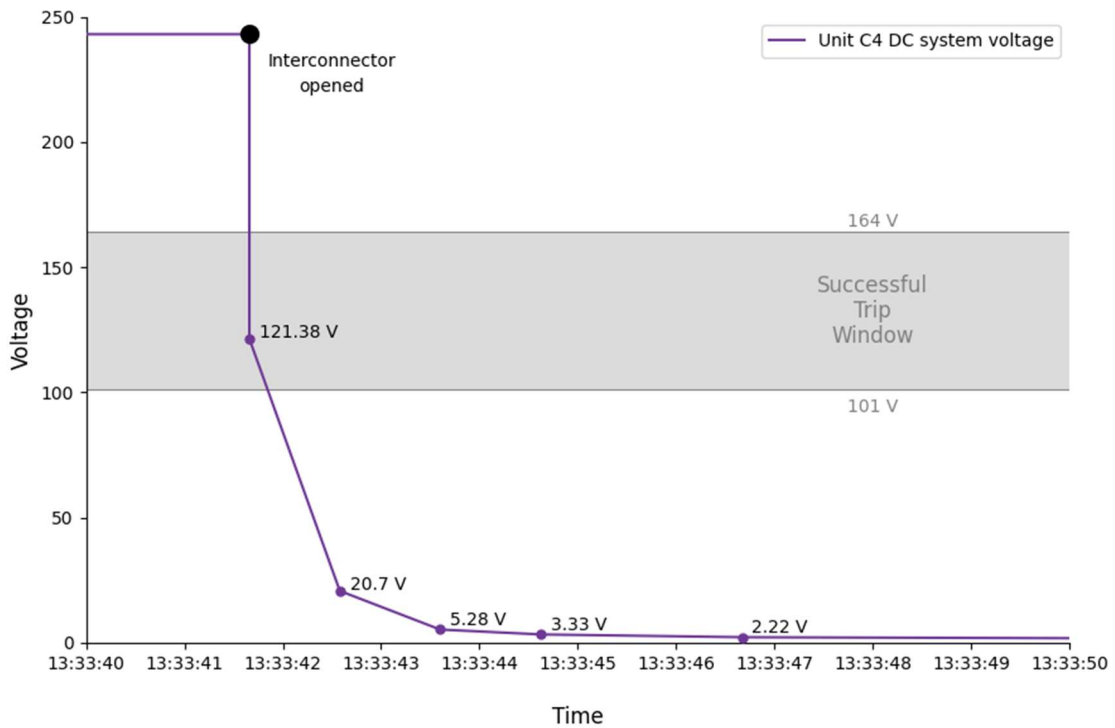
Figure 109 Trip window

- When the DC voltage collapsed to ~ 120 V, the protection relays responded as if an arc had occurred and sent a trip signal to the circuit breakers.
- The circuit breakers operated and tripped the AC supply to Unit C4 before the DC voltage had sufficient time to decay below 101 V.

While the voltage collapse from ~ 243 V to ~ 120 V was relatively instantaneous, it took time for the voltage to decay below 101 V.⁹⁵ Therefore, there was a window of time where the voltage was below

164 V (initiating the trip), but above 101 V (the minimum operating voltage for the circuit breaker to trip). This timeframe was of sufficient duration to successfully execute the trip, as illustrated in Figure 109.⁹⁶

⁹⁶ Data from the day of the incident shows that less than 100 milliseconds elapsed between the arc flap being detected by the protection relay and the incomer circuit breaker being opened. PowerPoint Presentation (8 July 2021) *Callide Power Station Unit C4 6.6kV Incomer Circuit Breaker Tripping*, CSE.001.002.9229.

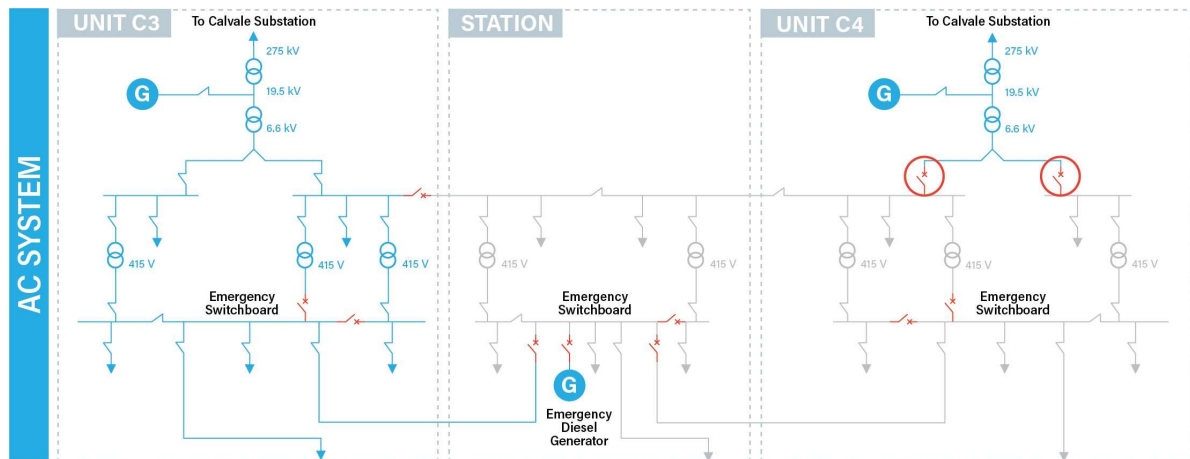
Figure 110 6.6 kV incomer circuit breakers trip and disconnect Unit C4 and Station AC supply

When the 6.6 kV incomer circuit breakers tripped, all AC supply was lost to Unit C4 and Station, see Figure 110.

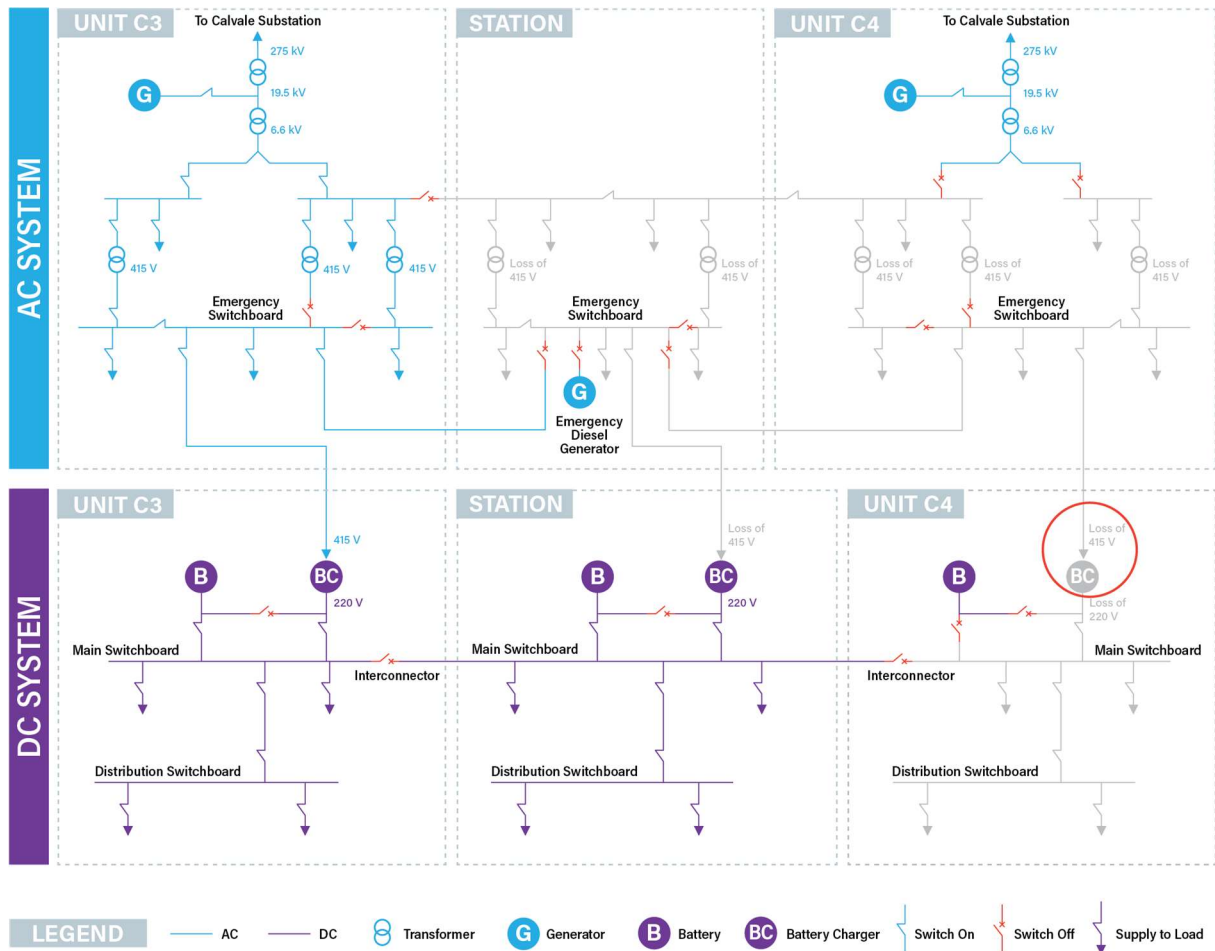
Figure 111 Opening of 6.6 kV incomer circuit breakers causes loss of AC supply to Unit C4 battery charger (indicated in red)

The trip of the 6.6kV incomer circuit breakers resulted in a complete loss of AC supply to the Unit C4 AC system, including the AC supply to the Unit C4 battery charger, see Figure 111.

Had the AC supply to the Unit C4 battery charger not been lost, it likely would have responded to the collapse in DC voltage and restored the DC system voltage to its usual level within 2 seconds.⁹⁹ However, with no AC supply, the Unit C4 battery charger shut down, leading to a complete loss of DC supply to Unit C4.

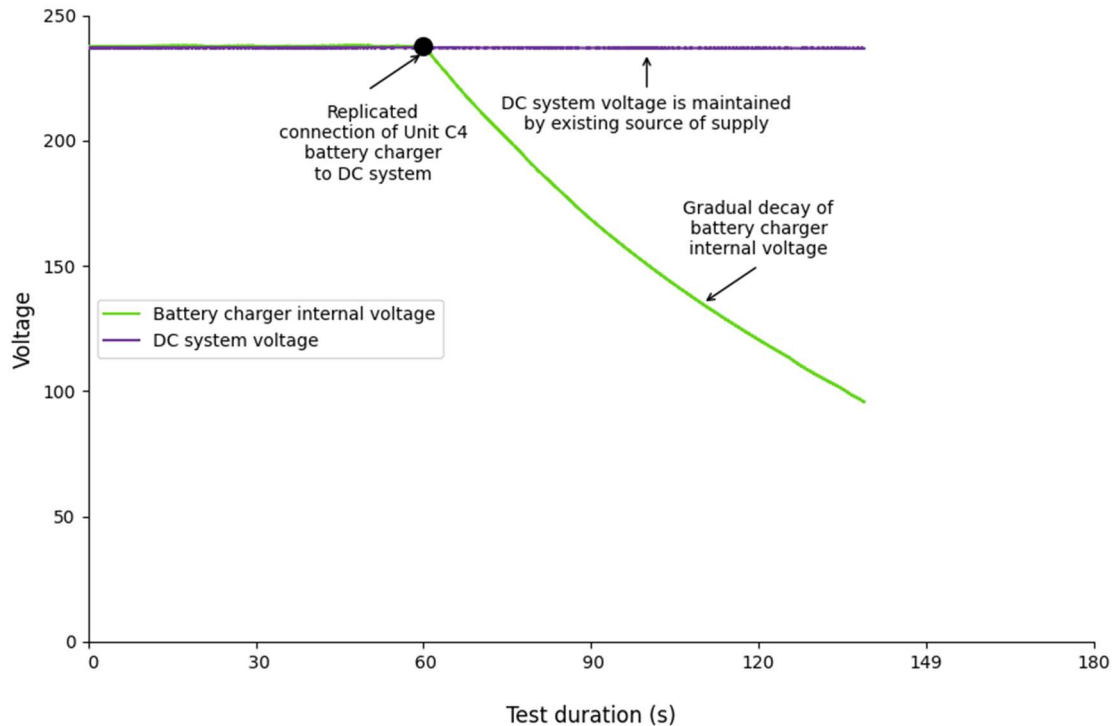
Figure 114 Unit C4 battery charger's internal voltage gradual decay as demonstrated by testing

However, if the voltage in the DC system is *higher* than the battery charger's target output voltage, the battery charger does not output any power. In this situation, when the Unit C4 battery charger is providing no output power, its internal voltage starts to gradually decay (towards 0 V).¹⁰⁴ This gradual decay of the battery charger's internal voltage is illustrated in Figure 114.¹⁰⁵

¹⁰⁴ This occurs because the Magellan MCR II battery chargers used in Callide C have a series connected diode at their output, and the feedback signal for the battery charger's control circuitry is likely taken from the load side (cathode) of this diode. This is discussed further in Appendix A4 *Battery Charger Investigation*.

The purple line depicts the voltage in the DC system (which is maintained by the existing source of supply at a higher voltage), and the green line illustrates the gradual decay of the Unit C4 battery charger's internal voltage.¹⁰⁶

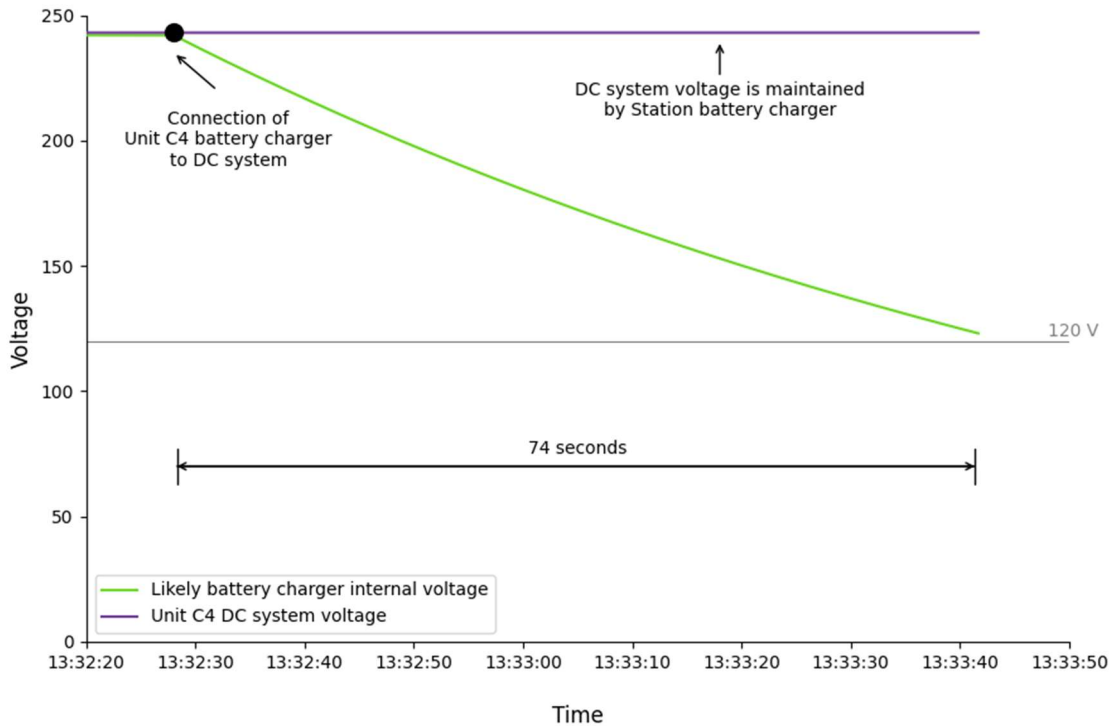
Figure 115 Likely gradual decay of the Unit C4 battery charger’s internal voltage to ~120 V

The time that elapsed between connecting the Unit C4 battery charger to the DC system (when its internal voltage would have begun to gradually decay) and disconnecting the Station DC system was 74 seconds. The Brady Heywood investigation tests showed that, in this 74 second period, the internal voltage of the Unit C4 battery charger would likely have decayed to ~120 V, as depicted in Figure 115.

¹⁰⁸ The Unit C4 battery charger had been configured to output 245.16 V and the Station battery charger had been configured to output 243 V. No evidence has been sighted that indicates that this difference in configuration was intentional.

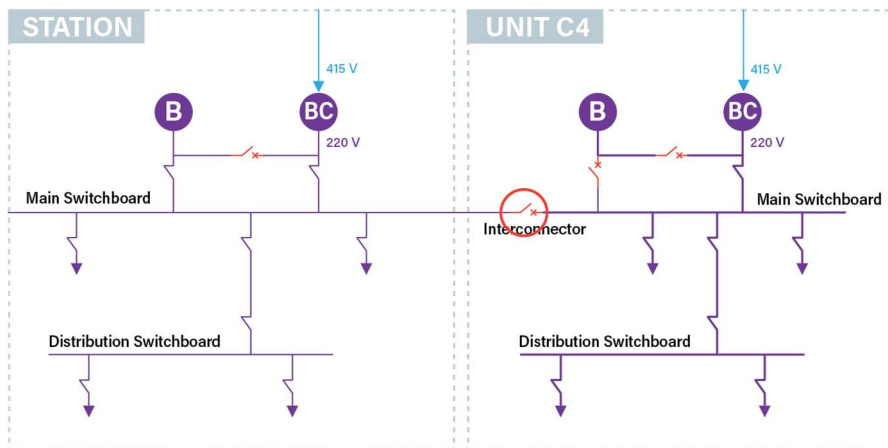
Figure 116 Disconnection of Station DC supply by opening interconnector (indicated in red circle)

The next step in the switching sequence was to disconnect the Station DC supply by opening the interconnector, see Figure 116.

This meant the Unit C4 battery charger was the sole source of supply to the Unit C4 DC system. This step was completed at 1:33 pm on the day of the incident.

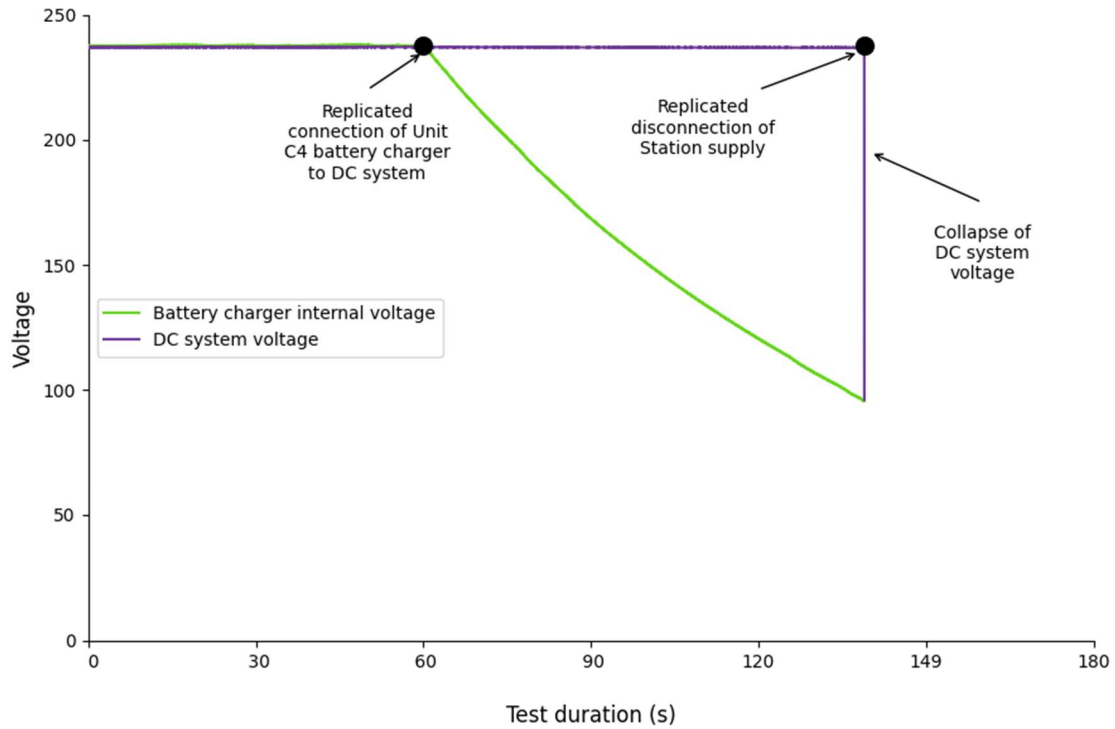
Figure 117 DC system voltage collapses to the level of the battery charger's internal voltage, as demonstrated by testing

The tests showed that, when the other source of DC supply is disconnected, the Unit C4 battery charger is only capable of outputting a voltage at the level of its internal voltage at that precise time. As a consequence, the voltage in the DC system collapses to the level of this internal voltage. This collapse in voltage is depicted by the purple line in Figure 117.¹⁰⁹
