Brady Heywood.

Technical and Organisational Investigation of the Callide Unit C4 Incident

July 2024

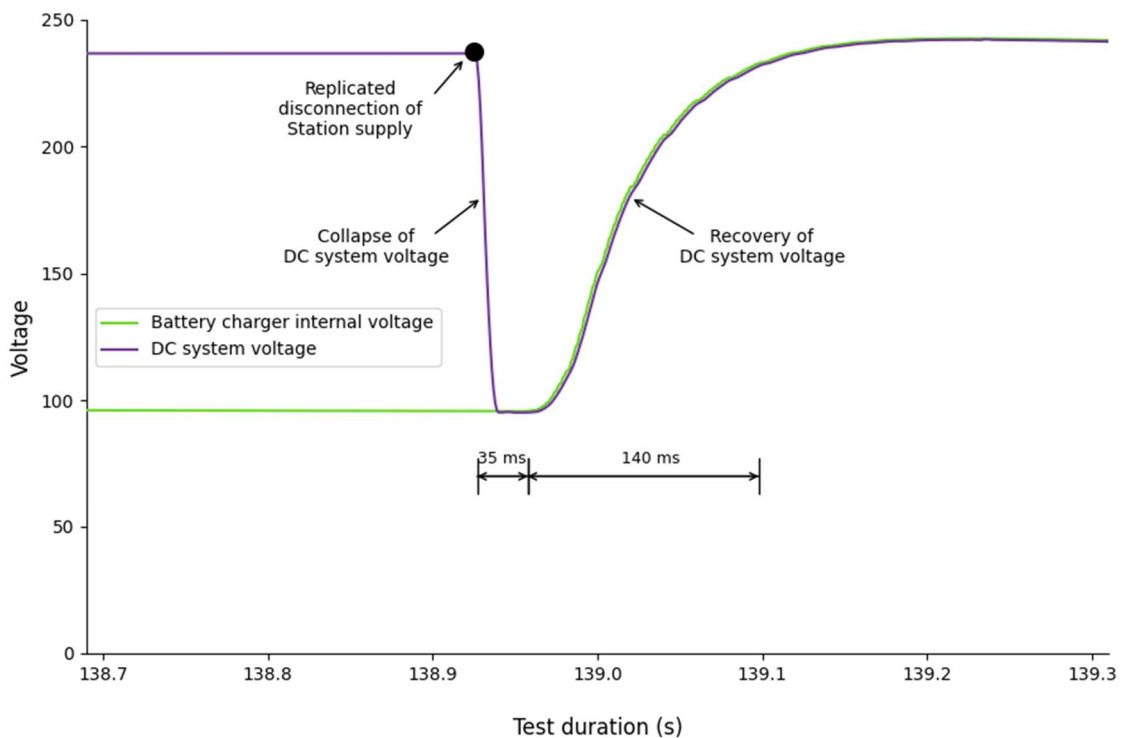
Figure 119 Detail of collapse and recovery of the DC system voltage, as demonstrated by testing

This voltage collapse and recovery is shown in greater detail in Figure 119.

During testing, the battery charger took ~35 milliseconds to respond to the collapse in voltage, and an additional ~140 milliseconds to restore the system voltage to ~240 V.

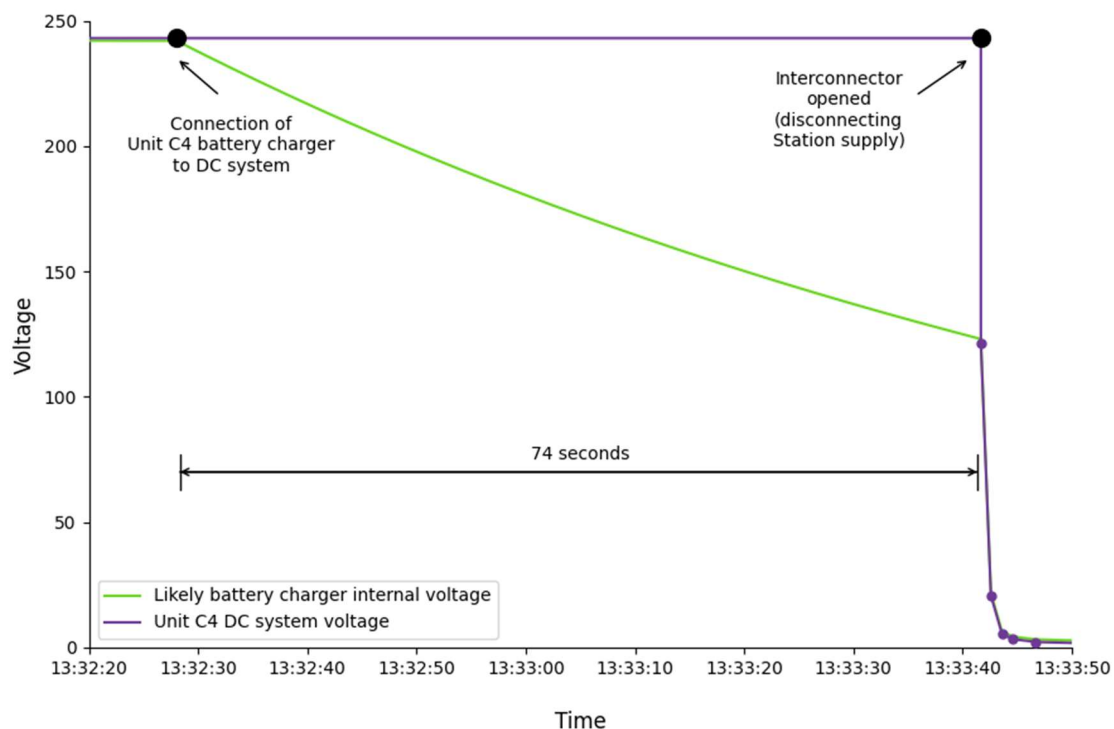
Figure 120 Collapse of DC system voltage to level of Unit C4 battery charger's internal voltage (~120 V)

On the day of the incident, when the Unit C4 battery charger was connected to the Unit C4 DC system, it responded in a manner consistent with the target output voltage being lower than the voltage in the DC system. This likely resulted in the voltage inside the Unit C4 battery charger gradually decaying.¹¹¹

When the interconnector was opened, the voltage in the Unit C4 DC system suddenly collapsed from ~243 V to ~120 V.¹¹² As discussed previously, ~120 V correlates with the likely level that the Unit C4 battery charger's internal voltage would have decayed to in this 74-second period, see Figure 120.¹¹³

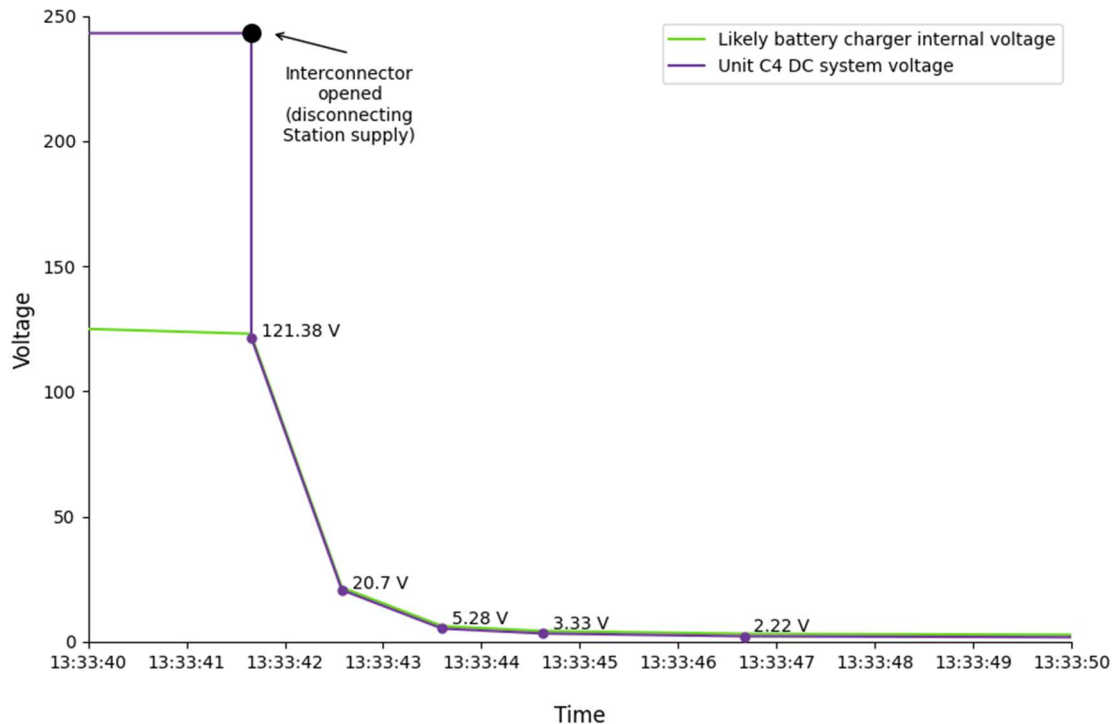
Figure 121 Detail of the rapid decay of the Unit C4 DC voltage

Following the collapse to ~120 V, the voltage in the DC system did not recover, but rapidly decayed. This rapid decay is shown in greater detail in Figure 121.

The reason for the rapid decay is twofold:

- The collapse of DC voltage resulted in the loss of AC supply to Unit C4. This loss of AC supply led to the Unit C4 battery charger shutting down and the loss of DC supply to Unit C4.
- With DC supply lost, the existing loads on the Unit C4 system (e.g., relays) continued to draw power. This led to the voltage in the system rapidly decaying.

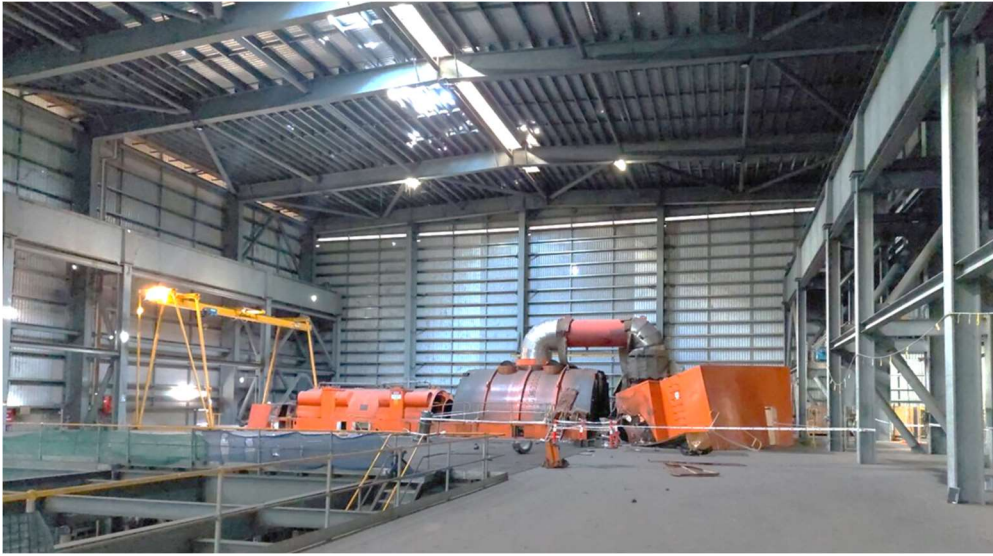
Figure 124 Post-incident Unit C4 in the turbine hall

Figure 124 shows Unit C4 in the turbine hall (post-incident). All four units are located in the same building.

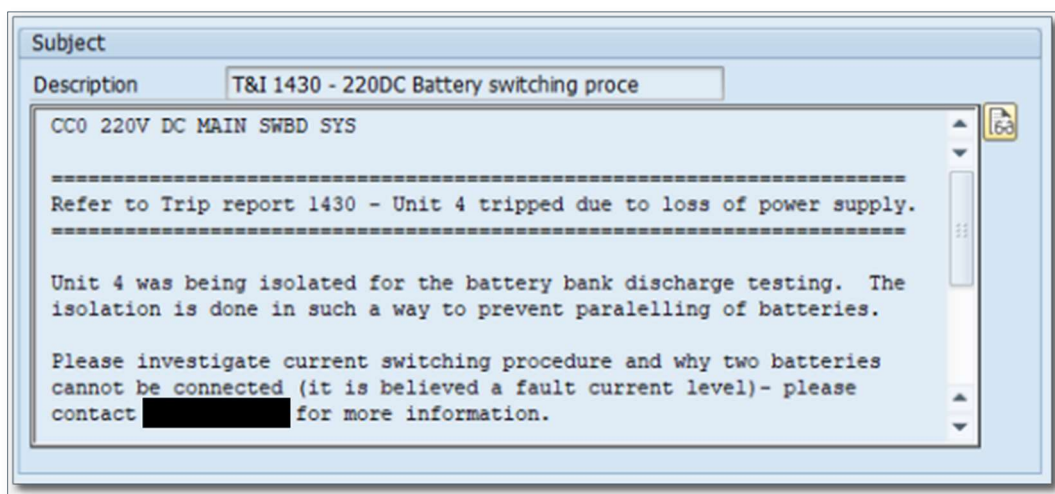
Figure 145 Notification 10284279

On 12 February 2010, a switching sequence was being undertaken on the DC system to perform routine maintenance. When a switch was operated, as part of the switching sequence, it caused a momentary voltage dip in the DC system, which caused Unit C4 to trip. The incident category assigned to this event is unknown. However, it did result in an investigation and the completion of a Significant Incident Report.⁴¹⁷

From this investigation, several notifications were raised.⁴¹⁸ Among these, a notification was raised to '*Please investigate current switching procedure and why two batteries cannot be connected*', see Figure 145.⁴¹⁹

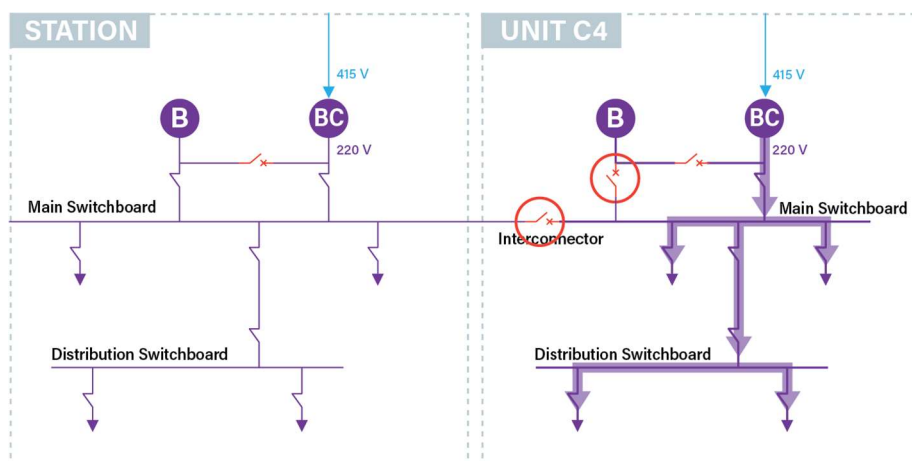
Figure 147 Requirement that the Unit C4 battery charger would maintain DC system voltage in the absence of the Unit C4 battery

The redundancy provided by the battery was unavailable when the switching sequence was being carried out on the day of the incident. This placed a requirement on the Unit C4 battery charger to respond when the Station DC supply was disconnected (by opening the interconnector), with the Unit C4 battery not yet connected, see Figure 147.

This created the situation that, if the battery charger did not operate as required, DC supply to Unit C4 would likely be lost.⁴⁴²

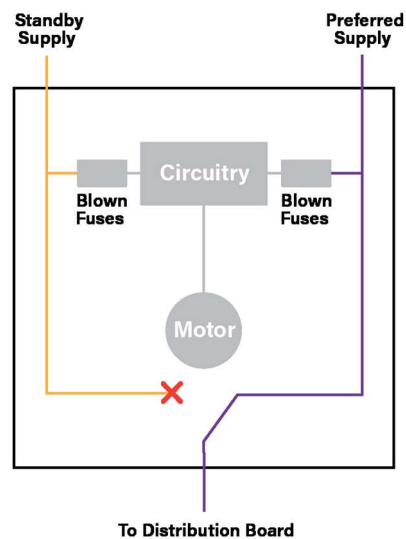
Figure 174 Blown fuses in the Unit C4 ACS

On 15 January 2021, when investigating the dual trip event from two days prior, CS Energy identified that both sets of fuses in the control circuitry of the Unit C4 ACS were blown, as illustrated in Figure 174.⁶¹⁷

If, however, the fuses had been blown before (or if the fuses blew during) the dual trip event, the inherent connectivity would be removed, and the fault would not propagate through the ACS. However, the IRP (which does not have fuses) provides inherent connectivity between Unit C4 and Station via the same mechanism.

It is likely that the fault that caused the dual trip event propagated via both paths initially (the ACS and IRP), and when the fuses in the ACS blew, the fault continued to propagate via the IRP only.

⁶¹⁹ The maintenance notification raised on 15 January 2021 (as a result of the January 2021 dual trip event) requested that the blown fuses be replaced and the control circuitry be checked – indicating it could have been damaged in the January 2021 dual trip event. CS Energy (15 January 2021) *CC4 Unit 220VDC DB Auto Changeover*, Notification 10603823, CSE.001.102.0074. The ACS would not operate automatically if the fuses were replaced, but the circuitry was damaged.

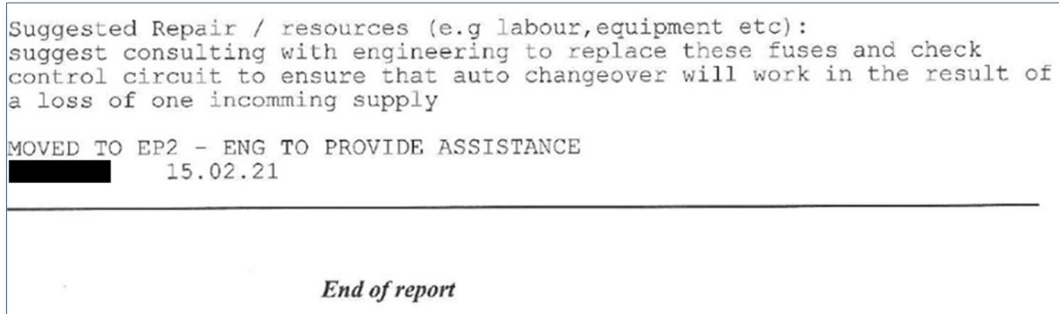
Figure 175 Actions suggested on the notification

On 15 January 2021, a maintenance notification was raised regarding 'the possible blown fuses' in the Unit C4 ACS. The notification requested that the fuses be replaced and the ACS be checked to ensure it was operational in automatic mode, see Figure 175.⁶²³

The notification was classified as Priority 4 – Low Consequence. Because it was classified as a Priority 4, in accordance with the CS Energy Work Management Manual, the work appears to have been considered a low priority. Priority 4 required the notification to be actioned by 9 April 2021, within 12 weeks of the date the notification being raised.⁶²⁴ The notification itself proposed an end date of 16 March 2021

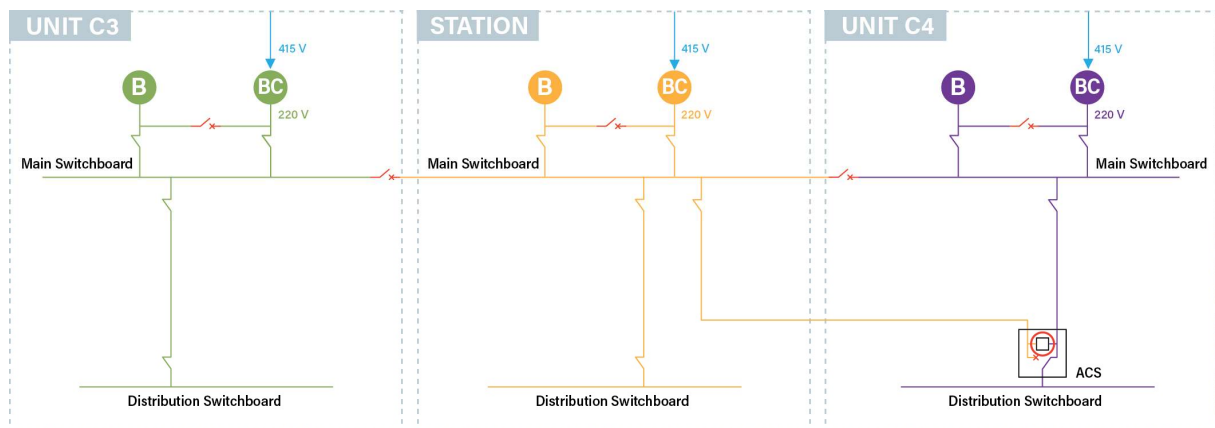
Figure 177 Unit C4 ACS control circuitry inherently connecting Station DC system to Unit C4 DC system

Figure 177 illustrates how the Unit C4 ACS inherently connects the Station DC system to the Unit C4 DC system.

This inherent connectivity is not a result of the ACS changing from the preferred supply to the standby supply, but rather it occurs through the ACS's control circuitry.⁶²⁹

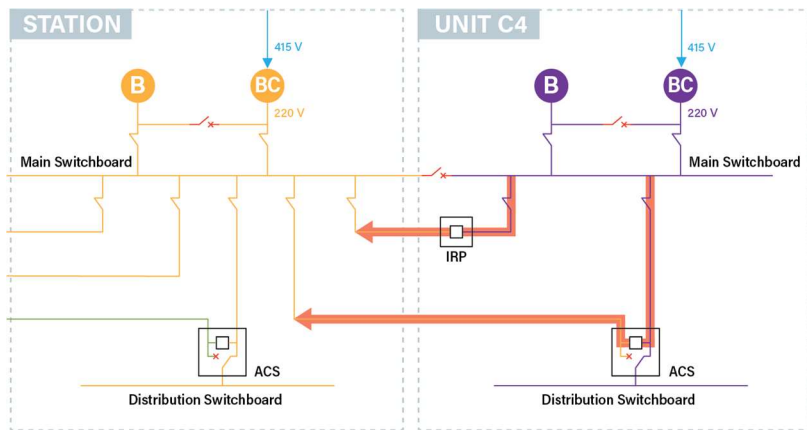
Figure 181 Electrical fault propagated from Unit C4 to Station

The cause of the January 2021 dual trip event was an electrical fault in the Unit C4 DC system that propagated to the Station and Unit C3 DC systems.⁶³¹ The CS Energy investigation into the event determined that the fault propagated from Unit C4 to Station, via the Unit C4 ACS control circuitry and the interlocking relay panel between Unit C4 and Station, see Figure 181.⁶³²

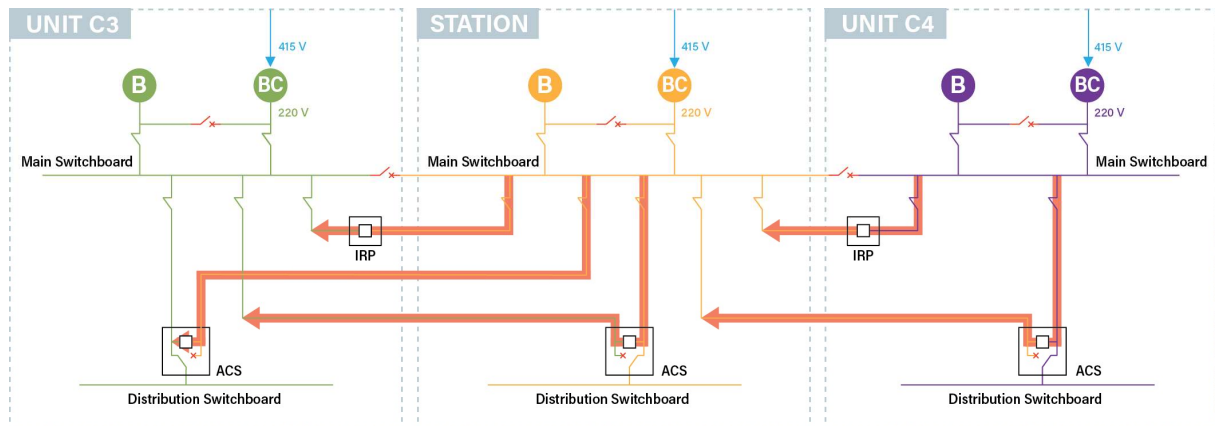
Figure 182 Electrical fault propagated from Station to Unit C3

Similarly, the fault then propagated from the Station DC system to the Unit C3 DC system, via the Station ACS, the Unit C3 ACS, and Unit C3 IRP, see Figure 182.

The propagated electrical fault caused both Unit C4 and Unit C3 to trip and likely caused damage to several pieces of equipment.⁶³³

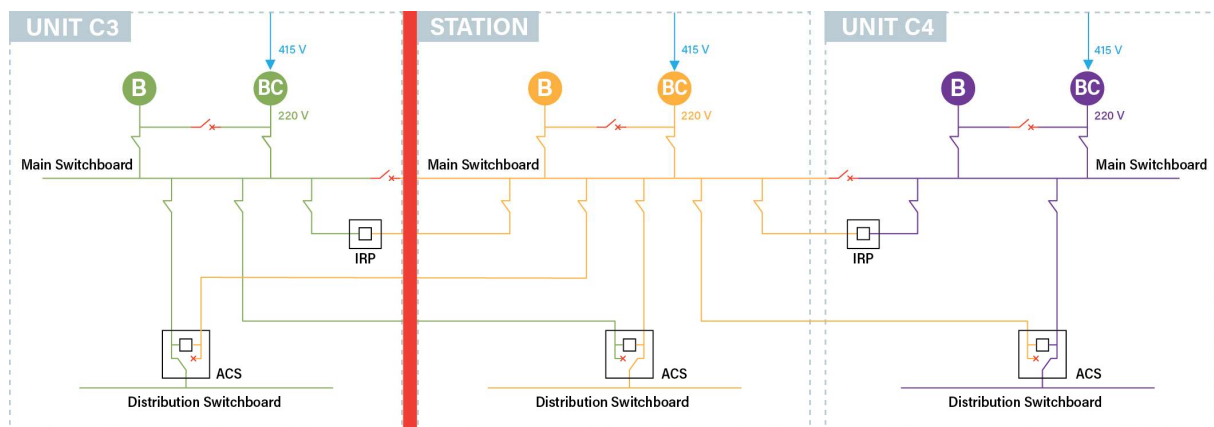
Figure 183 The proposed separation of Unit C3 and Station (indicated by red line)

To meet AEMO's requirements (so that AEMO would lift the restrictions), CS Energy informed AEMO they would make changes that would effectively remove the connectivity between Unit C3 and Station. This is illustrated conceptually by the red line in Figure 183.

Removal of connectivity between these two systems would also remove connectivity between Unit C3 and Unit C4. (It was not necessary to remove connectivity between Station and Unit C4 as separating Unit C3 from Station was sufficient – this broke the link between Unit C4 and Unit C3.) CS Energy's

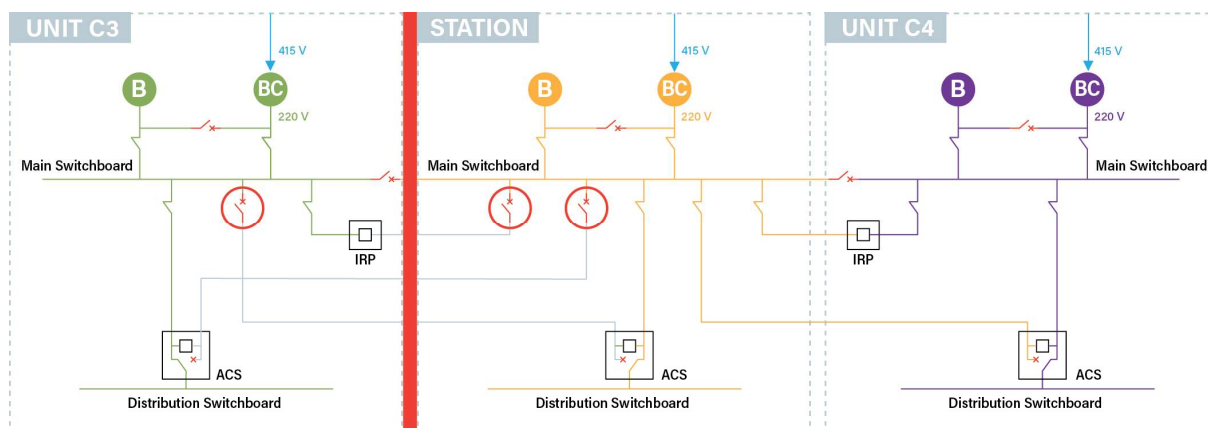
Figure 184 CS Energy advised AEMO on 25 January 2021 that these isolations (circled in red) had been made

CS Energy informed AEMO via email that this removal of connectivity would be achieved by performing several 'isolations', meaning that certain switches (known as 'isolators') would be opened.⁶³⁸ This email included a sketch showing the proposed isolations. Figure 184 is a simplified version of that sketch, showing the isolations in the DC systems (isolations circled in red).⁶³⁹

These changes deliberately rendered the Unit C3 and Station ACSs inoperable. As a result, if a loss of DC supply occurred in either Unit C3 or Station, the ACS would be unavailable to restore supply.

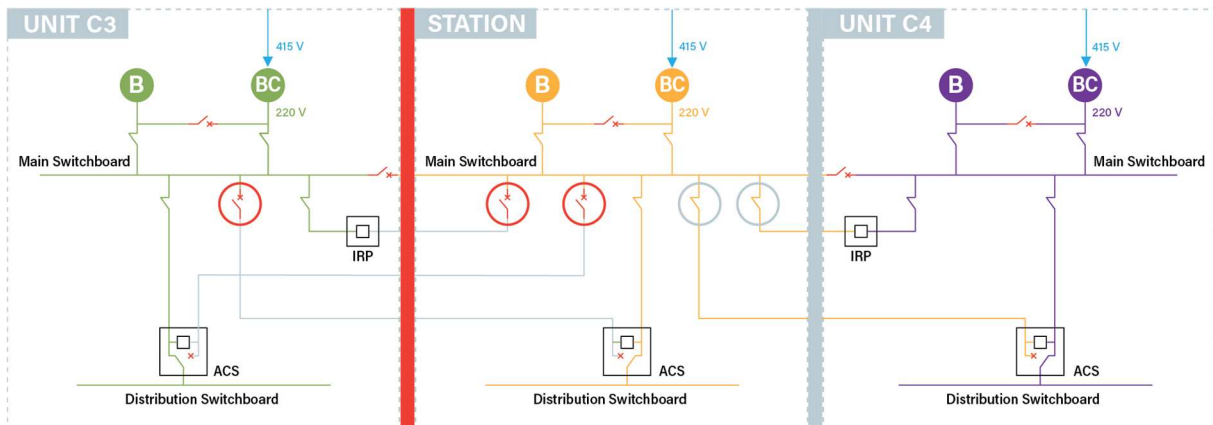
Figure 185 CS Energy did not perform isolations to remove the inherent connectivity between the Unit C4 and Station DC systems

It is important to note that no isolations were undertaken to deliberately render the Unit C4 ACS inoperable in the same manner as the Unit C3 and Station ACSs. The isolator from the Station DC mainboard to the Unit C4 ACS was not opened, nor was the isolator to the IRP.⁶⁴⁰ The grey circles in Figure 185 show the isolators that would have needed to have been opened to deliberately render the Unit C4 ACS inoperable and electrically isolate the Unit C4 DC system from the Station DC system.

It is likely that both of these isolators would have been opened if the intention had been to separate the Unit C4 and Station DC systems and render the Unit C4 ACS inoperable.⁶⁴¹ These isolations did not occur.

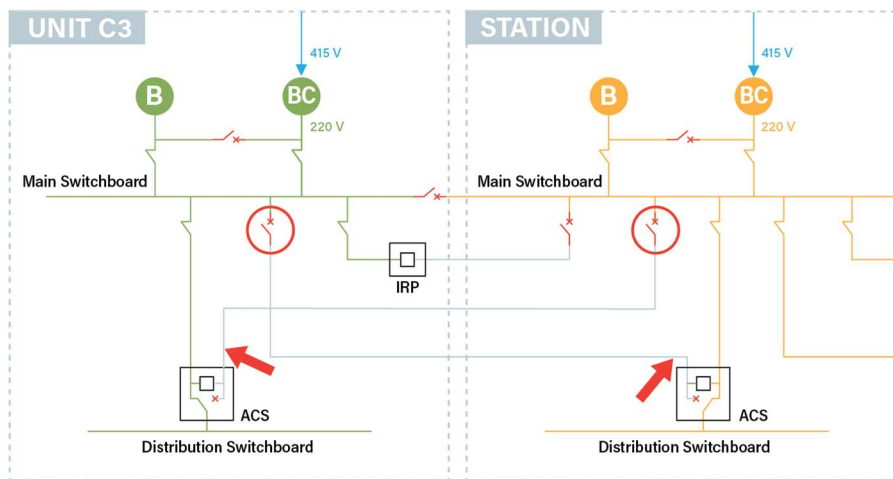
Figure 186 Standby supplies to both the Unit C3 and Station ACSs (red arrows) were disconnected by the isolations (red circles)

Opening these isolators on the supplies to the Unit C3 and Station ACSs removed the standby supply to both of these ACSs, as illustrated in Figure 186.

⁶⁴² Despite informing AEMO on 25 January 2021 that the isolations had been made, ICMS data shows that the standby power supplies to the Unit C3 ACS, the Station ACS and the IRP between Unit C3 and Station were actually isolated on 27 January 2021.

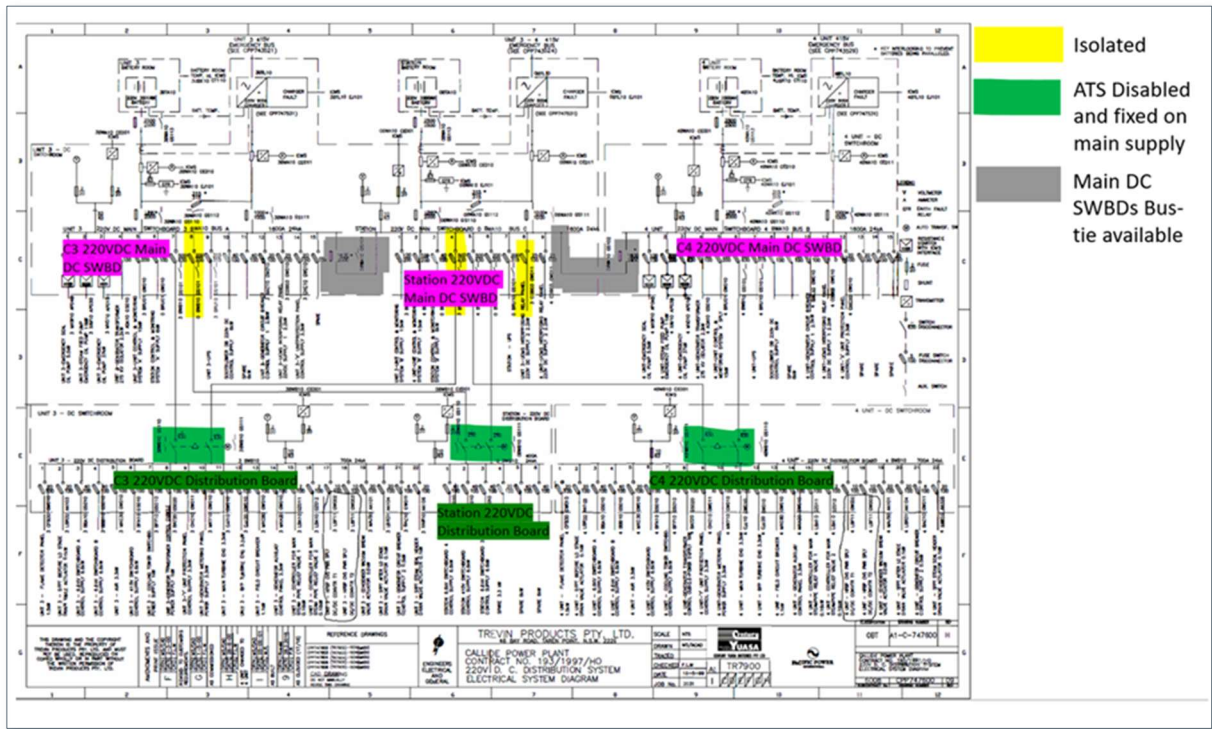
Figure 187 Marked-up drawing in email from CS Energy to AEMO on 27 January 2021

Energy to AEMO included a marked-up drawing of the Callide C power station DC system, see Figure 187.⁶⁵³

⁶⁵³ The email stated that 'the automatic changeovers to the 220VDC Distribution Boards have been isolated as these were the location where the DC coupling occurred'. 'DC coupling' means the same as the electrical connectivity. Email (27 January 2021) Brief Update – RE: Reclassification of the simultaneous tripping of Callide units C3 and C4-Rectification Actions, 12:16 pm, CSE.001.102.0254.

At the time this email was sent to AMEO, CS Energy was aware that the fuses in the Unit C4 ACS had blown and would also have been aware that these blown fuses could impact the automatic operation of the ACS. It is, therefore, likely that the green highlighting of the Unit C4 ACS in Figure 187 above, is to indicate that the Unit C4 ACS was inoperable (because of the blown fuses), and that no action was taken to deliberately render it inoperable.⁶⁵⁵
